NORTHERN COLORADO REGIONAL AIRPORT COMMISSION

Hangar Leases Discussion and Possible Executive Session Consistent with C.R.S. Sections 24-6-402(4)(e)(I), 4(a), and 4(b)

RE: Northern Colorado Regional Airport
T-Hangar Structural Analysis

T-Hangar Observation Report Log

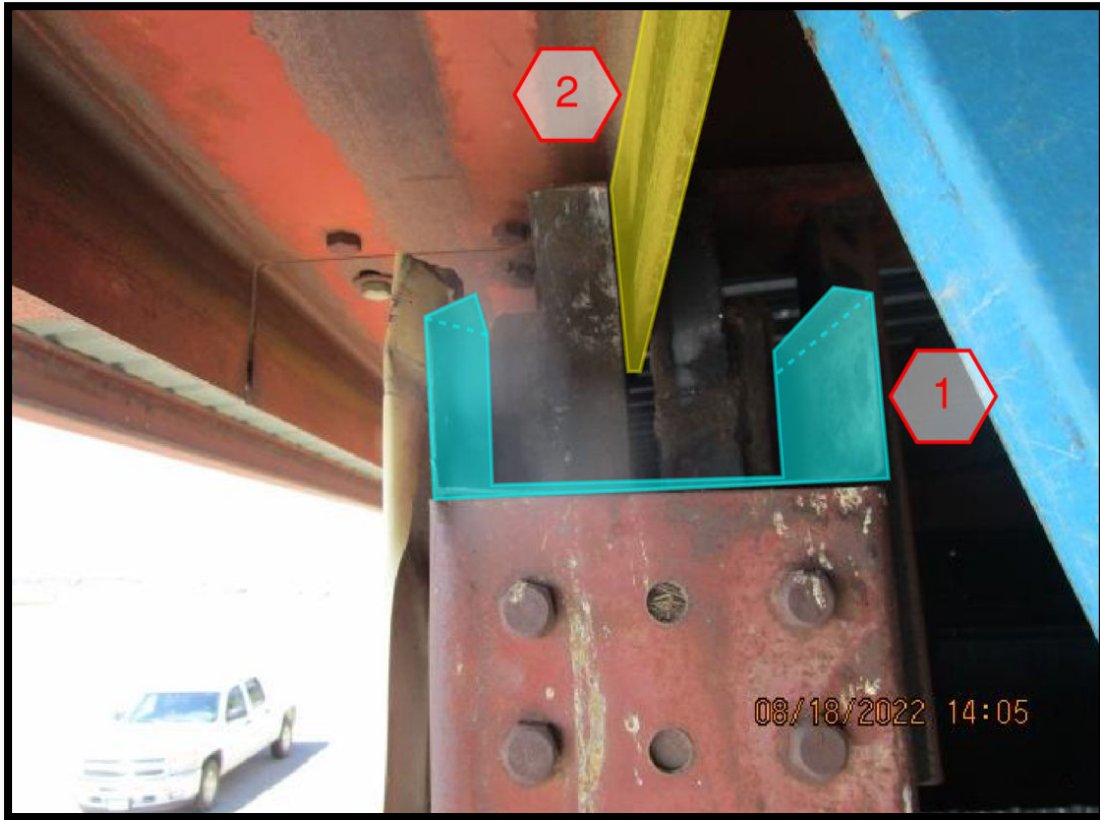
Figure 2

The FNL maintenance staff reported various challenges with the operation of the doors of the hangars. The doors have wheels mounted to the bottom where it bears its weight. The doors are mobilized by a two-rail system cast into a concrete pad. A C-channel (location 1) is mounted to the top of the door where the legs are intended to hold the door in place on the beam (location 2), as shown in Figure 2.

There are on-going issues where the doors are failing as a direct result of the movement and uplift of the structure from its failed foundation connections. The FNL maintenance staff has retrofitted the doors using three methods to mitigate this issue and prevent damage to tenant property housed in the hangars. The three repairs can be referenced in Photo 17, 22, and 28 of Appendix A. While these repairs may be temporarily effective, they do not address the greater issue associated with the hangars and are not recommended as a future repair method.

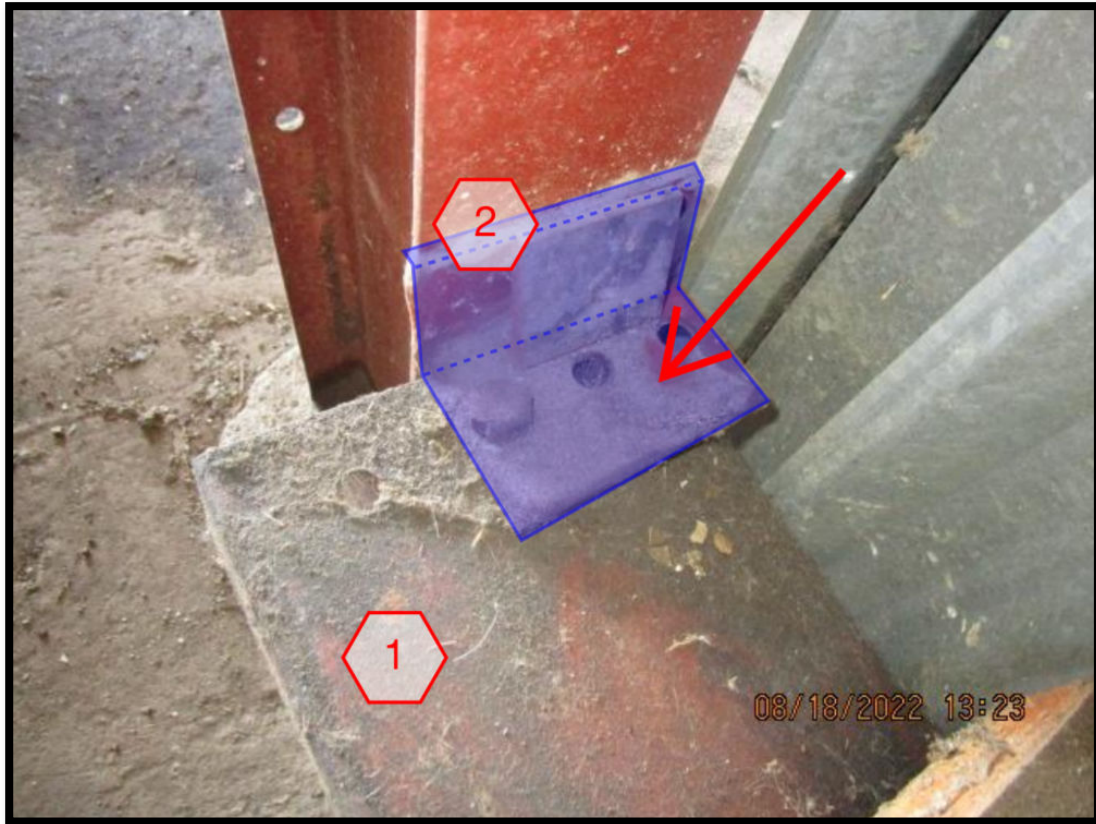
Figure 3

Additionally, it was observed that the hangar was constructed incorrectly. In Hangar 4910-B (Unit 8) it was observed that the shop-fabricated members were not fully fastened. However, it is unclear if full attachment is necessary based on the original design. Additionally, at the connection between the column and wall girt, there is a welded bracket on the column, as shown in Figure 3. The girt (location 1) has been connected to the underside of the bracket (location 2) and secured with one bolt. Instead, it is assumed that the girt should have been installed on top of the bracket so that the loads would be transferred through the weld and column, rather than relying solely on the bolt. It is also likely that this connection was intended to be fastened with more than one bolt, however without the original plans, this cannot be confirmed. This condition was observed in several instances throughout both units and is assumed to be consistent for the building in its entirety.

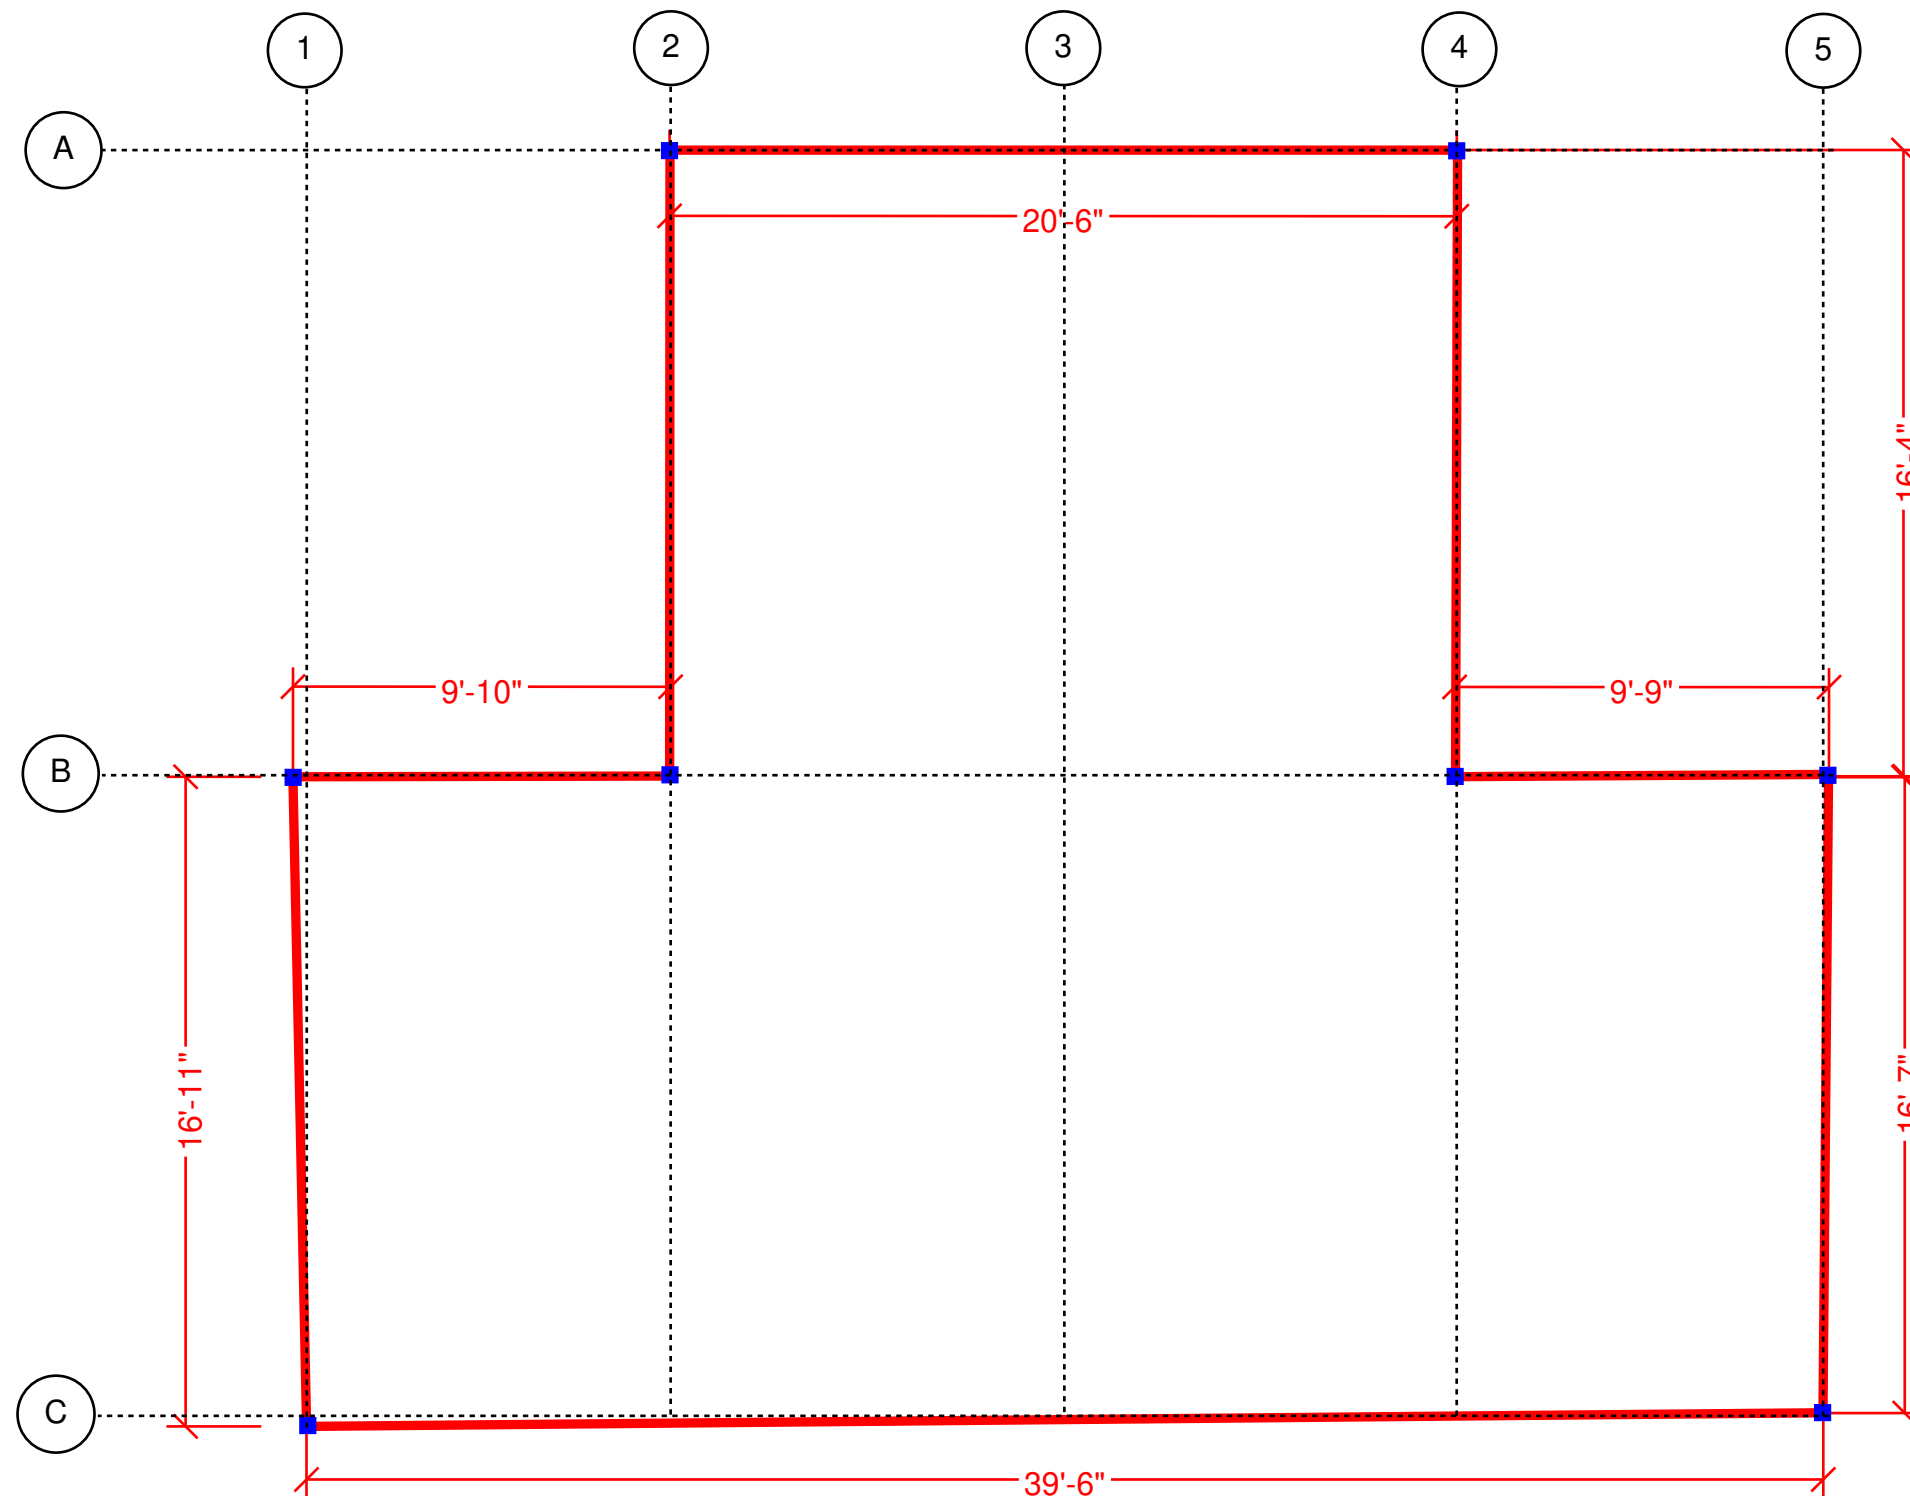
HANGAR 4920-A UNIT 5

<div>PHOTO 1</div> <div>Gridline C</div> <div> <p>Unsuitable, expansive soils are causing the pavement to heave.</p> </div>	 	<div>PHOTO 4</div> <div>Entire Structure</div> <div> <p>Roof is not properly sealed allowing water infiltration.</p> </div>	 
<div>PHOTO 2</div> <div>Gridline A</div> <div> <p>After market remediation repairs completed. Rebar has been welded to wall girt along its length.</p> </div>	 	<div>PHOTO 5</div> <div>Gridline B2</div> <div> <p>20-inch diameter caissons with two anchors connected to the column. Depth of foundation is unknown.</p> </div>	 
<div>PHOTO 3</div> <div>Gridline C</div> <div> <p>The door roller mechanism is in poor condition with misaligned track.</p> </div>	 	<div>PHOTO 6</div> <div>Gridline A</div> <div> <p>Damage to exterior metal panels.</p> </div>

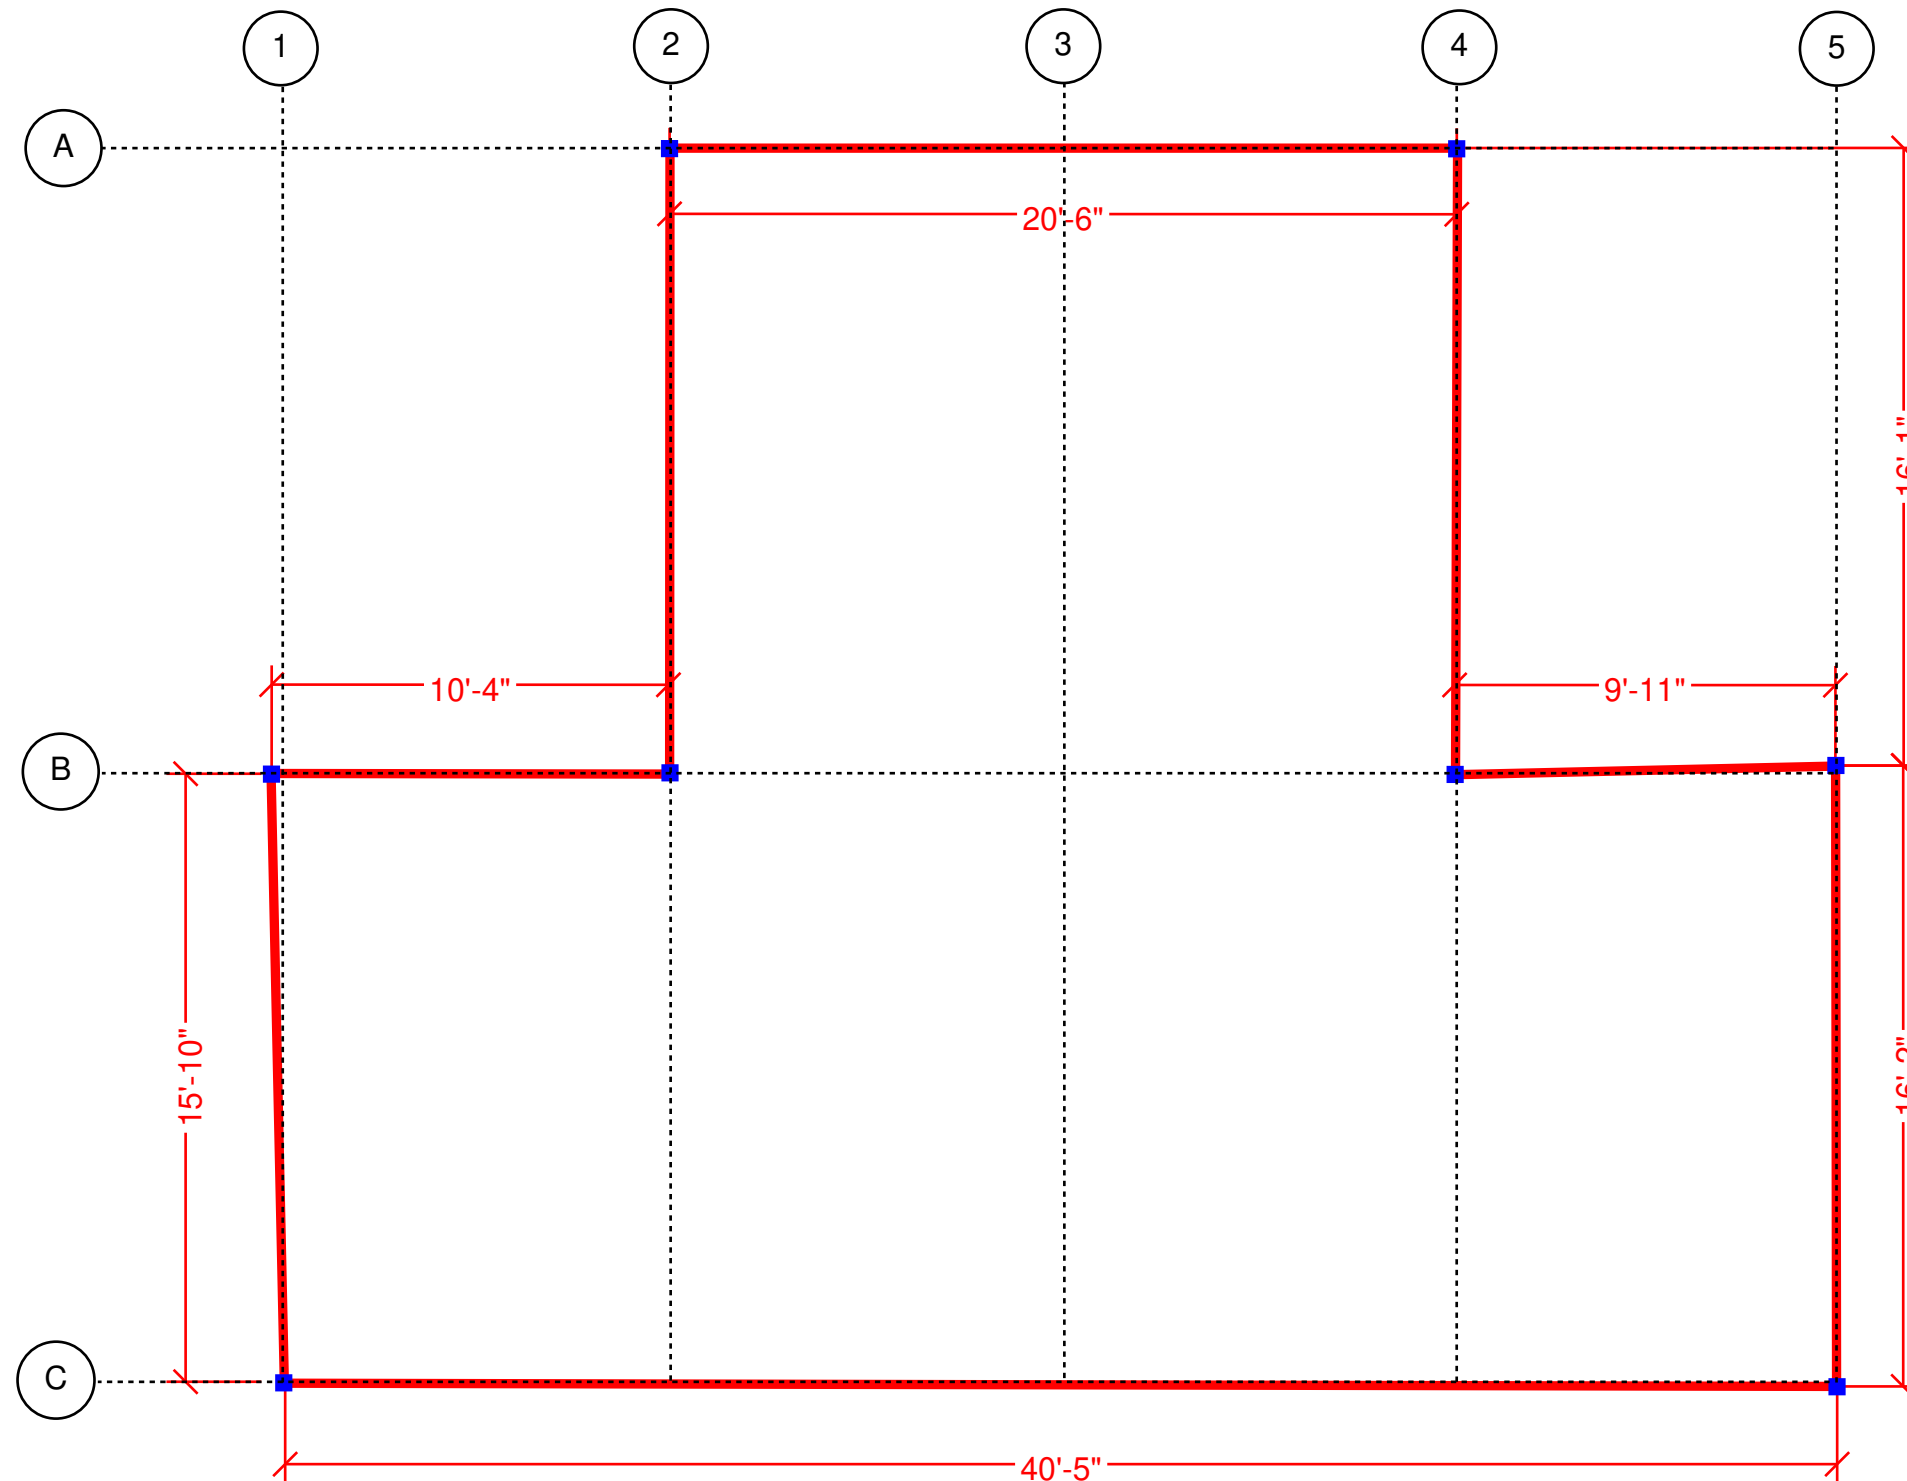
HANGAR 4920-A UNIT 2

<div>PHOTO 7</div> <div>Gridline A2</div> <div>Damage to structural member. Column observed to be torqued in the upper third.</div>	 	<div>PHOTO 10</div> <div>Gridline B4 to B5 and B5 to C5</div> <div>After market remediation repairs completed. Additional 2 x 4's installed as stiffeners for the columns.</div>	 	<div>HANGAR 4920-A UNIT 2</div> <div>PHOTO LOG</div> <div>   <div>NORTHERN COLORADO REGIONAL AIRPORT</div>   </div>
<div>PHOTO 8</div> <div>Gridline A</div> <div>20-inch diameter caissons with two anchors connected to the column. Depth of foundation is unknown.</div>	 			
<div>PHOTO 9</div> <div>Gridline B4 to C4</div> <div>After market remediation repairs completed. Additional truss members have been added to the double howe truss.</div>

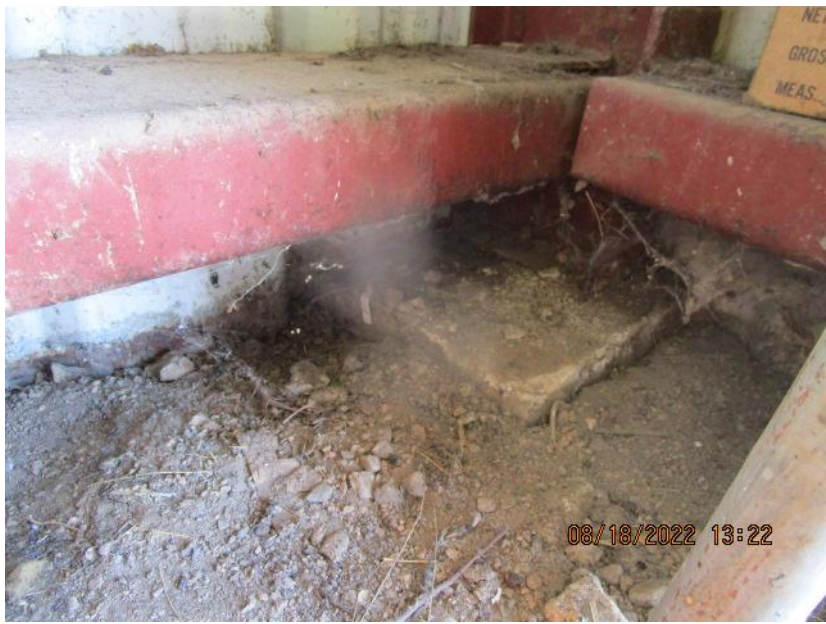
<div>PHOTO 11</div> <div>Gridline C4</div> <div>Deterioration of foundation and missing anchors.</div>

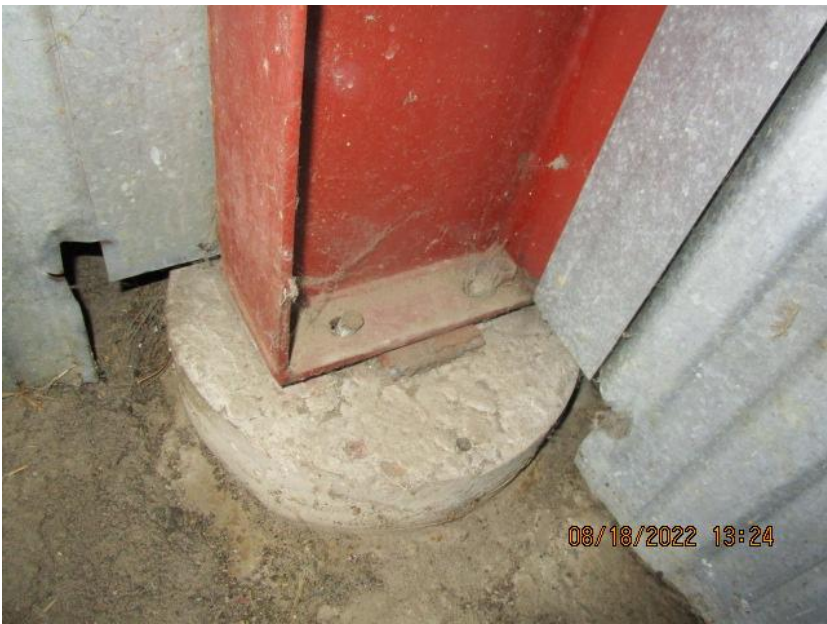
<div>PHOTO 14</div> <div>Gridline A2</div> <div>16-inch caisson at column connection. Anchors are missing the nut and washer. Hole in column is oversized for anchor allowing additional movement. Column is incorrectly bearing on the shim.</div>

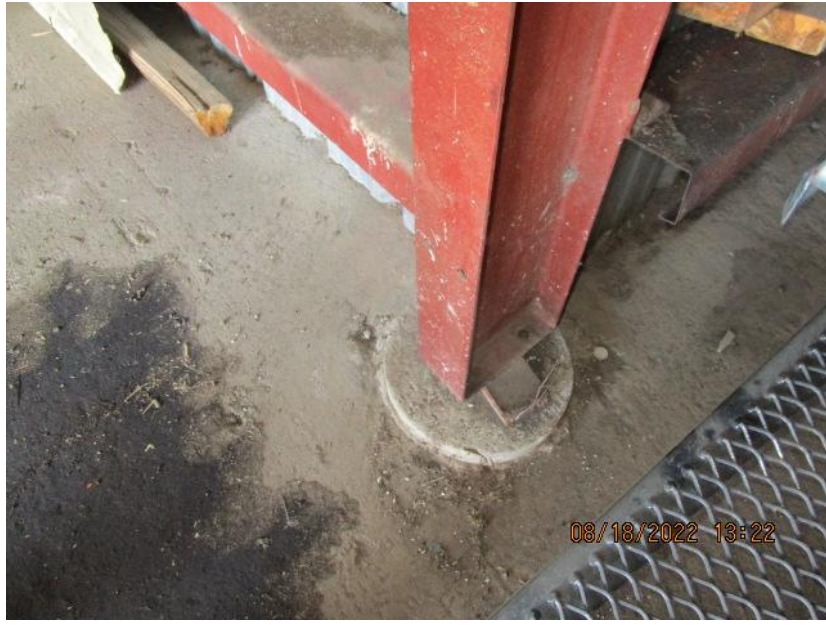
<div>PHOTO 12</div> <div>Gridline B2</div> <div>16-inch caisson at column connection. Missing anchors and incorrectly bearing on shim.</div>

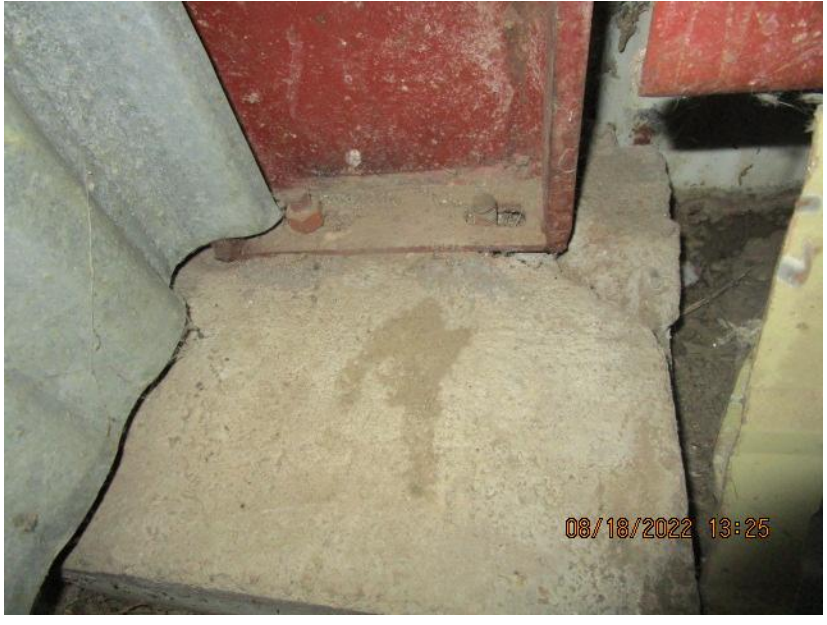
<div>PHOTO 15</div> <div>Gridline A4</div> <div>Concrete failure of foundation at anchor location. Anchor is missing nut and washer. Hole in column is oversized for anchor allowing additional movement.</div>

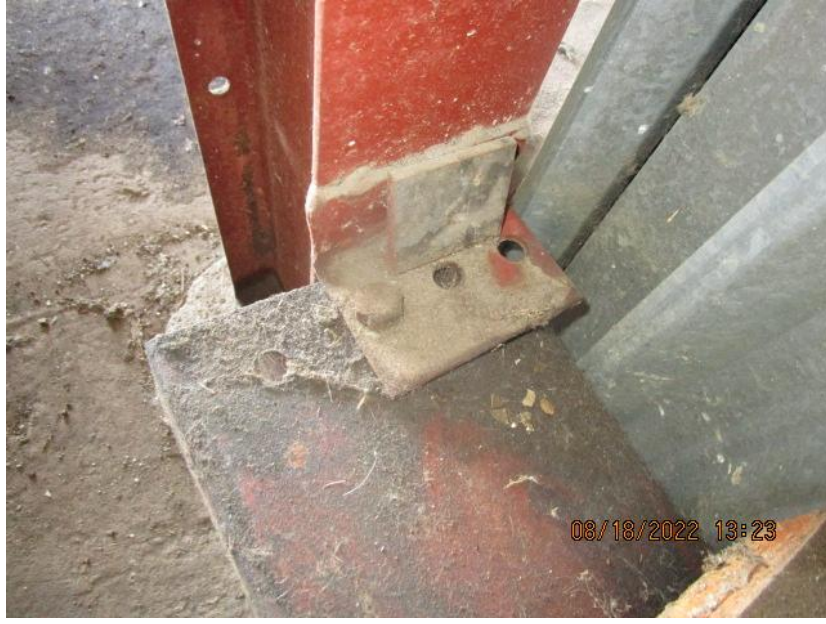
<div>PHOTO 13</div> <div>Gridline B2</div> <div>Incorrect installation of structural members. Wall girt should be bearing on welded bracket.</div>

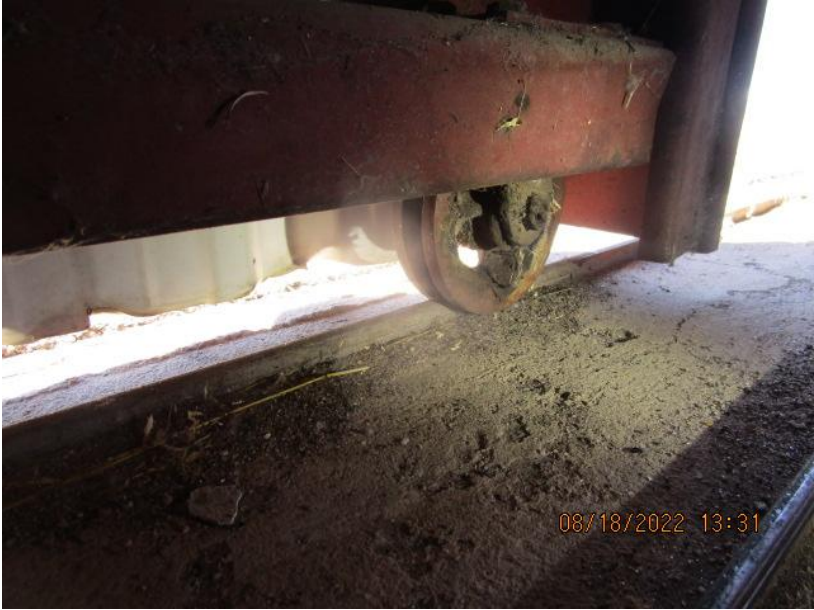
<div>PHOTO 16</div> <div>Gridline C</div> <div>Poorly maintained wheel roller mechanism.</div>

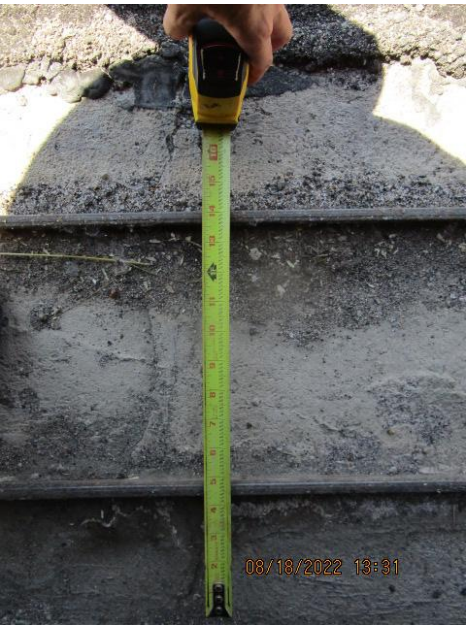
<div>PHOTO 19</div> <div>Gridline C</div> <div>Poorly maintained rail system for door operation. Concrete degradation adjacent to rails.</div>

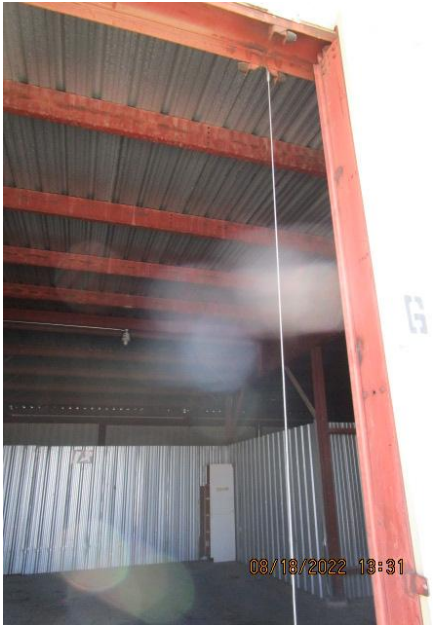
</div>
<div>PHOTO 17</div> <div>Gridline C4</div> <div>After market remediation repairs. Cable installed from floor to beam to prevent doors from falling into hangar.</div>

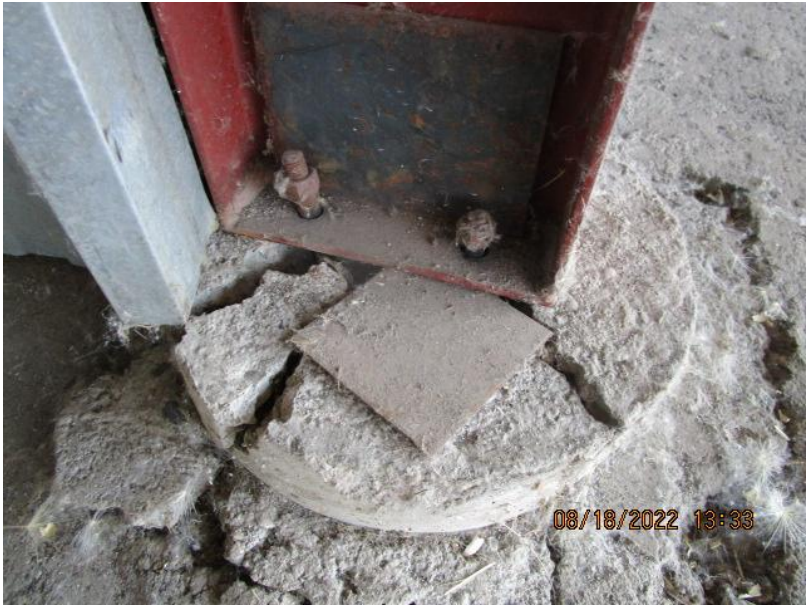
<div>PHOTO 18</div> <div>Gridline B4</div> <div>Concrete failure of 16-inch caisson at column connection. Anchor embedment is compromised. Anchors are missing washer and nut. Column is incorrectly bearing on the shim plate.</div>

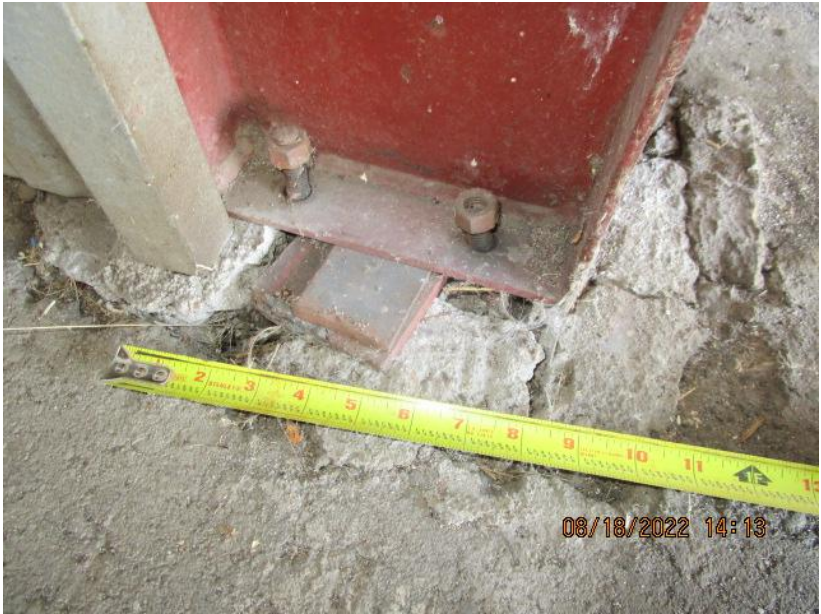
<div>PHOTO 26</div> <div>Gridline B4</div> <div>Failed concrete causing imbalanced heaving of column. Anchor bolts are corroded and entirely removed from column/concrete connection.</div>

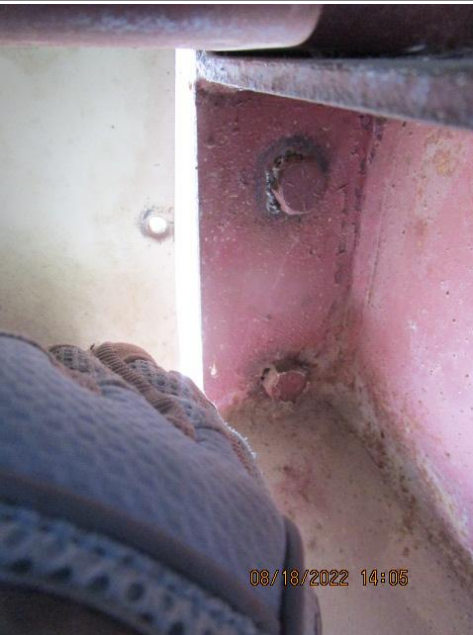
<div>PHOTO 29</div> <div>Gridline C2</div> <div>Corrosion of structural members.</div>

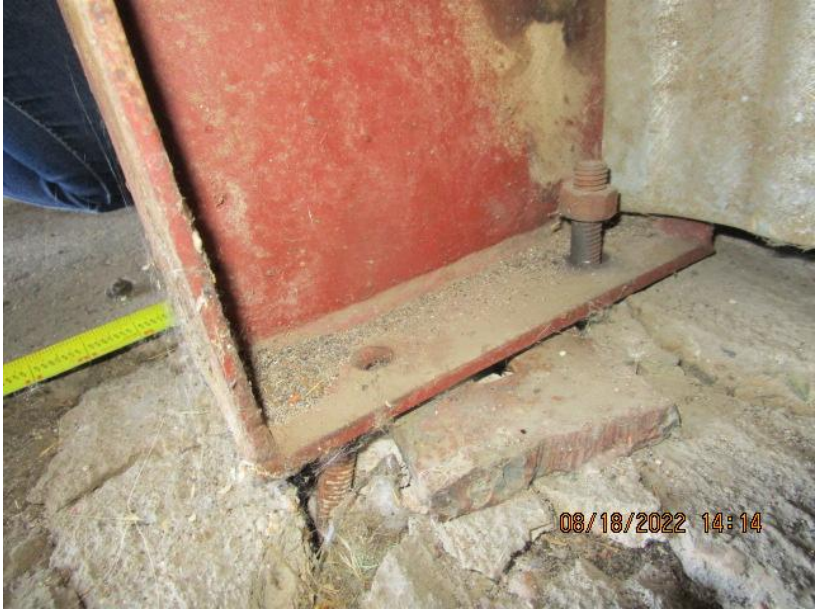
</div>
<div>PHOTO 27</div> <div>Gridline B4</div> <div>Failed concrete causing imbalanced heaving of column. Anchor bolts are corroded and entirely removed from column/concrete connection.</div>

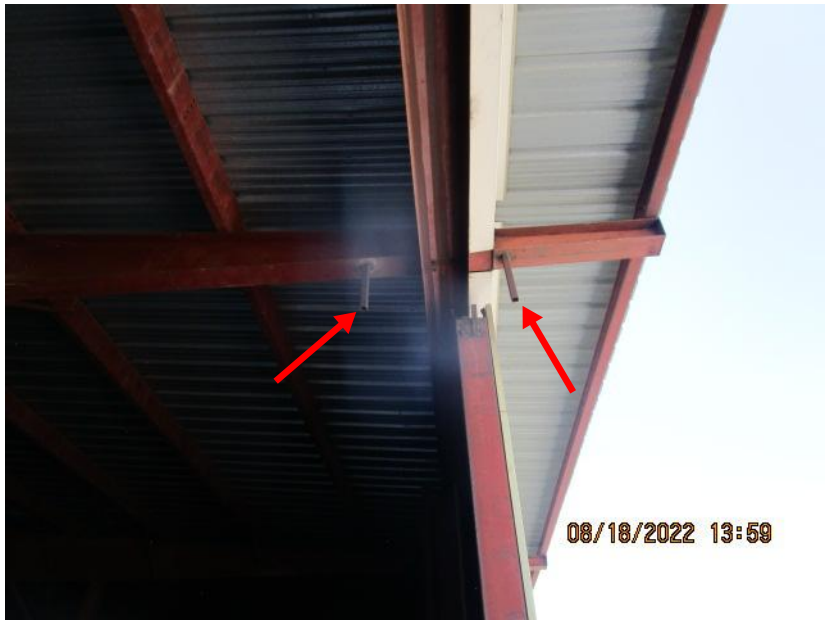
<div>PHOTO 28</div> <div>Gridline A</div> <div>After market repairs to prevent door failure. Additional HSS tubes were welded on either side of door frame to prevent door from caving in or falling outward.</div>

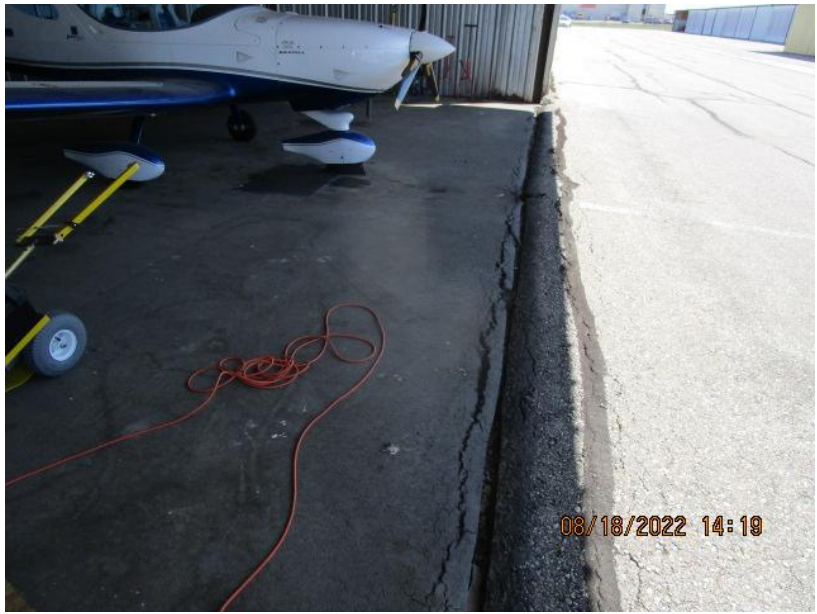
Another issue was observed as a result of the FNL pavement maintenance. FNL has performed a mill and overlay on the taxilanes adjacent to the hangars. This has resulted in the exterior grade being

higher than the hangar's finish floor elevation, preventing any drainage out of the hangar units. Once water enters the unit through the unsealed roof or perimeter, it has no exit path, leading to a build-up of condensation on the interior of the structure. Excess moisture, in combination with poor ventilation, is assumed to accelerate corrosion of the steel members in the hangar.

<div>PHOTO 30</div> <div>Gridline C</div> <div> <p>Mill and overlay maintenance has resulted in taxilane grade higher than hangar finish floor, resulting in poor drainage.</p> </div>

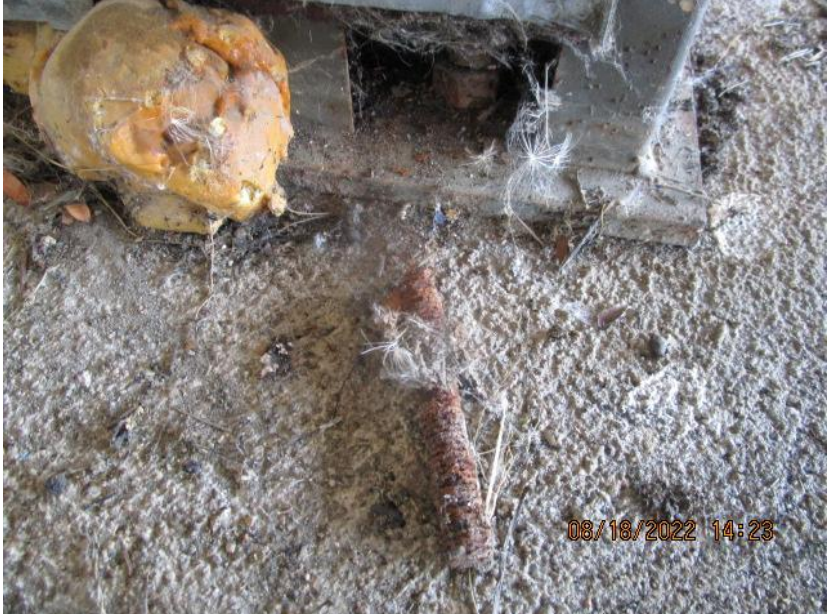
<div>PHOTO 33</div> <div>Gridline B4</div> <div> <p>Anchor completely removed from connection. Anchor is corroded and likely undersized.</p> </div>

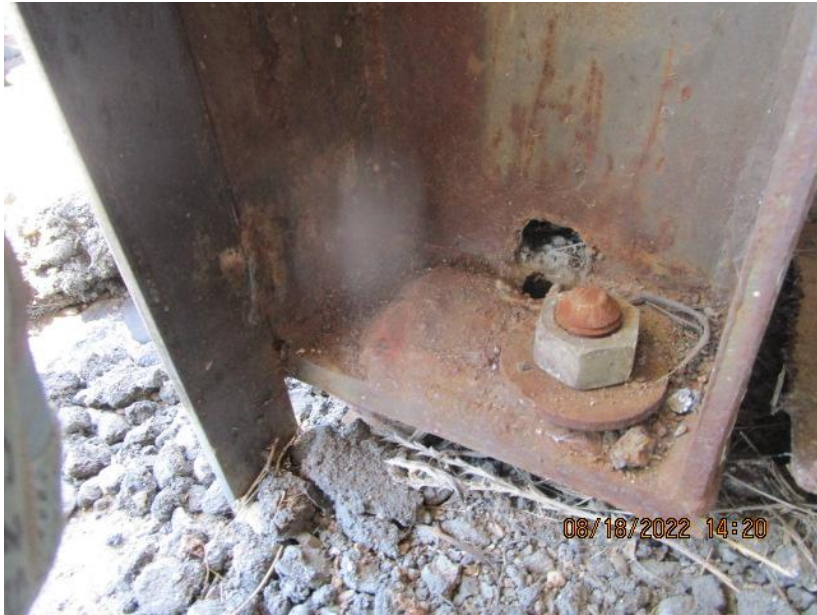
<div>PHOTO 31</div> <div>Gridline C1</div> <div> <p>Corrosion of steel. Column loads bear poorly on foundation.</p> </div>

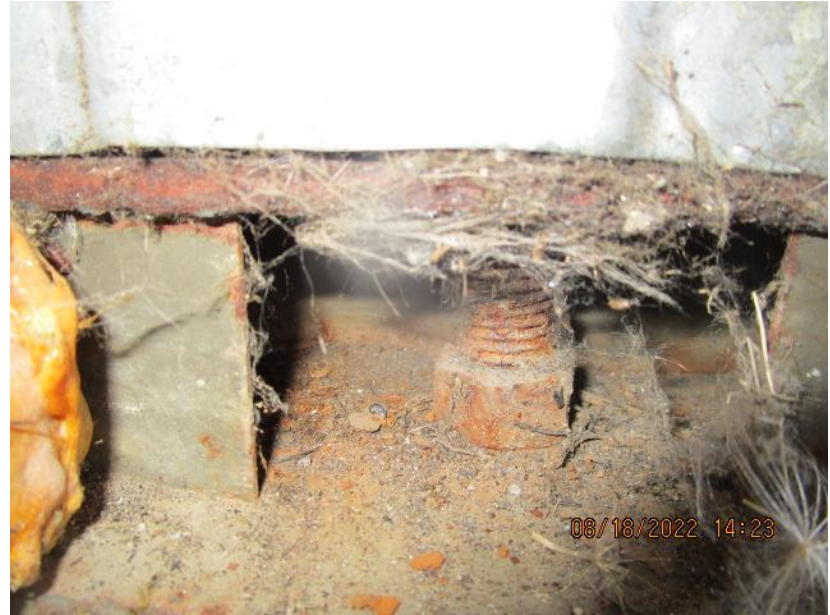
<div>PHOTO 34</div> <div>Gridline B4</div> <div> <p>Corrosion of steel at column to foundation connection.</p> </div>

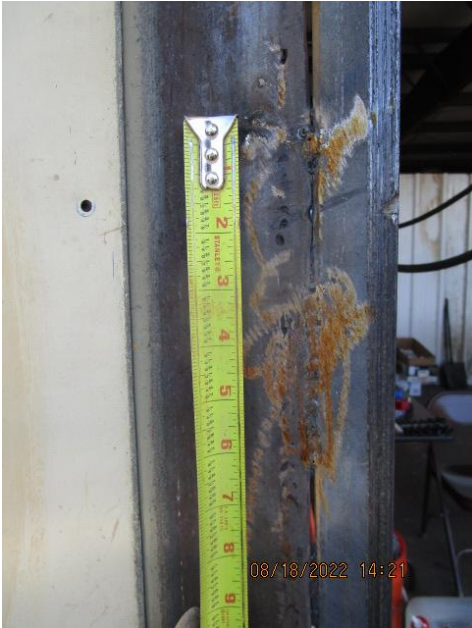
<div>PHOTO 32</div> <div>Gridline A</div> <div> <p>Corrosion of steel.</p> <p>After market remediation repairs to maintain functionality of the doors.</p> </div>

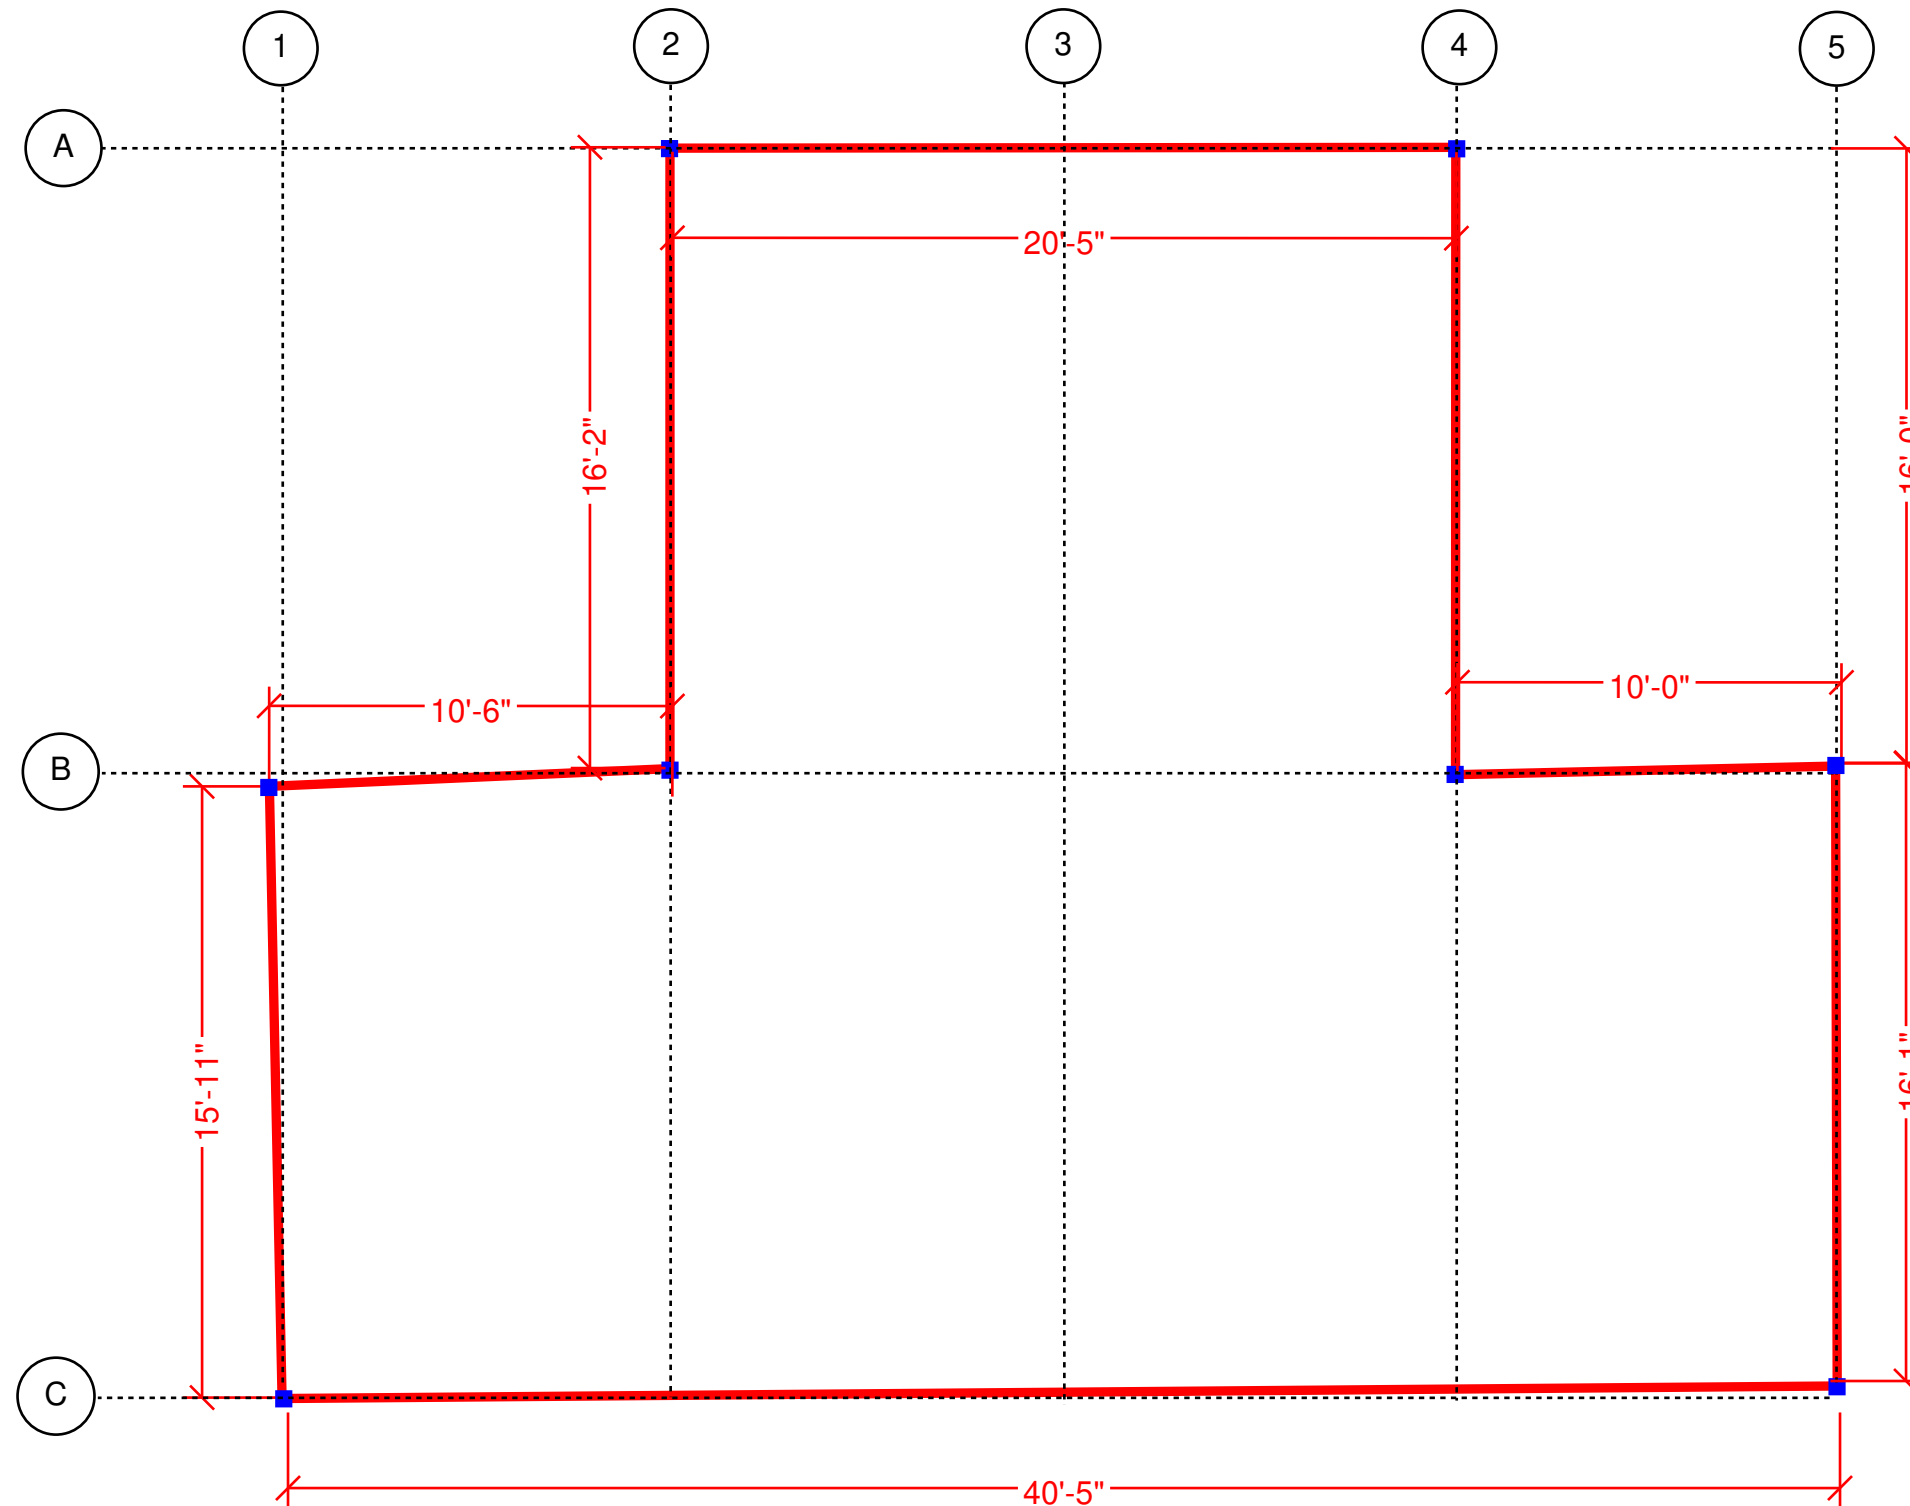
HANGAR 4960-C UNIT 15

Corrosion was present on the steel columns, anchor bolts, and the hangar door track. In some instances, the corrosion at the column led to pitting of the steel creating an oversized hole at the anchor bolt connection, as shown in Photo 35 of Appendix A. The oversized hole allows excess movement of the structure, or in the most severe cases, provide no connectivity to the foundation. In Hangar 4930-C (Unit 2), the column at Gridline B4 had an anchor bolt completely removed from the foundation. The anchor bolt was severely corroded and assumed to be undersized compared to current industry standards. Additionally, in Hangar 4960-C (Unit 15), the corrosion of the steel resulted in a failed weld at the tension rod connection to the column at Gridline B4.

<div>PHOTO 35</div> <div>Gridline C1</div> <div>Corrosion of steel column resulting in oversized hole at anchor bolt location. Column is not anchored to concrete at this location.</div>	 	<div>PHOTO 38</div> <div>Gridline B4</div> <div>Top view of failed weld at tension rod connection to column.</div>	 
<div>PHOTO 36</div> <div>Gridline B4</div> <div>Corrosion of tension rod and column.</div>	 	<div>PHOTO 39</div> <div>Gridline C5</div> <div>Corrosion of tension rod.</div>	 
<div>PHOTO 37</div> <div>Gridline B4</div> <div>Side view of failed weld at tension rod connection to column.</div>	 	<div>PHOTO 40</div> <div>Gridline C5</div> <div>Corrosion of column and anchor bolt. Column load bears poorly on foundation.</div>
