## **Report of Findings**

Knott Laboratory Project Number: 20939

Northern Colorado Regional Airport  
"C" Hangars  
4930/4960 Grumman Street  
Loveland, Colorado 80538

April 25, 2023

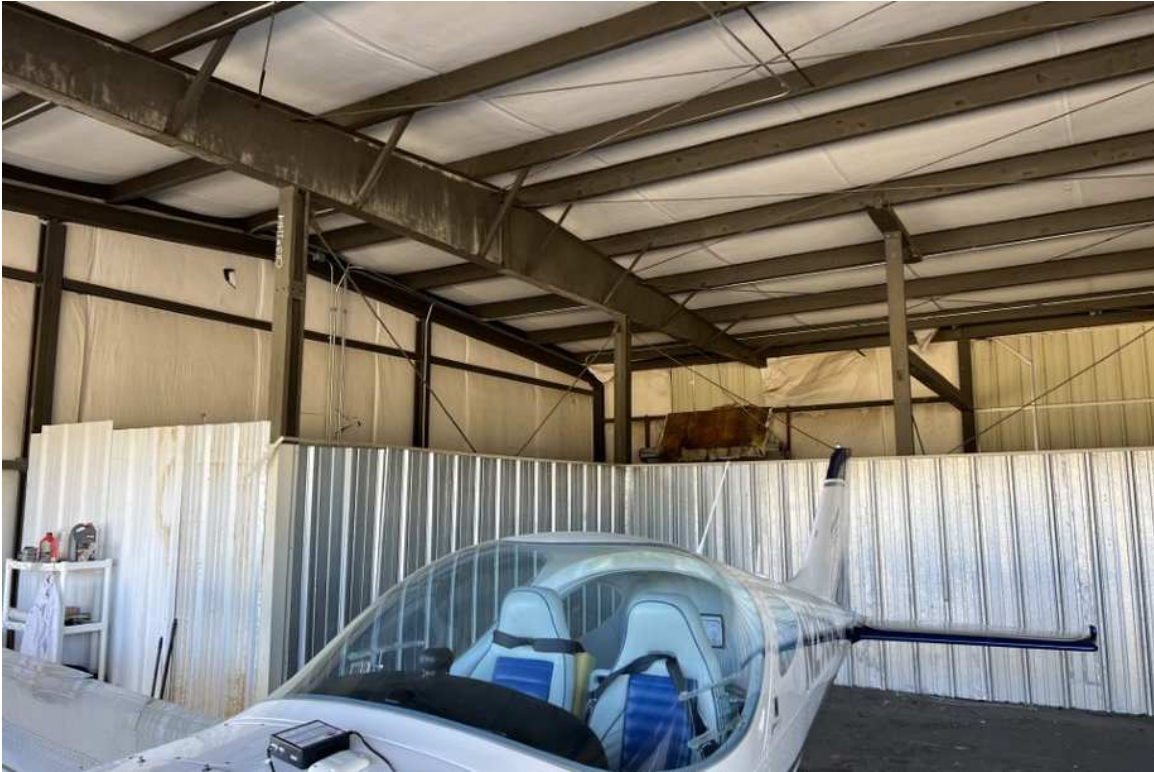
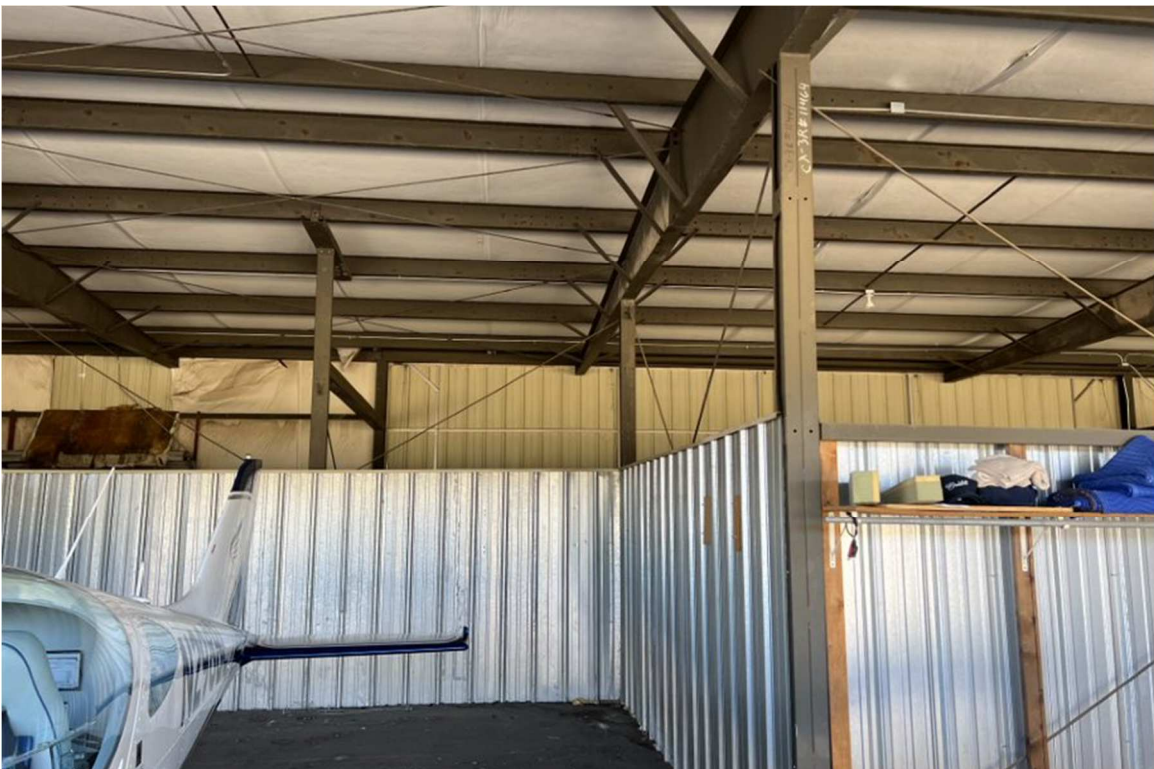
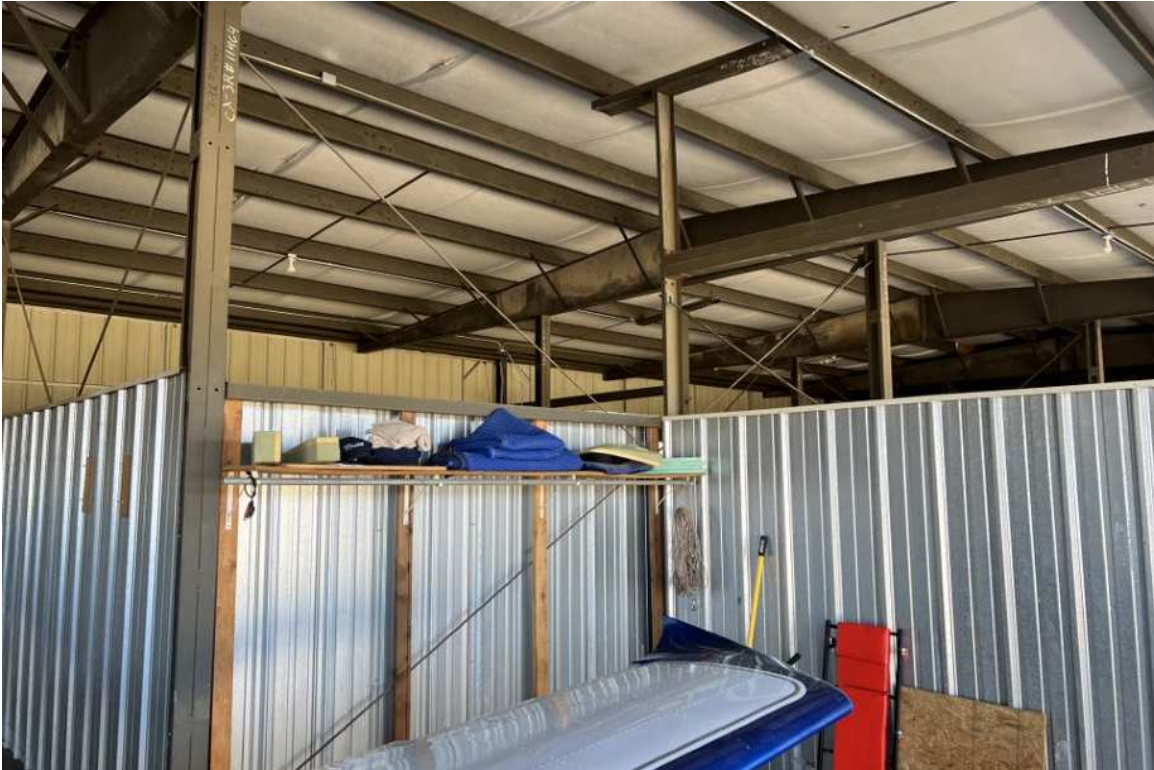
Figure 5 – IMG\_5135 – Building 1, Unit 2 – Exemplar overview of “T” hangar.

Figure 6 – IMG\_5136 – Building 1, Unit 2 – Exemplar overview of “T” hangar.

Figure 7 – IMG\_5137 – Building 1, Unit 2 – Exemplar overview of “T” hangar.

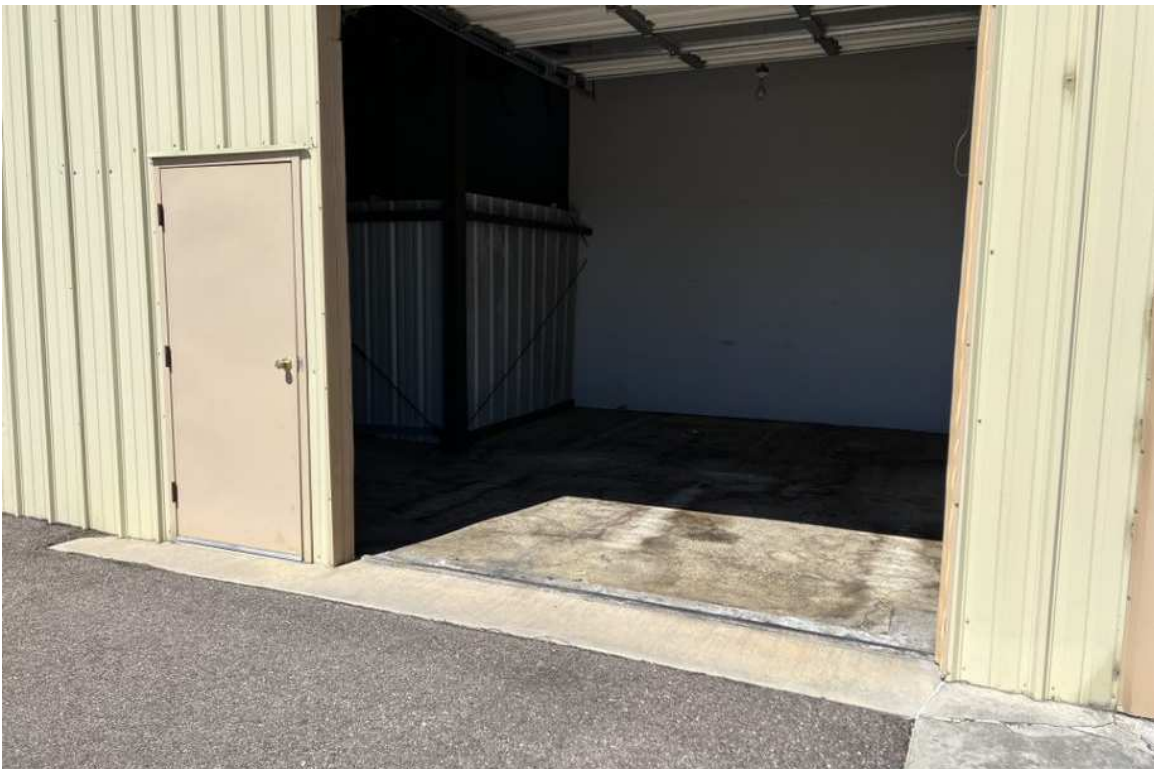
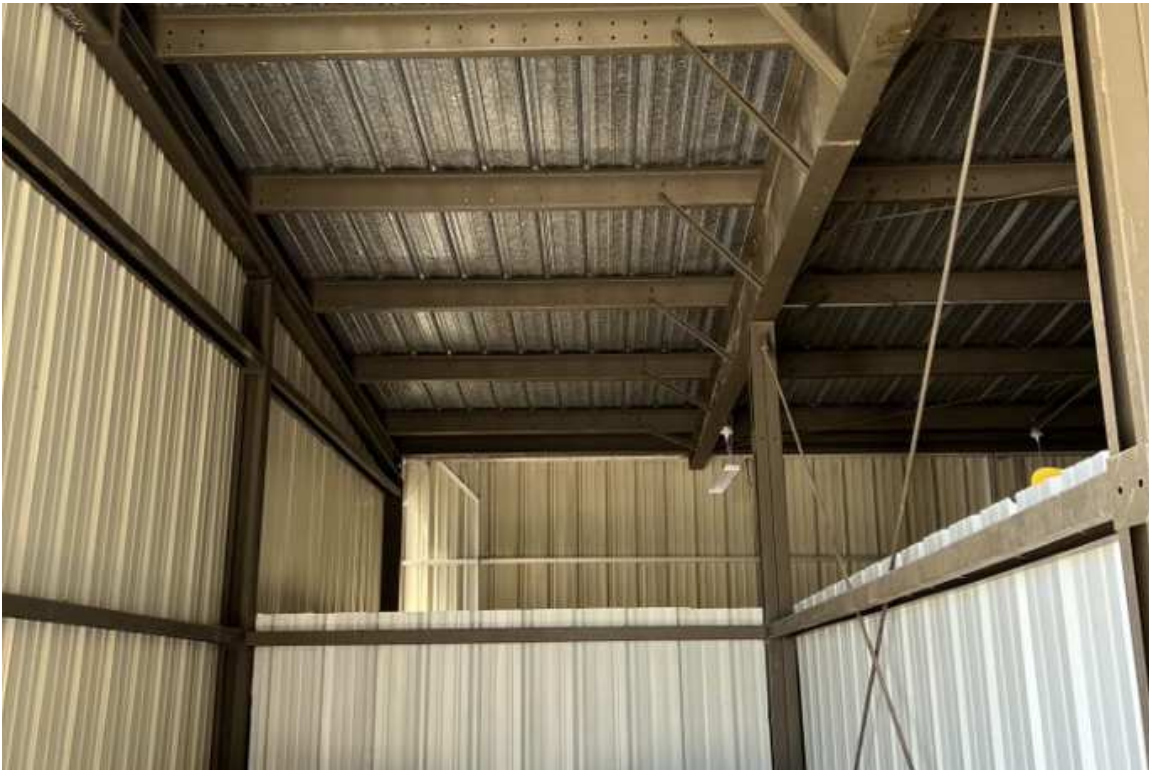
Figure 8 – IMG\_5166 – Building 2, Storage unit adjacent to Unit 19 – Exemplar overview of storage unit.

Figure 9 – IMG\_5170 – Building 2, Storage unit adjacent to Unit 19 – Exemplar overview of storage unit.

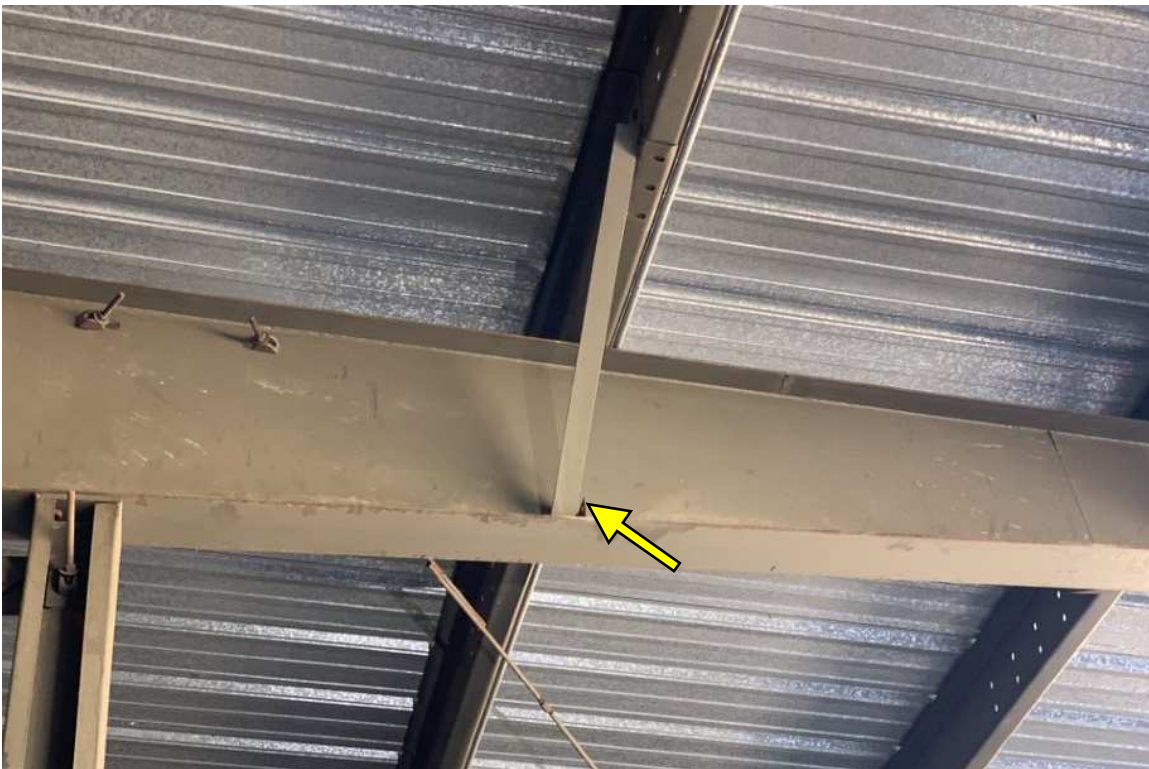
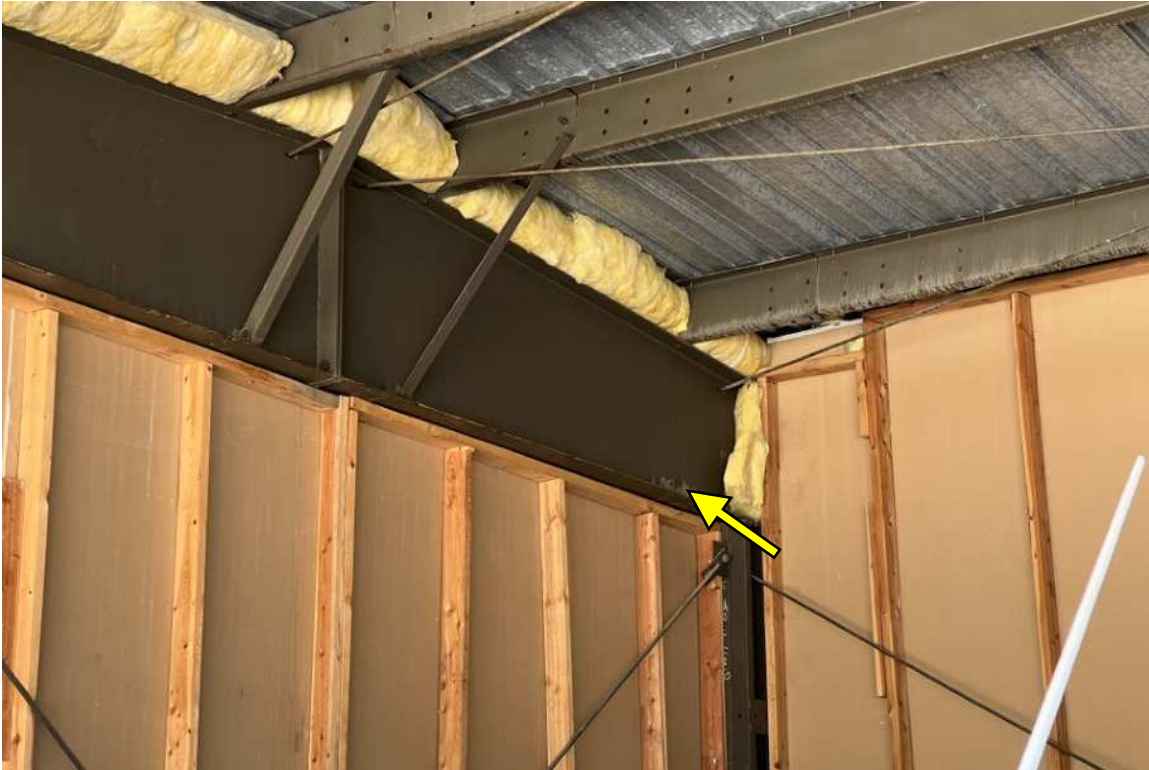
- **Importance:** Medium
- **Building 1:**
  - Unit 17 (1)
  - Unit 19 (2)
  - Unit 20 (1)
- **Building 2:**
  - Unit 2 (3)
  - Unit 4 (1)
  - Unit 10 (1)
  - Unit 15 (1)

Figure 10 – IMG\_6620 – Building 1, Unit 20 – Exemplar photograph of detached angle kicker bracing bottom flange of tapered wide-flange girder member.

Figure 11 – IMG\_5236 – Building 2, Unit 10 – Exemplar photograph of missing angle kicker bracing bottom flange of tapered wide-flange girder member.

- **Gravity System:**
  - Engineered detail to repair missing/detached angle kickers bracing the bottom flange of the tapered wide-flange girder members. Knott estimates a minimum of (10) instances of this repair (**Figures 10 and 11**).

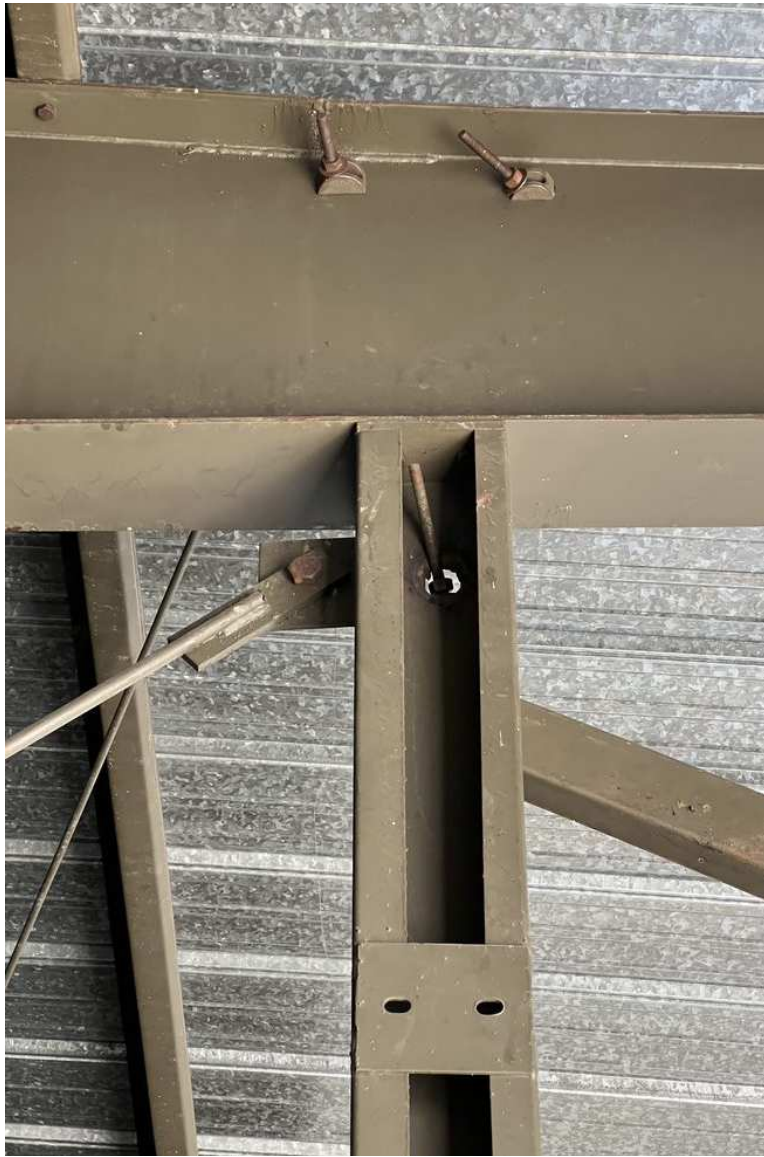
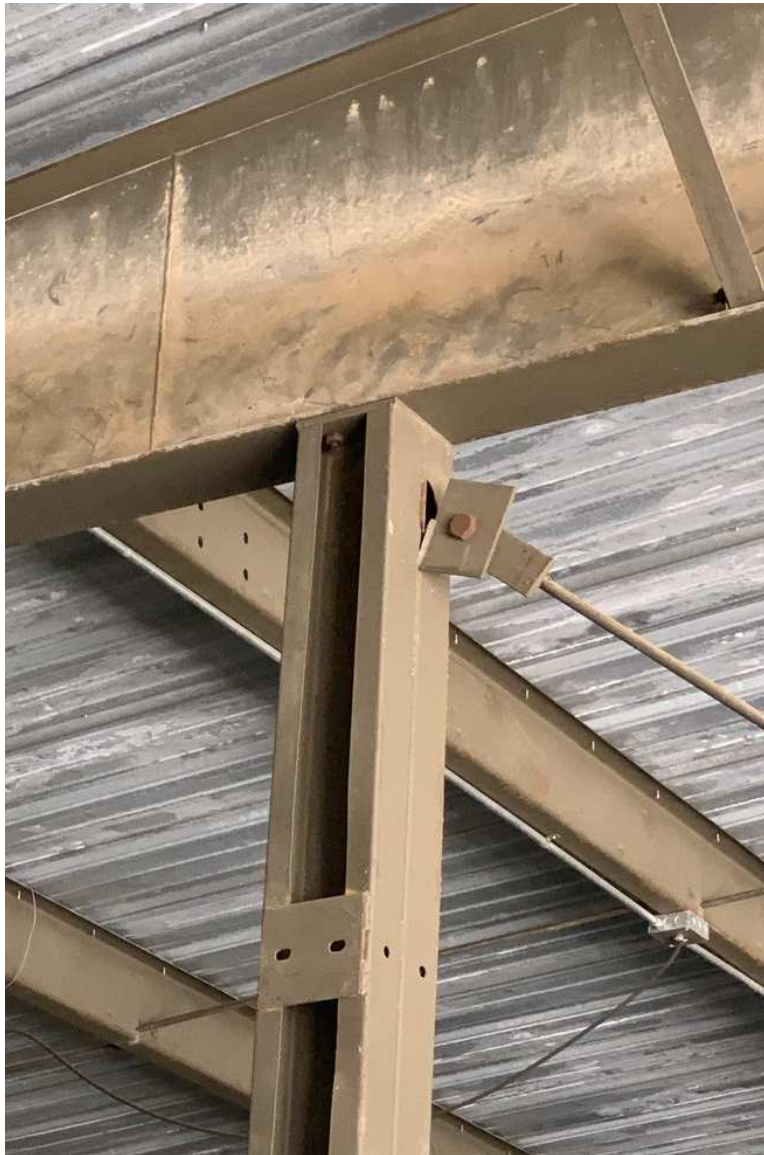
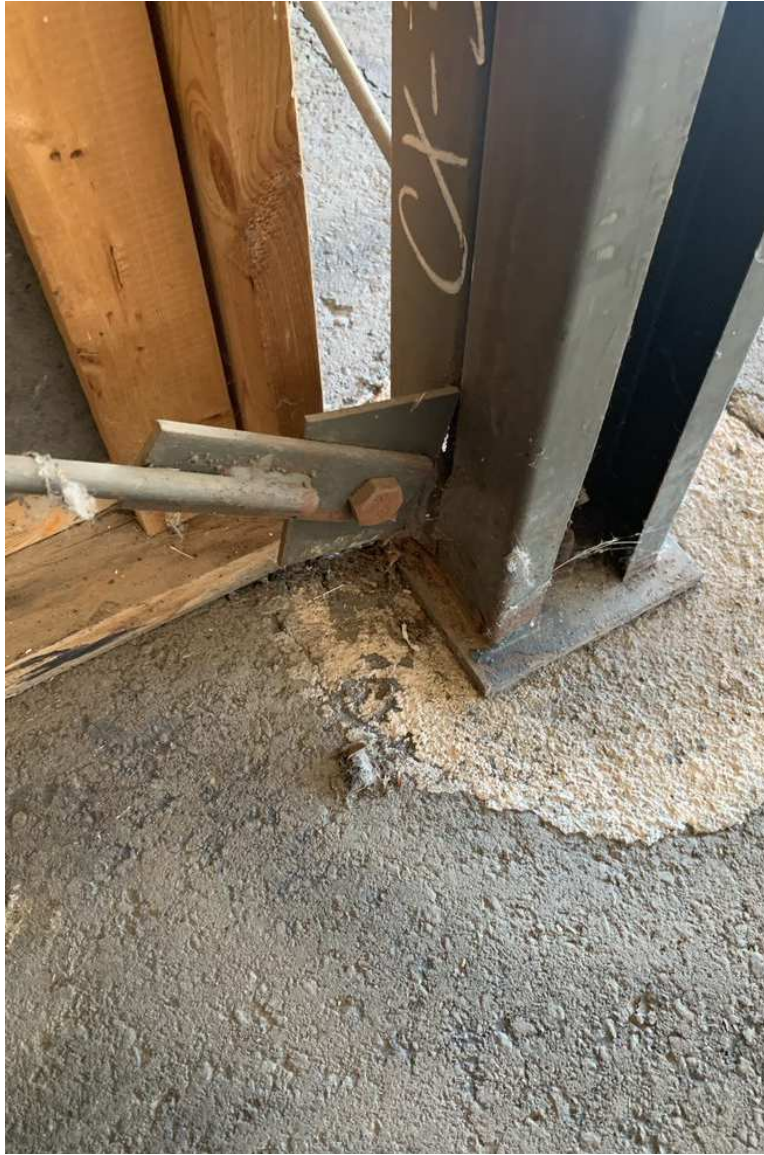
Vertical bracing systems were generally observed to be damaged and in need of engineered repair. Knott noted multiple instances of tension elements sagging and/or buckling, as well as the failure of multiple connections from the tension elements to their

- **Importance:** High
- **Building 1:**
  - Storage unit adjacent to Unit 1 (1)
  - Storage unit adjacent to Unit 20 (1)
  - Unit 1 (3)
  - Unit 3 (1)
  - Unit 7 (1)

Figure 12 – IMG\_5167 – Building 2, Storage unit adjacent to Unit 19 – Damaged lateral tension tie connection at column.

Figure 13 – IMG\_6513 – Building 1, Unit 7 – Exemplar photograph of detached lateral brace plate connection to top of supporting column.

Figure 14 – IMG\_6733 – Building 2, Unit 3 – Exemplar photograph of detached lateral brace plate connection to base of supporting column.

- **Lateral System:**
  - Engineered detail to repair damaged/detached lateral tension tie plate connection to restore a continuous load path for the building's lateral system. Knott estimates a minimum of (15) instances of this repair (**Figures 12-14**).

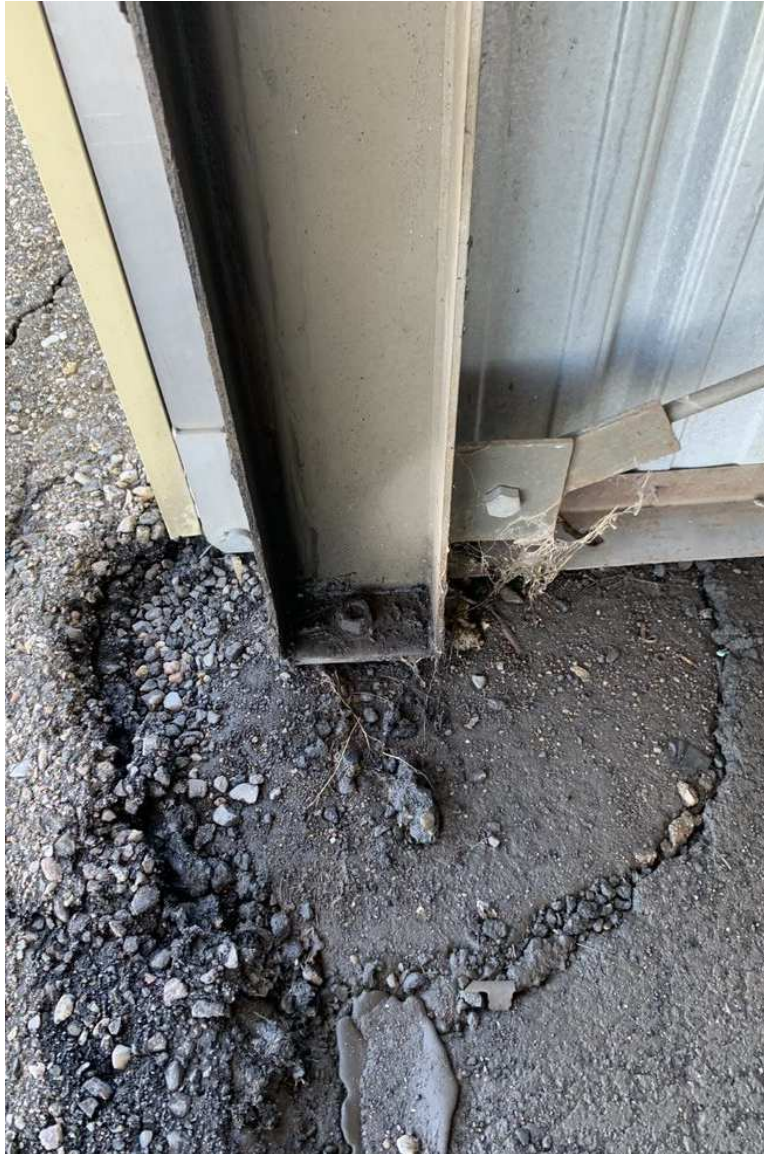
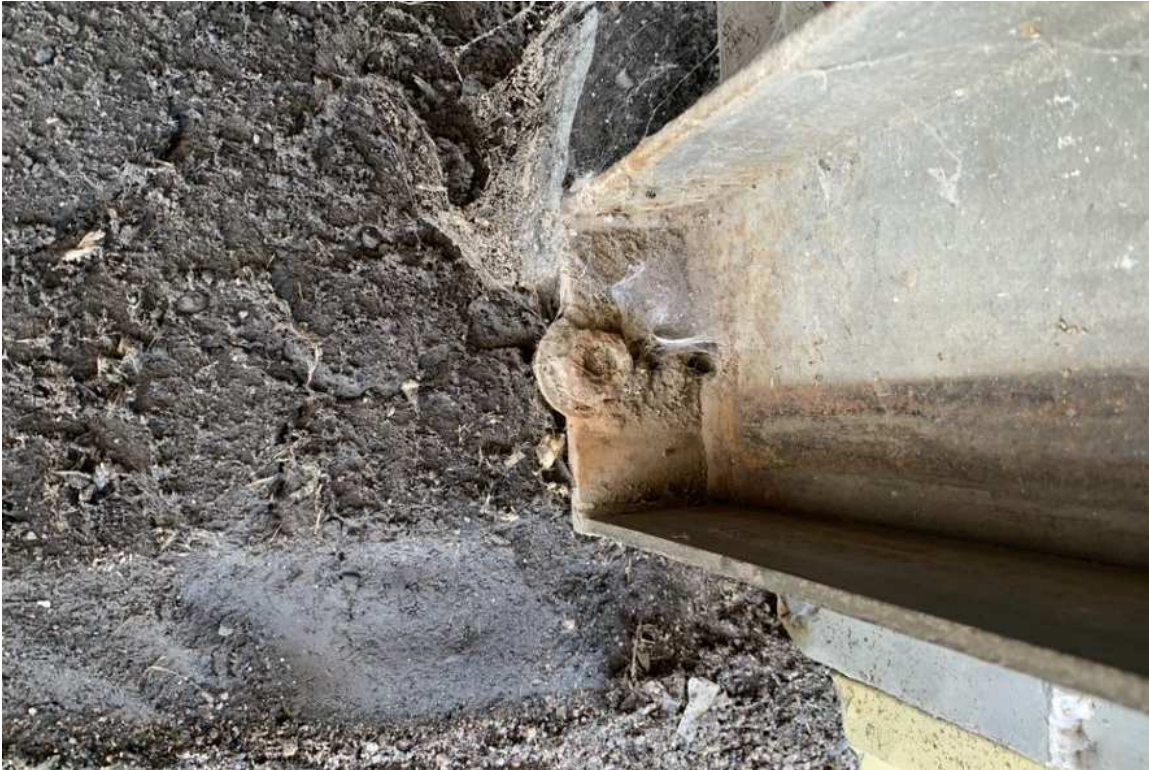
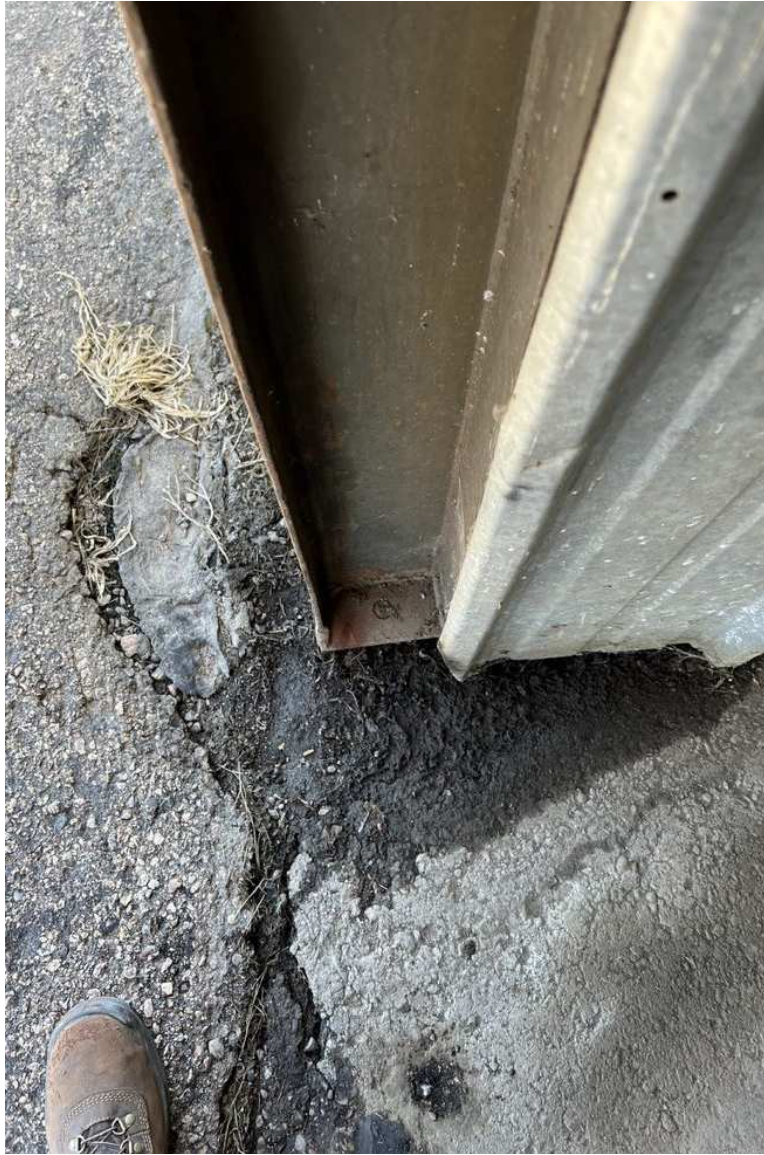
The foundation system, including baseplates and anchorages, were generally observed to be damaged and in need of engineered repair. Many baseplates were in various stages of deterioration, and Knott recorded multiple instances of missing or detached anchorages as stated previously.

- **Importance:** High
- **Building 1:**

Figure 15 – IMG\_6666 – Building 1, Unit 12 – Exemplar condition of damaged anchorage (threads not protruding above nut due to column sitting on shims installed during, or post, construction).

Figure 16 – IMG\_6751 – Building 2, Unit 7 – Exemplar condition of detached anchorage (anchor bolt originally placed too near edge of plate and subject to corrosion).

Figure 17 – IMG\_5163 – Building 2, Unit 7 – Exemplar condition of detached anchorage (anchor connection failed due to corrosion; threads not protruding above nut due to column sitting on shims installed during, or post, construction; or both).

- Engineered detail to repair damaged, detached or missing column anchorages. Knott estimates a minimum of (24) instances of this repair (**Figures 15-17**).

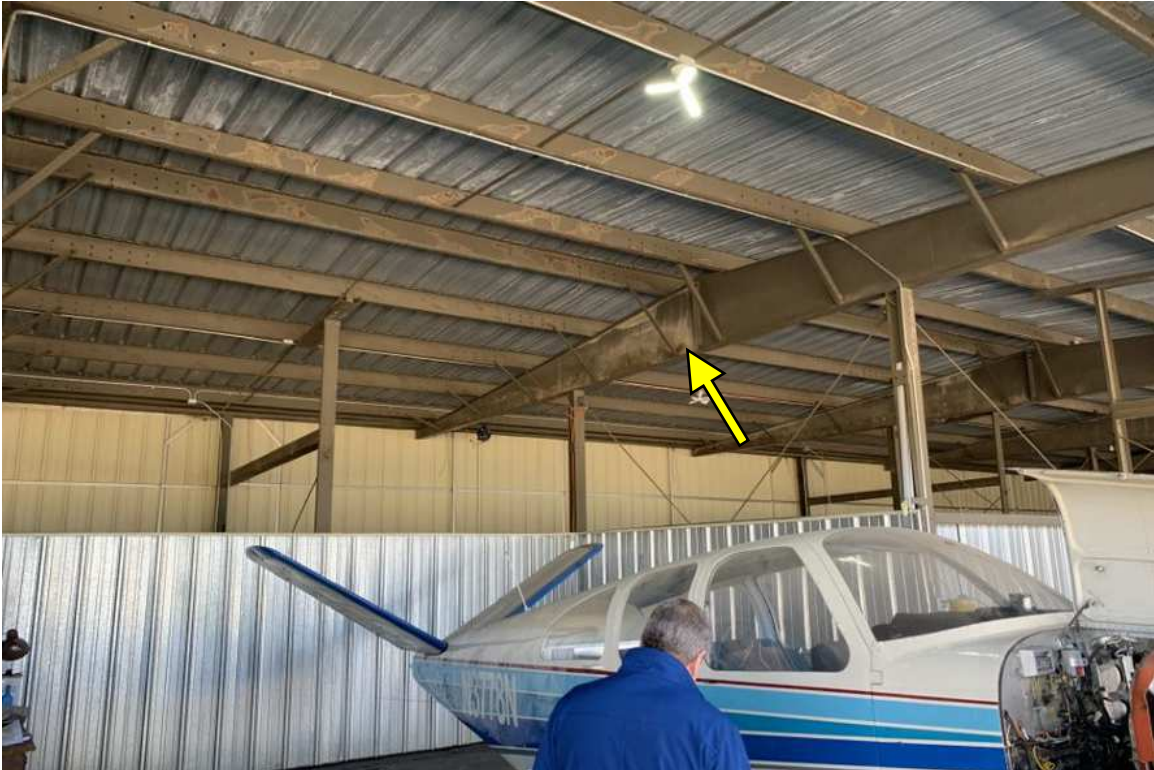
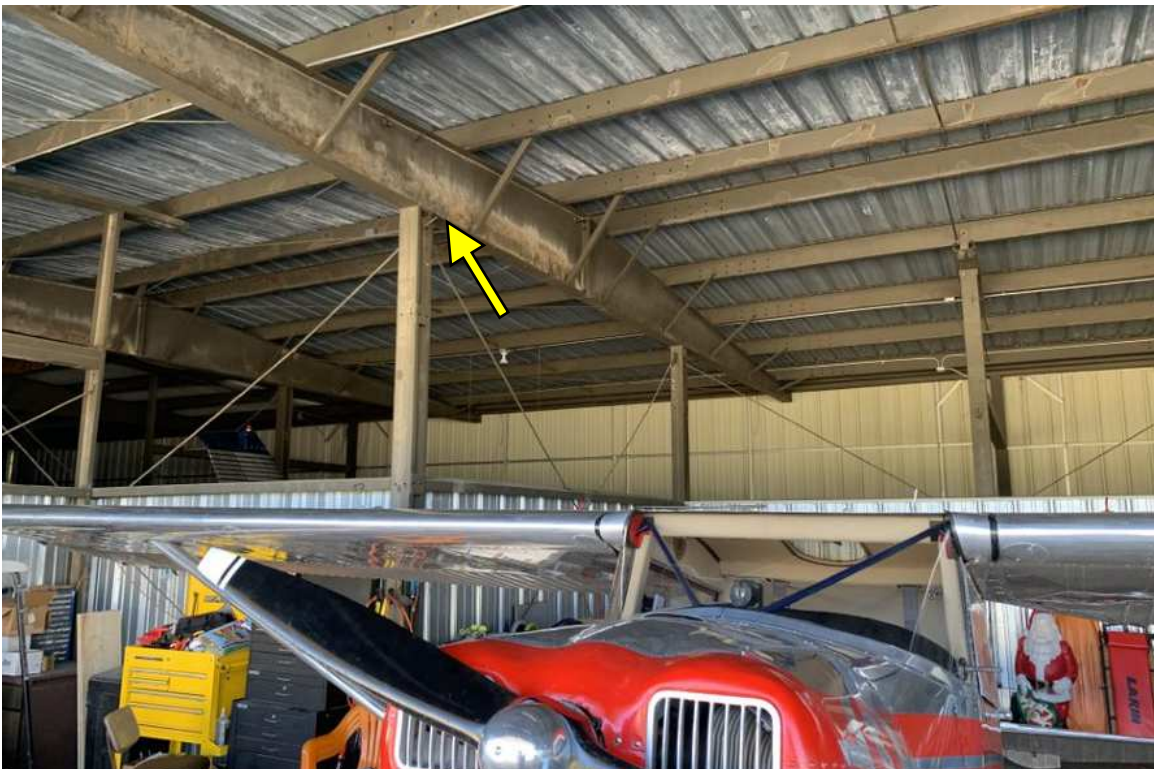
Figure 18 – IMG\_6674 – Building 1, Unit 10 – Example wide-flange girder candidate for cleaning and inspection to evaluate extent of rust/deterioration damage.

Figure 19 – IMG\_6688 – Building 1, Unit 8 – Example wide-flange girder candidate for cleaning and inspection to evaluate extent of rust/deterioration damage.

- **Gravity System:**
  - Cleaning and inspection of (1) primary girder member to evaluate extent of rust/deterioration damage. Knott is available to provide an engineering evaluation after cleaning is complete. Knott recommends the following candidates as "worst-case" scenarios that may be used to judge the suitability of the remaining girders (**Figures 18 and 19**):
    - **Importance:** Medium
    - **Building 1:**
      - Unit 8

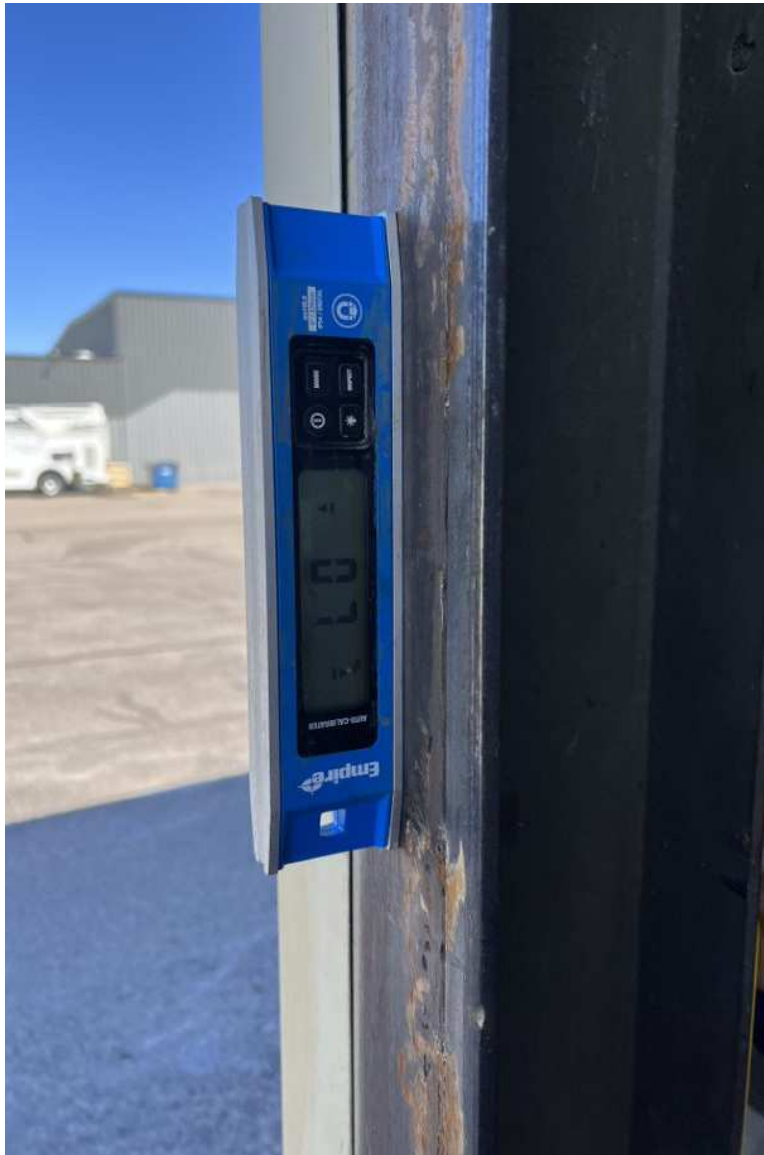
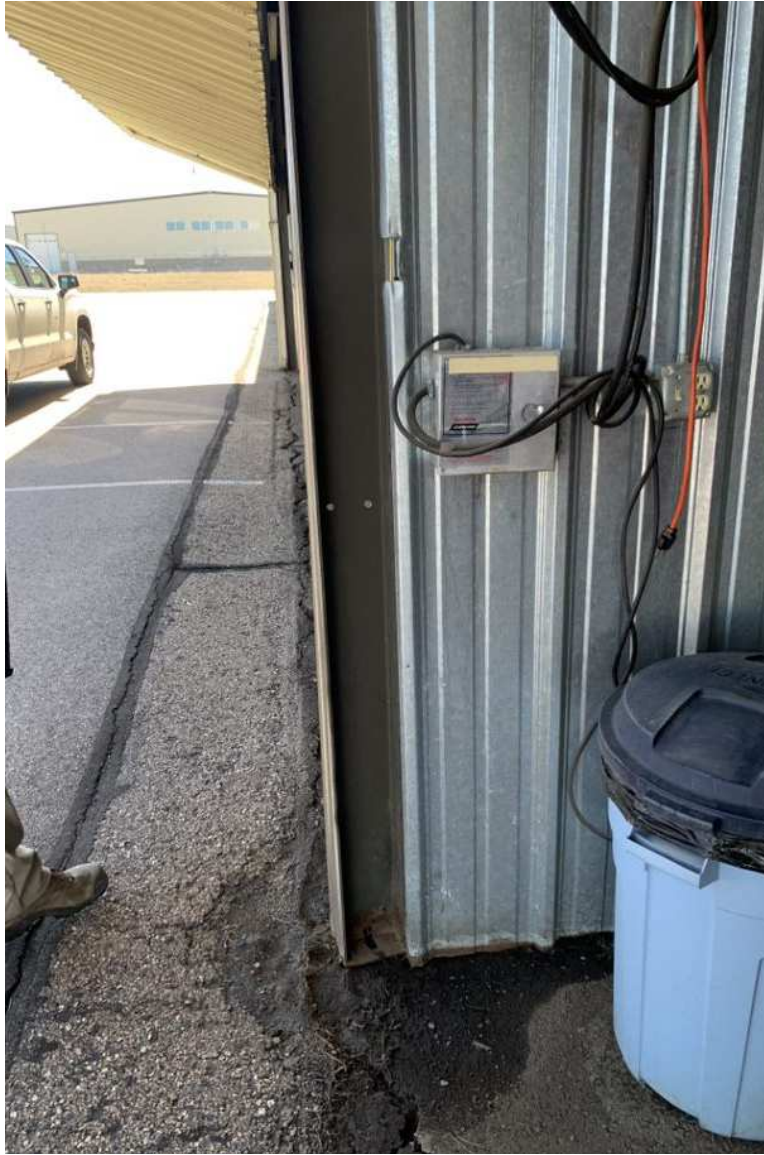
- **Importance:** Medium
    - **Building 1:**
      - Unit 2 (1)
    - **Building 2:**
      - Unit 9 (1)
      - Unit 13 (1)
      - Unit 20 (1)
  - Tightening of existing bolts to a snug-tight condition, and replacement of any bolt not capable of being tightened, or with inadequate thread count above tightening nut. A minimum of (2) threads are required to protrude above the tightening nut. This is a common condition throughout the “C” Hangars (**Figure 22 and 23**).

Figure 20 – IMG\_5129 – Building 1, Unit 2 – Exemplar photograph of out-of-plumb column.

Figure 21 – IMG\_6790 – Building 2, Unit 13 – Exemplar photograph of rotated column.

- Unit 10
  - Manually reversing out-of-plumb/rotated columns back to straight. Knott estimates a minimum of (4) instances of this repair (**Figures 20 and 21**).

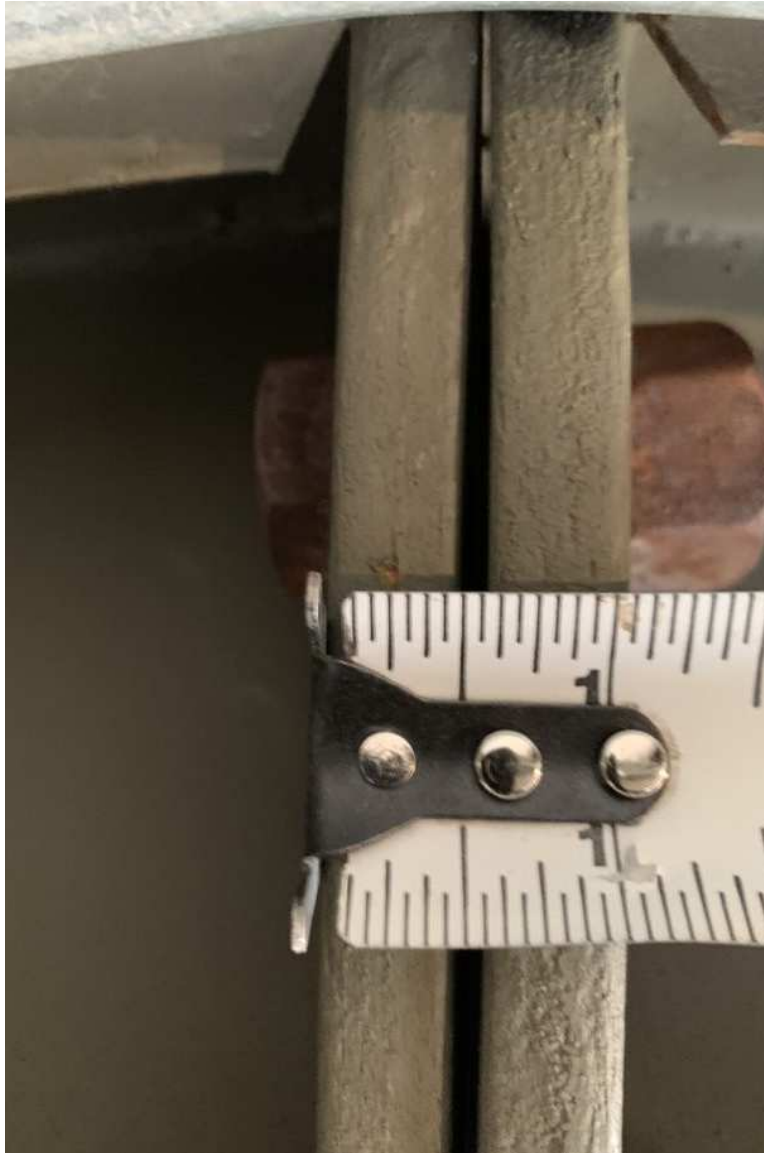
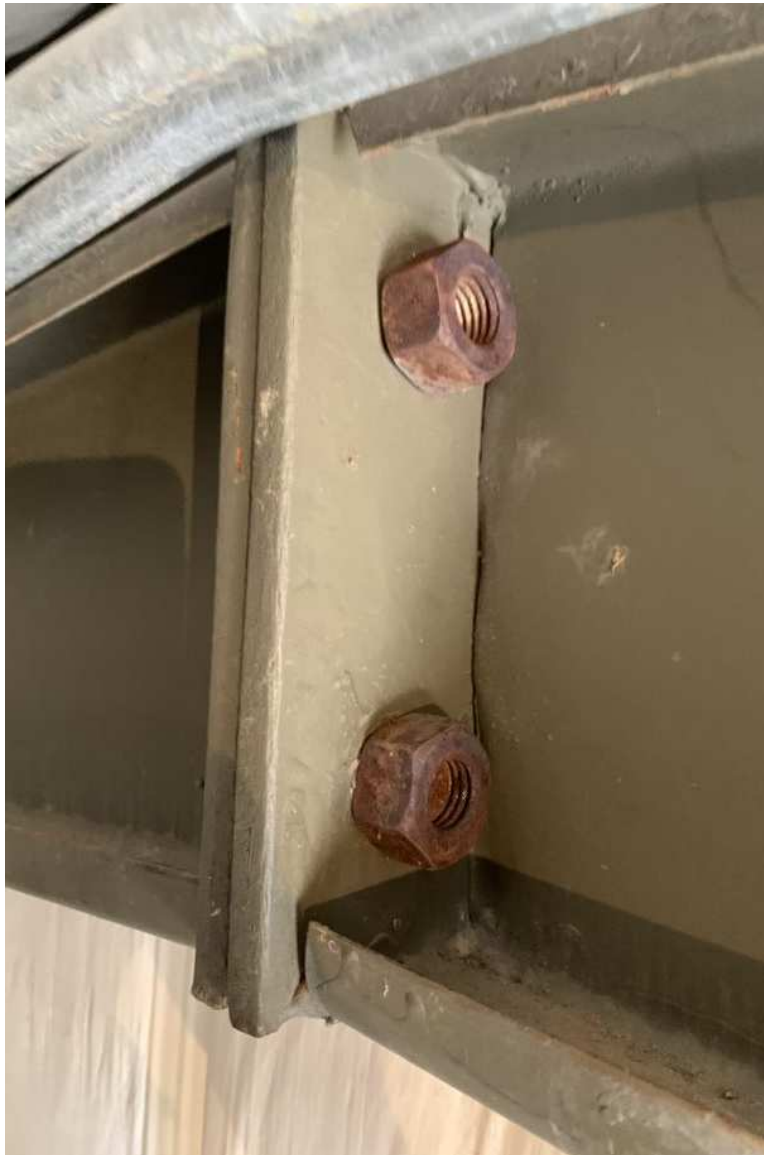
Figure 22 – IMG\_6465 – Building 1, Storage unit adjacent to Unit 1 – Exemplar photograph of bolts requiring tightening to snug-tight condition.

Figure 23 – IMG\_6461 – Building 1, Storage unit adjacent to Unit 1 – Exemplar photograph of inadequate thread count above tightening nut.

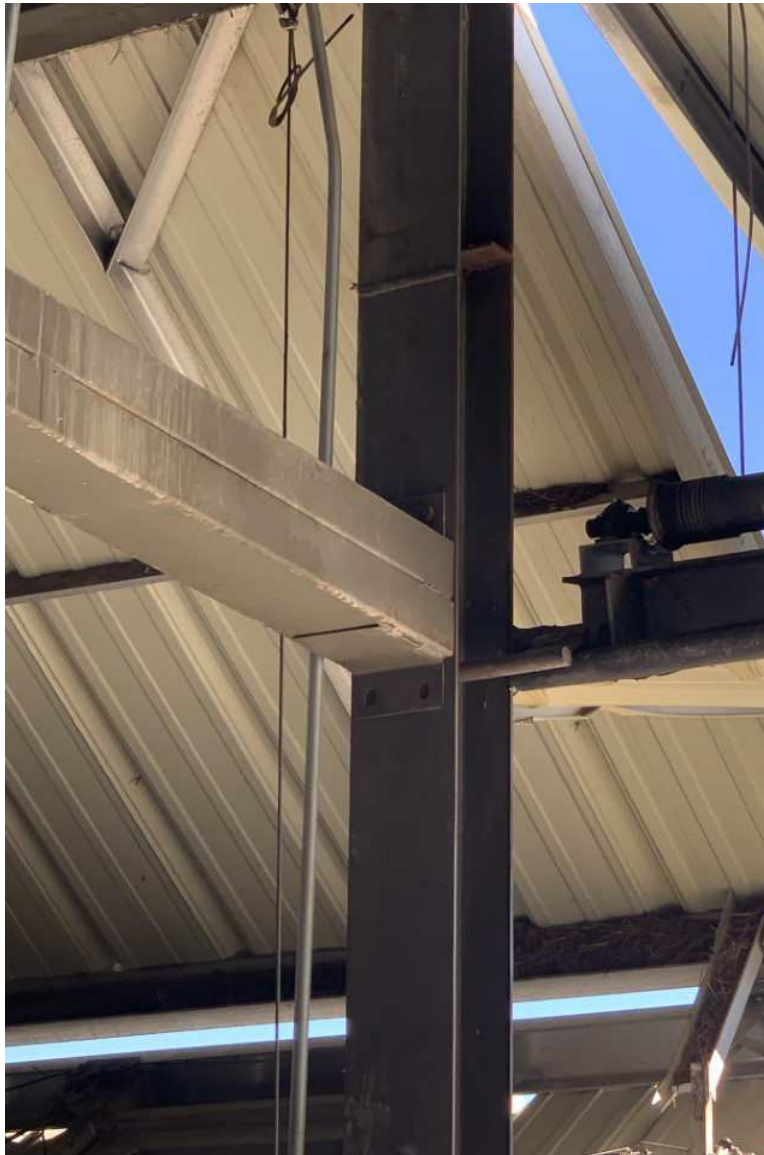
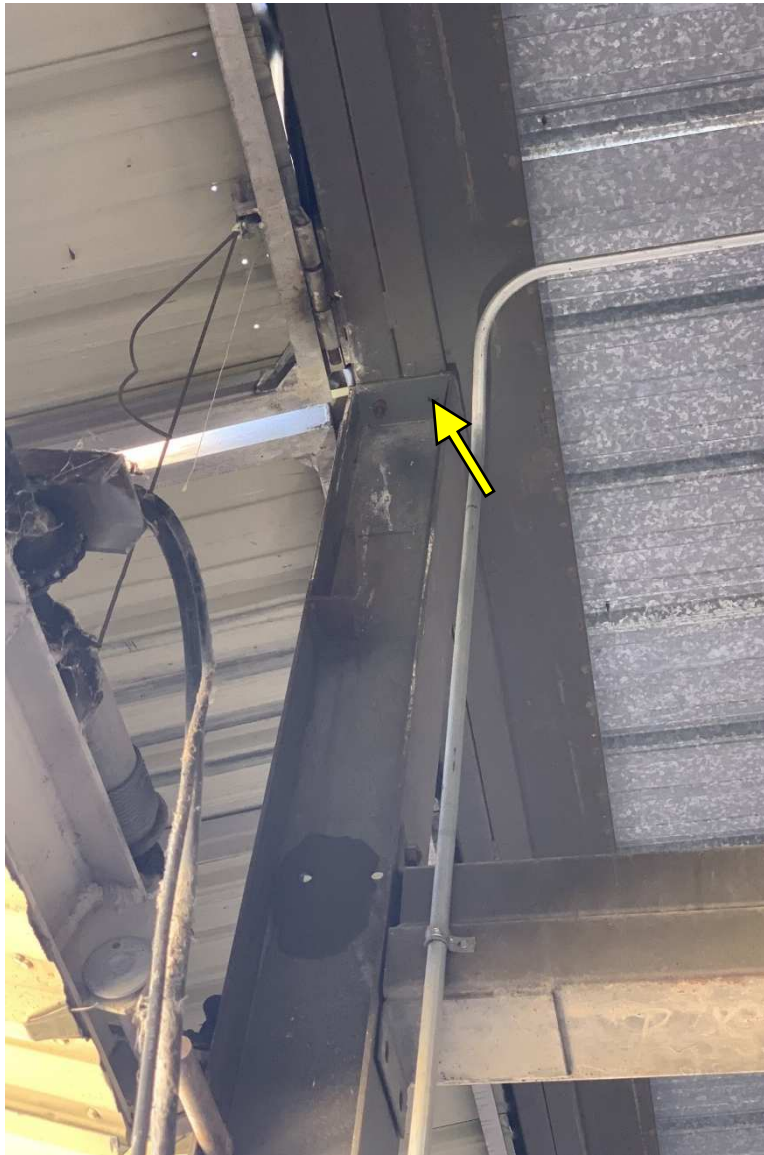
Figure 24 – IMG\_6554 – Building 1, Unit 13 – Exemplar photograph of missing bolts in structural bolted connections.

Figure 25 – IMG\_6654 – Building 1, Unit 14 – Exemplar photograph of missing bolts in structural bolted connections.

- Re-attachment/addition of missing bolts in structural bolted connections where a bolt previously existed. This is a common condition throughout the “C” Hangars (**Figure 24 and 25**).

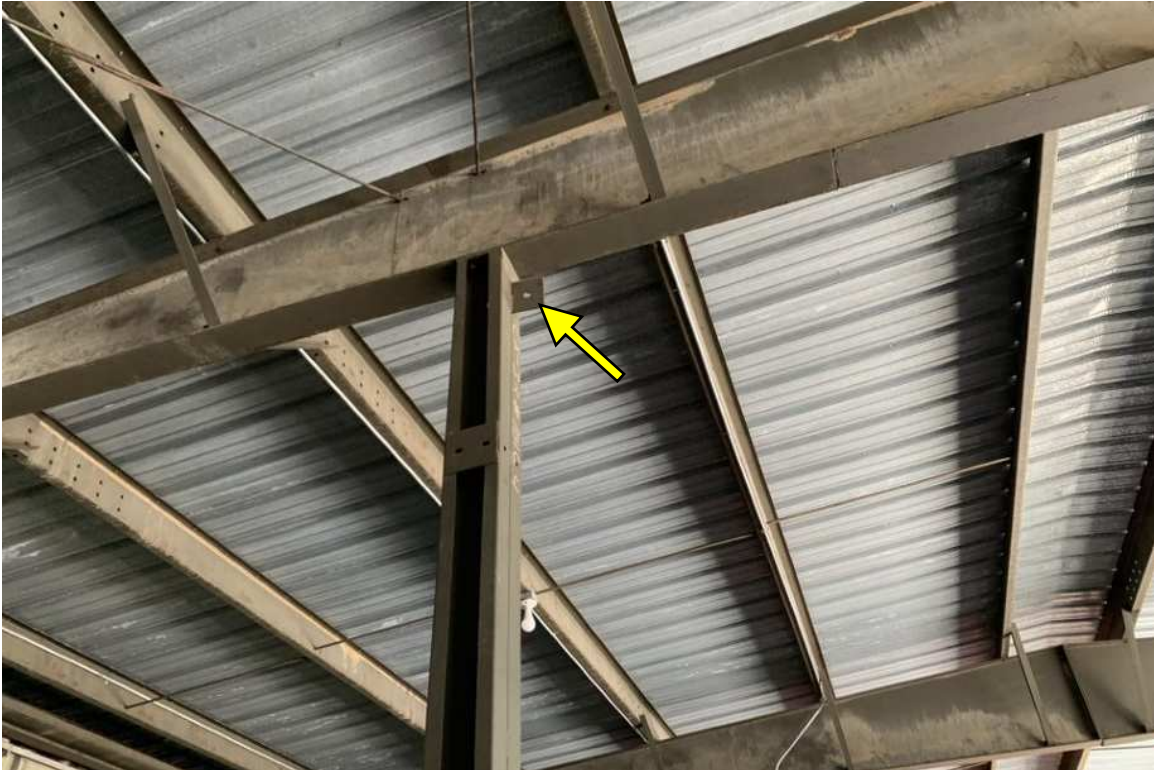
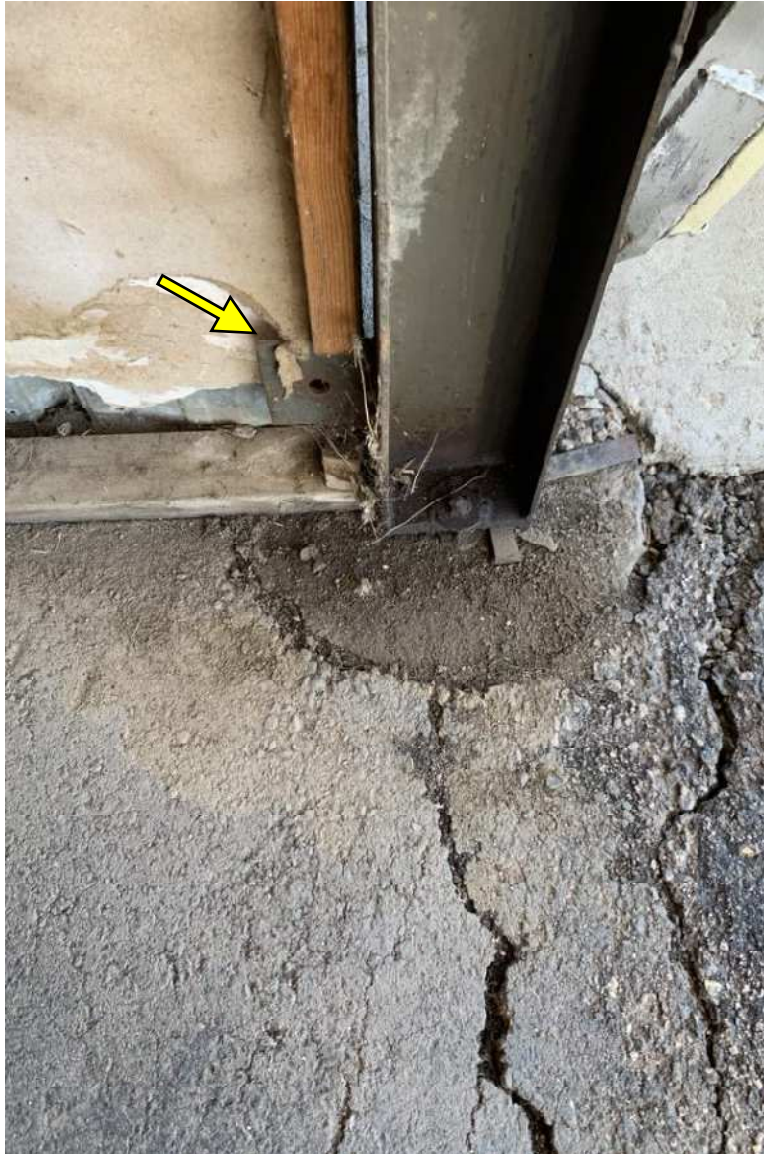
- **Importance:** High
    - **Building 1:**
      - Unit 1 (1)
      - Unit 15 (3)
      - Unit 17 (2)
      - Unit 20 (2)
    - **Building 2:**
      - Unit 3 (2)

Figure 26 – IMG\_6563 – Building 1, Unit 15 – Exemplar photograph of missing vertical tension rod element.

Figure 27 – IMG\_6732 – Building 2, Unit 3 – Exemplar photograph of missing vertical tension rod element.

- **Lateral System:**
  - Replacement of vertical tension rod elements, to match existing, where current brace is missing or buckled. Knott estimates a minimum of (14) instances of this repair (**Figure 26 and 27**).
