## **Report of Findings**

Knott Laboratory Project Number: 20939

Northern Colorado Regional Airport  
"C" Hangars  
4930/4960 Grumman Street  
Loveland, Colorado 80538

April 25, 2023

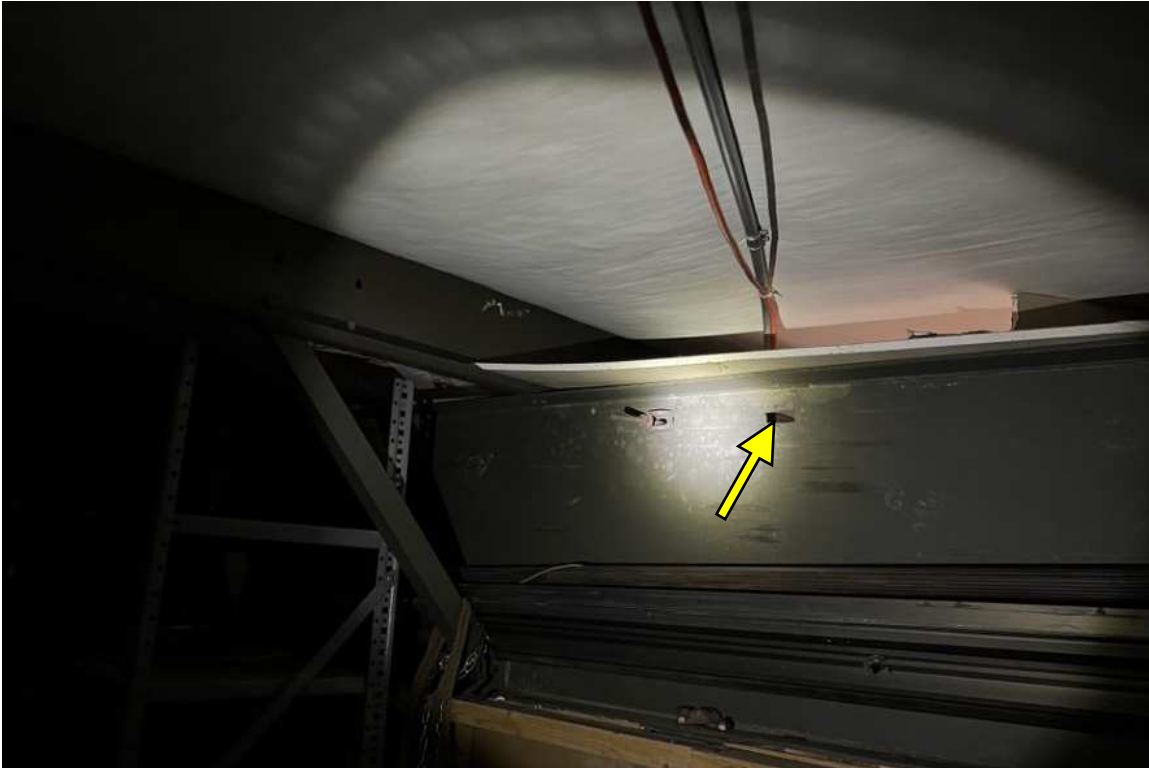
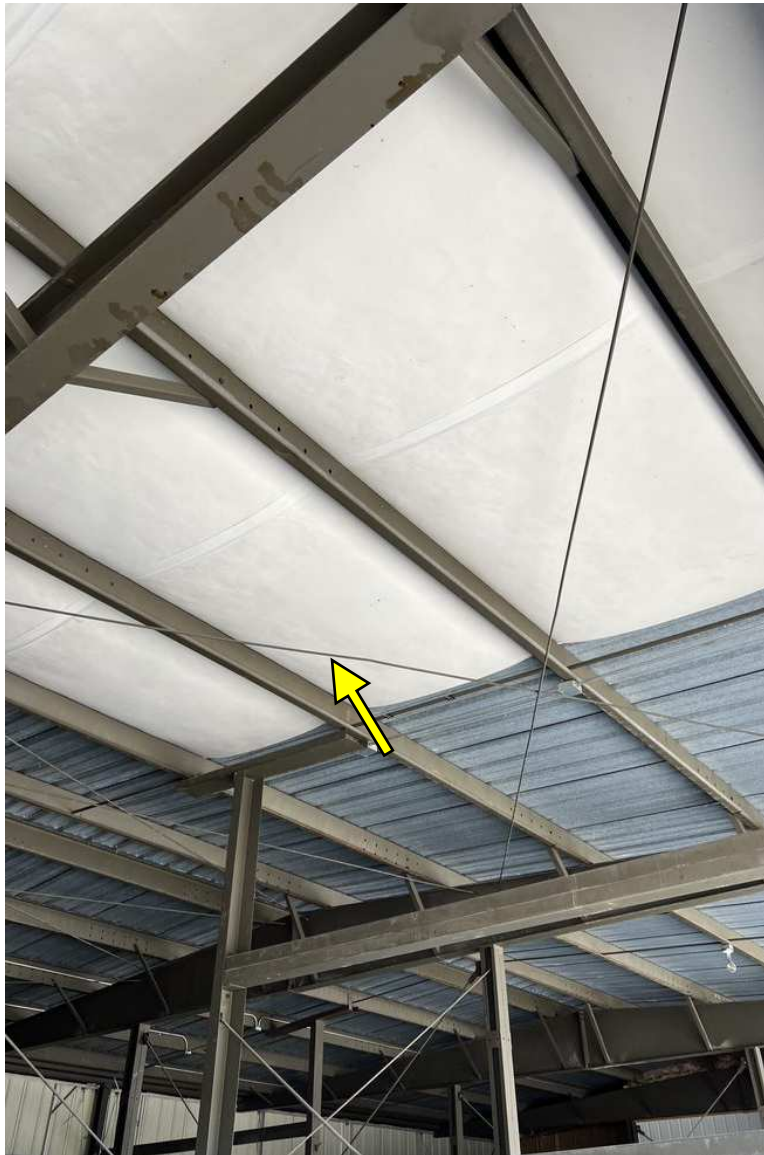
Figure 28 – IMG\_5288 – Building 2, Storage unit adjacent to Unit 2 – Exemplar photograph of missing diaphragm bracing.

Figure 29 – IMG\_5276 – Building 2, Unit 4 – Exemplar photograph of buckling of diaphragm bracing.

- Replacement of horizontal/diaphragm tension rod elements, to match existing, where current brace is missing or buckled. Knott estimates a minimum of (5) instances of this repair (**Figure 28 and 29**).
  - **Importance:** High
  - **Building 1:**
    - Unit 18 (2)
  - **Building 2:**
    - Storage unit next to Unit 2 (2)
    - Unit 4 (1)
- Snug hand tightening of existing brace turnbuckles and column connections, and replacement of any brace not capable of being tightened. This is a common condition throughout the “C” Hangars (**Figure 30 and 31**).
  - **Importance:** Medium
- See “Gravity System” recommendations where applicable to the lateral system.
- **Foundation System:**
  - None.

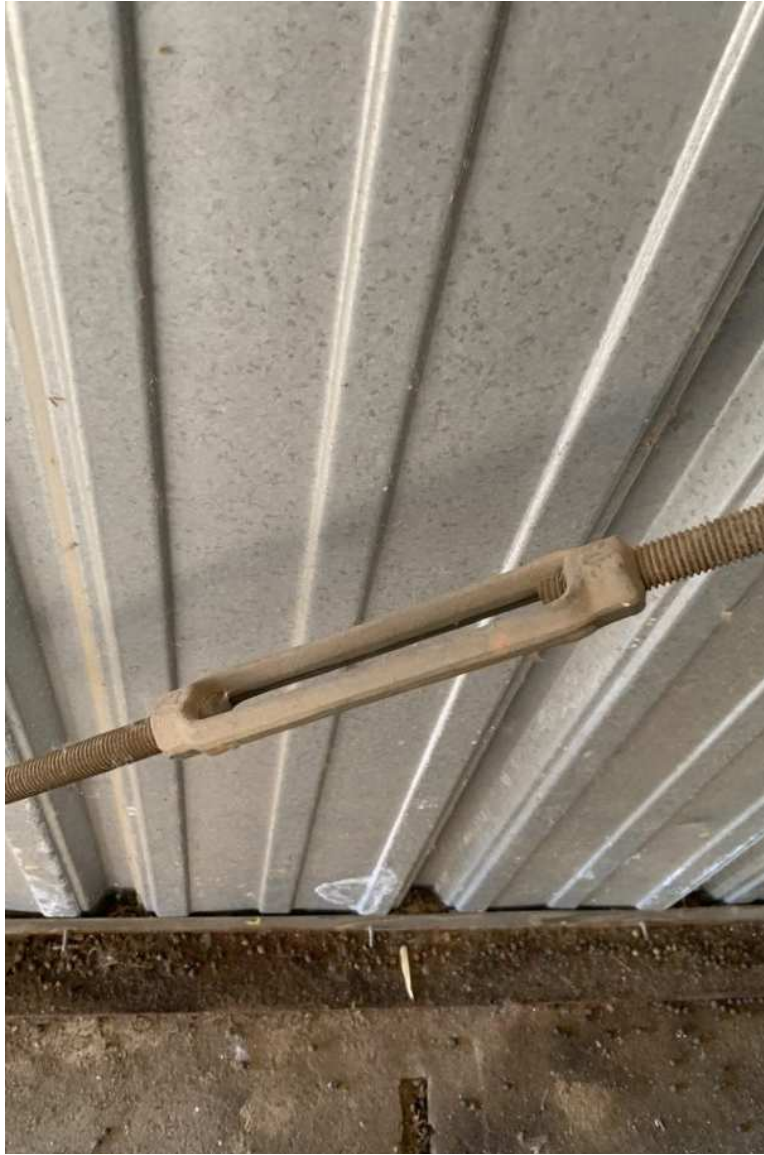
Figure 30 – IMG\_6470 – Building 1, Storage unit adjacent to Unit 1 – Exemplar photograph of turnbuckle requiring snug hand tightening.

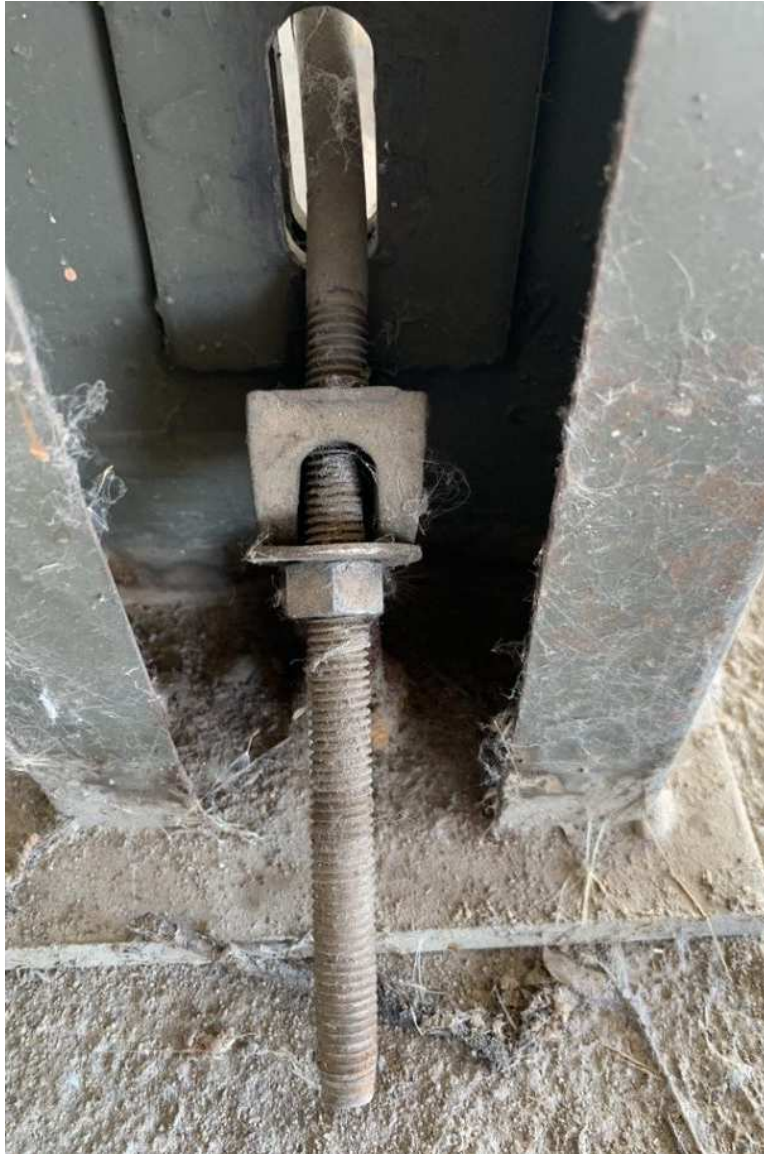
Figure 31 – IMG\_6481 – Building 1, Storage unit adjacent to Unit 1 – Exemplar photograph of tension rod column connection requiring tightening.

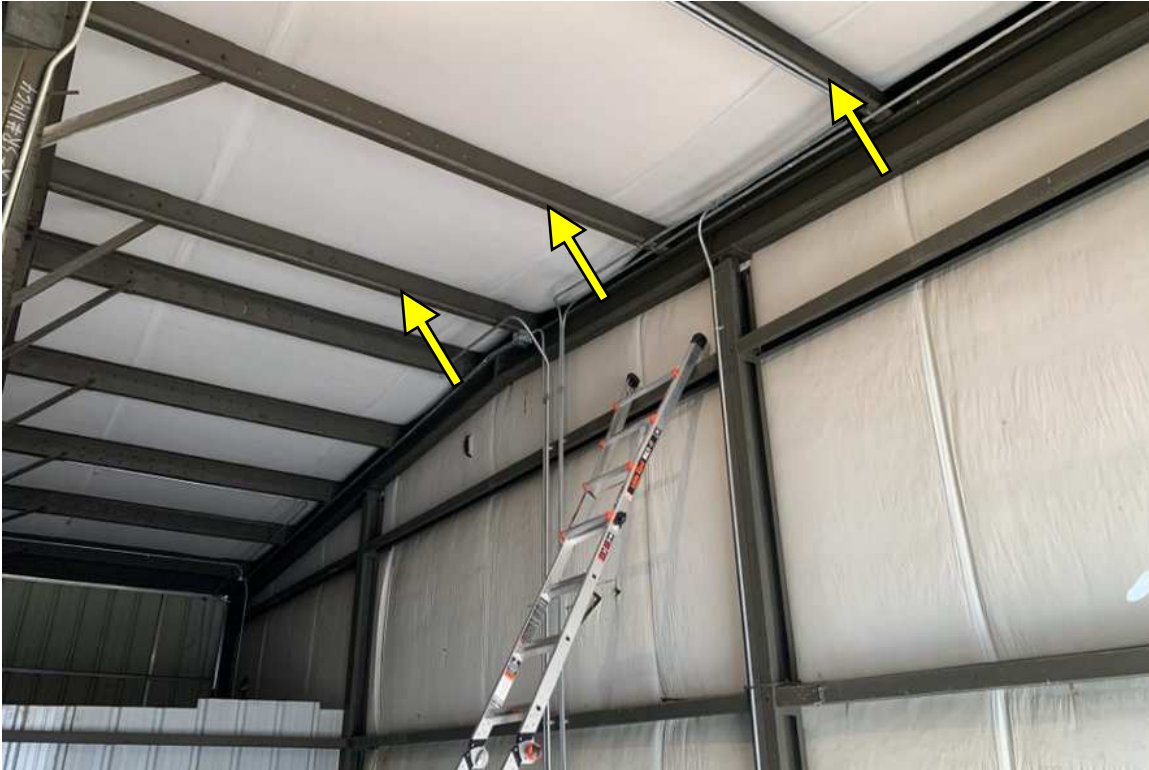
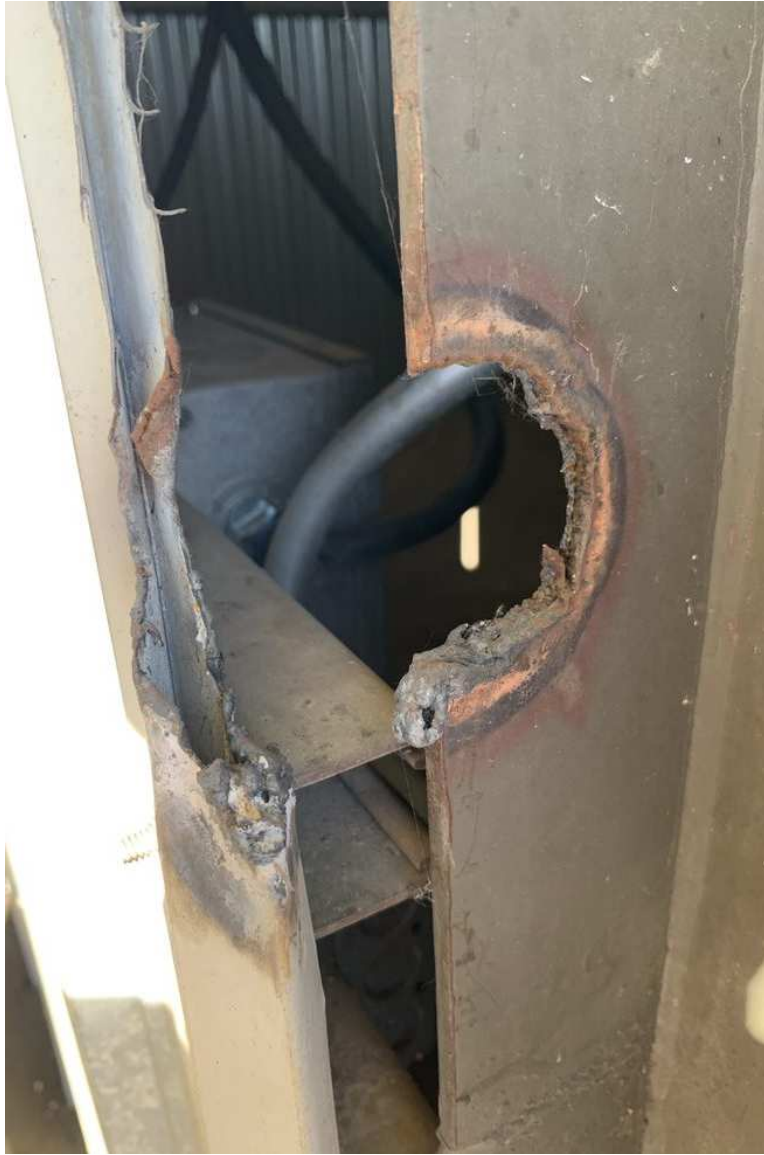
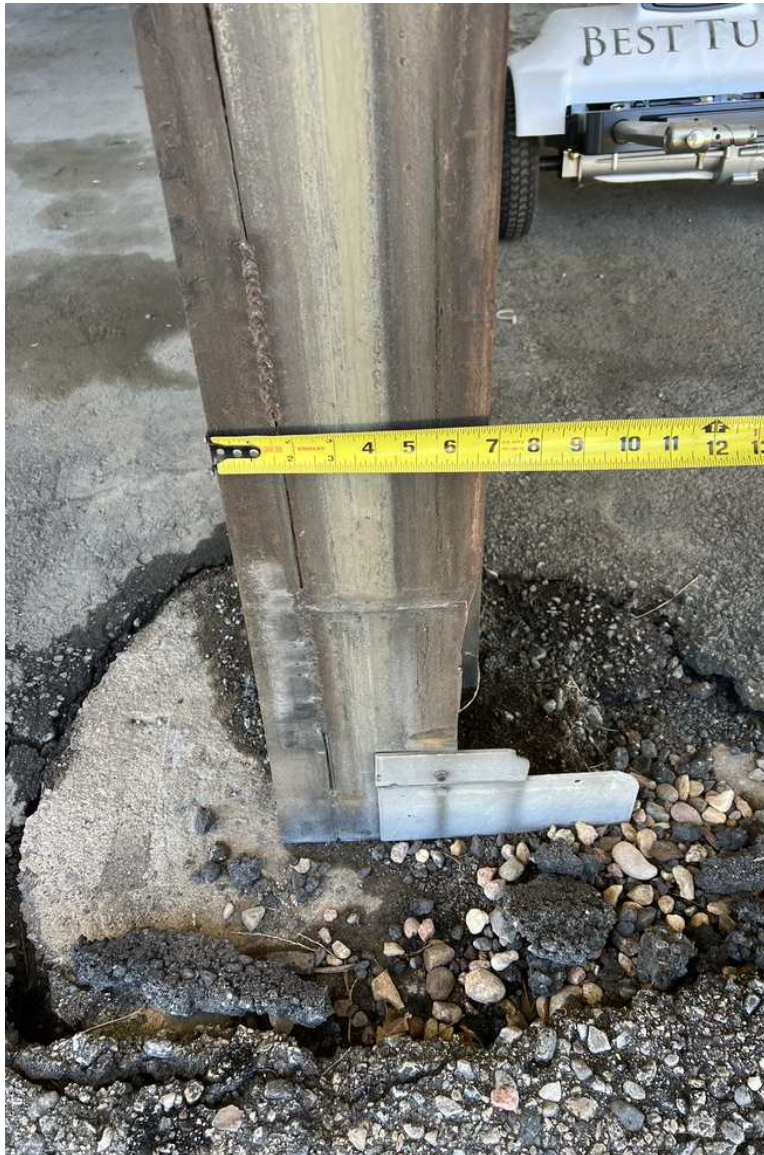
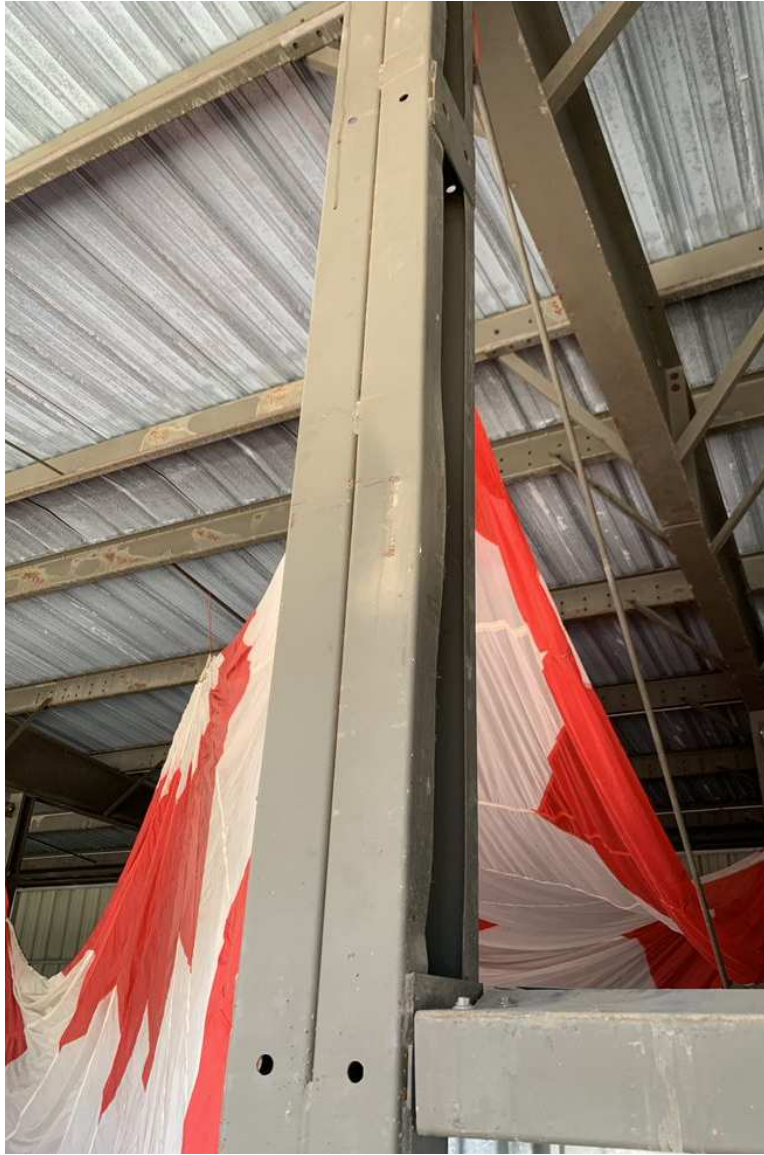
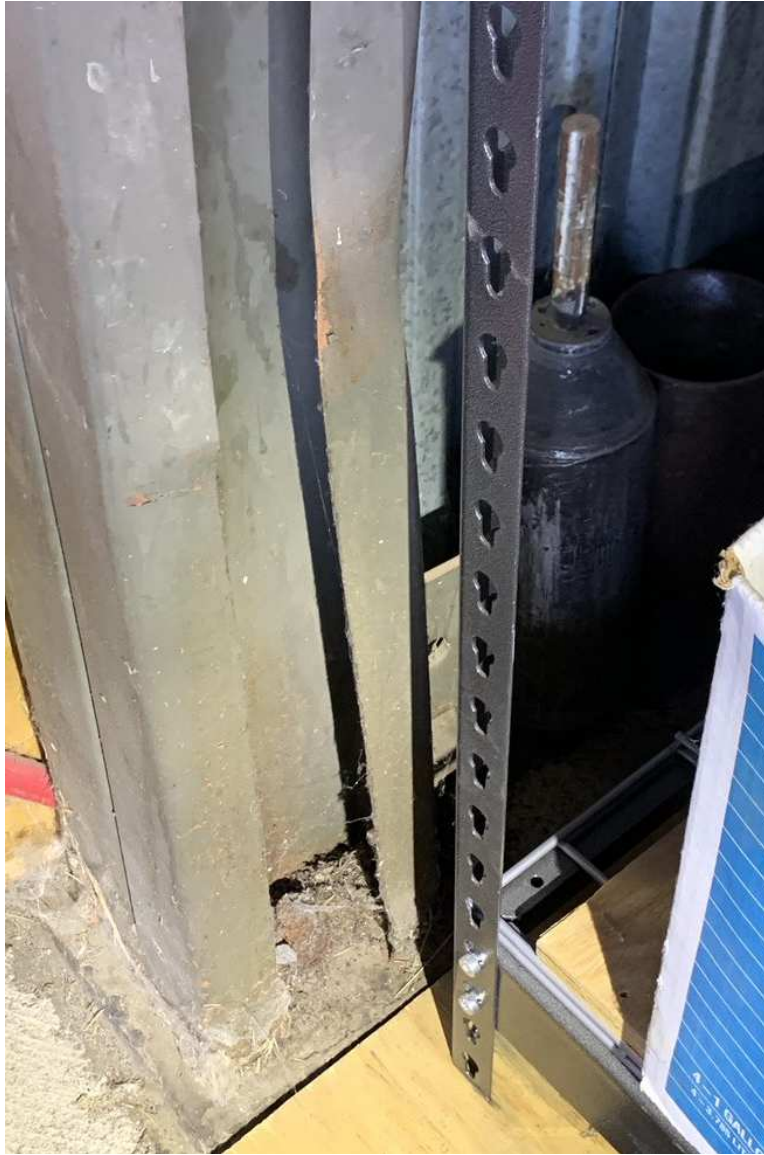
Figure 32 – IMG\_6456 – Building 1, Storage adjacent to Unit 1 - Isolated roof framing members exhibiting deviations from the vertical ("rolling") -ongoing monitoring required.

Figure 33 – IMG\_6492 – Building 1, Unit 3 – Section loss in structural member - ongoing monitoring required.

Figure 34 – IMG\_5125 – Building 1, Unit 4 – Section loss in structural member - ongoing monitoring required.

Figure 35 – IMG\_6555 – Building 1, Unit 13 – Deformation, presumably due to impact, in structural member - ongoing monitoring required.

Figure 36 – IMG\_6621 – Building 1, Unit 20 – Deformation, presumably due to impact, in structural member - ongoing monitoring required.

- **Gravity System:**
  - Monitor gravity framing for excessive deflection and/or continued “rolling.” Monitor gravity column elements with existing section loss and/or deformation for excessive deflection (**Figure 32-36**)
    - **Importance:** General Maintenance
- **Lateral System:**
  - Monitor diaphragm bracing connections to tapered wide-flange girder members to ensure bracing members and connections are taut, particularly where a sharp angle occurs between the bracing connection and the brace line. This is a common condition throughout the “C” Hangars (**Figure 37**).

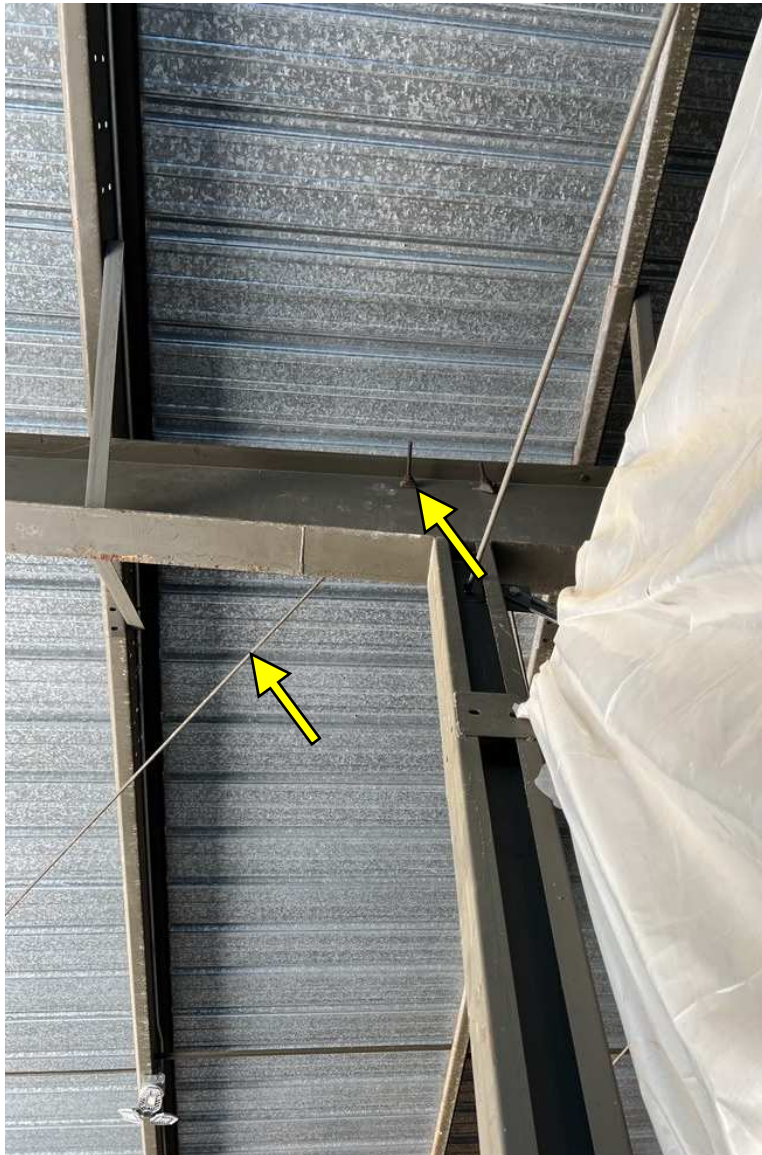
Figure 37 – IMG\_5235 – Building 2, Unit 10 – Exemplar photograph of sharp angle created between diaphragm bracing connection and brace line.

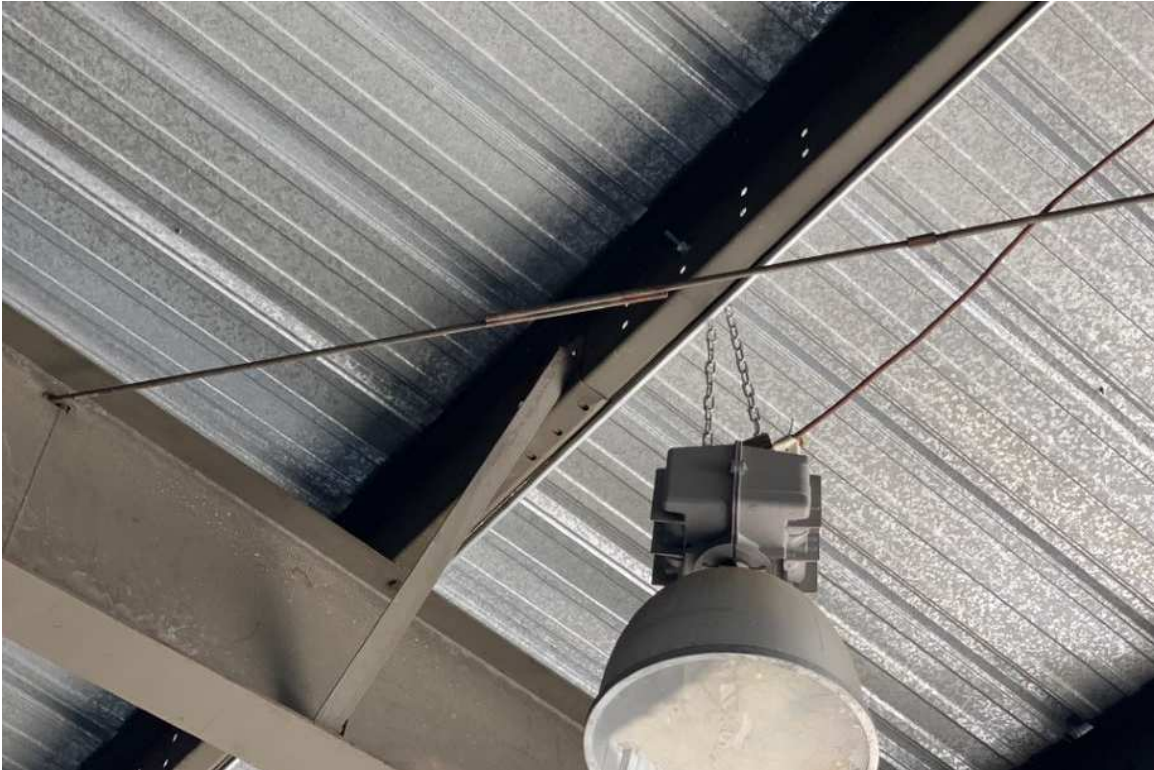
Figure 38 – IMG\_6606 – Building 1, Unit 19 – Exemplar photograph of eccentric welded connection between two tension members in diaphragm bracing.

- **Importance:** General Maintenance
  - Monitor diaphragm bracing splices to ensure bracing members are taut, where an eccentric welded connection occurs between two tension members. This is a common condition throughout the “C” Hangars (**Figure 38**).
- **Importance:** General Maintenance
- **Foundation System:**
  - None.
