DATE:	September 20, 2022
TO:	Aaron Ehle - Northern Colorado Regional Airport
FROM:	Jill Burrell, PE – Ditesco Kelsey Madsen, PE - Ditesco
RE:	Northern Colorado Regional Airport T-Hangar Structural Analysis

Appendix A T-Hangar Observation Report Log

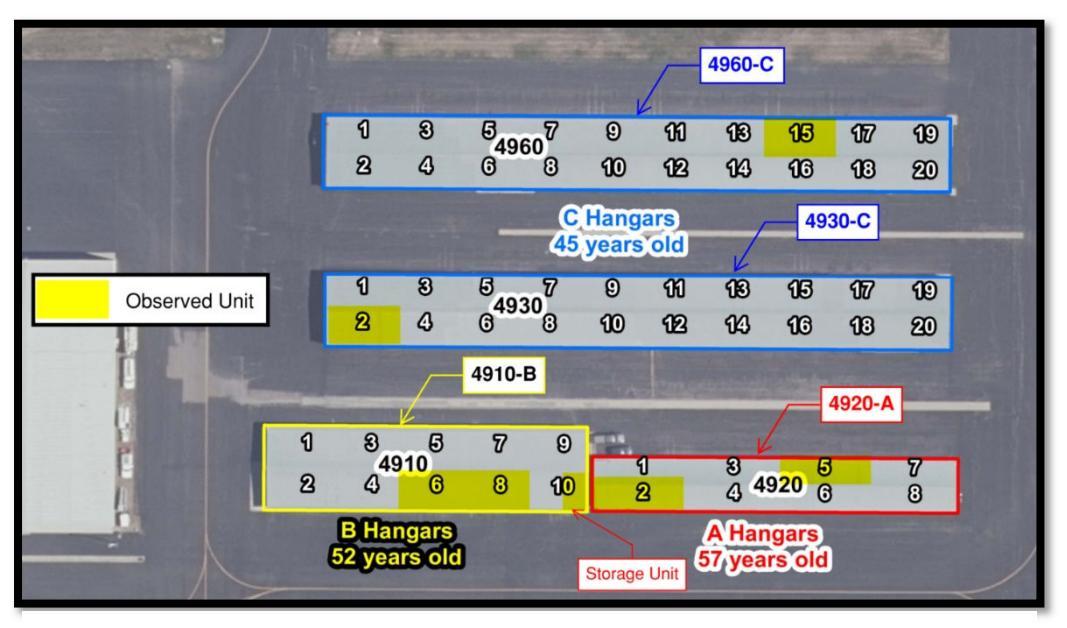
Figure 1

Ditesco performed a structural evaluation of the four hangars on August 18, 2022. Due the high-level approach of this report, only select units were inspected in detail, as shown in Figure 1. The conditions observed in the select units were assumed to be representative of the hangars in their entirety.

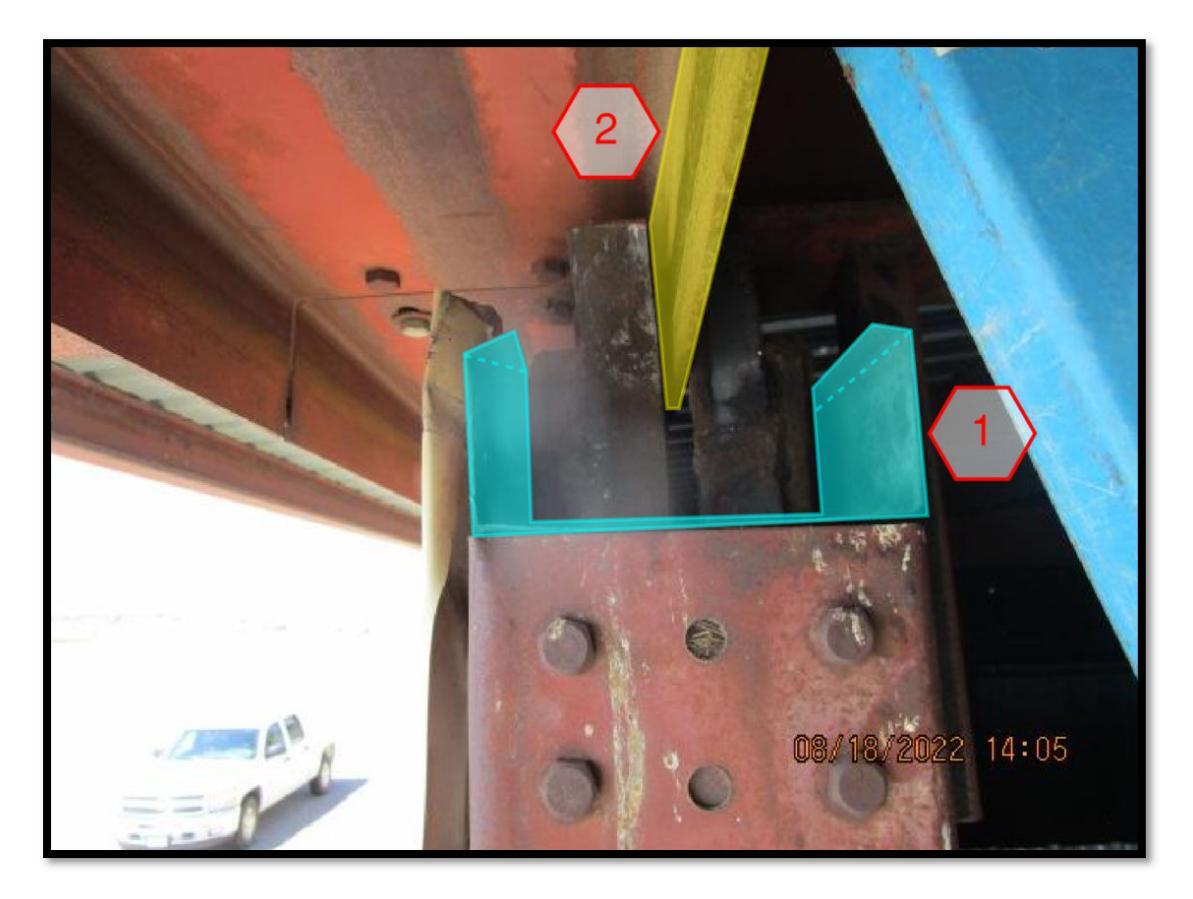
Figure 2

The FNL maintenance staff reported various challenges with the operation of the doors of the hangars. The doors have wheels mounted to the bottom where it bears its weight. The doors are mobilized by a two-rail system cast into a concrete pad. A C-channel (location 1) is mounted to the top of the door where the legs are intended to hold the door in place on the beam (location 2), as shown in Figure 2.

There are on-going issues where the doors are failing as a direct result of the movement and uplift of the structure from its failed foundation connections. The FNL maintenance staff has retrofitted the doors using three methods to mitigate this issue and prevent damage to tenant property housed in the hangars. The three repairs can be referenced in Photo 17, 22, and 28 of Appendix A. While these repairs may be temporarily effective, they do not address the greater issue associated with the hangars and are not recommended as a future repair method.

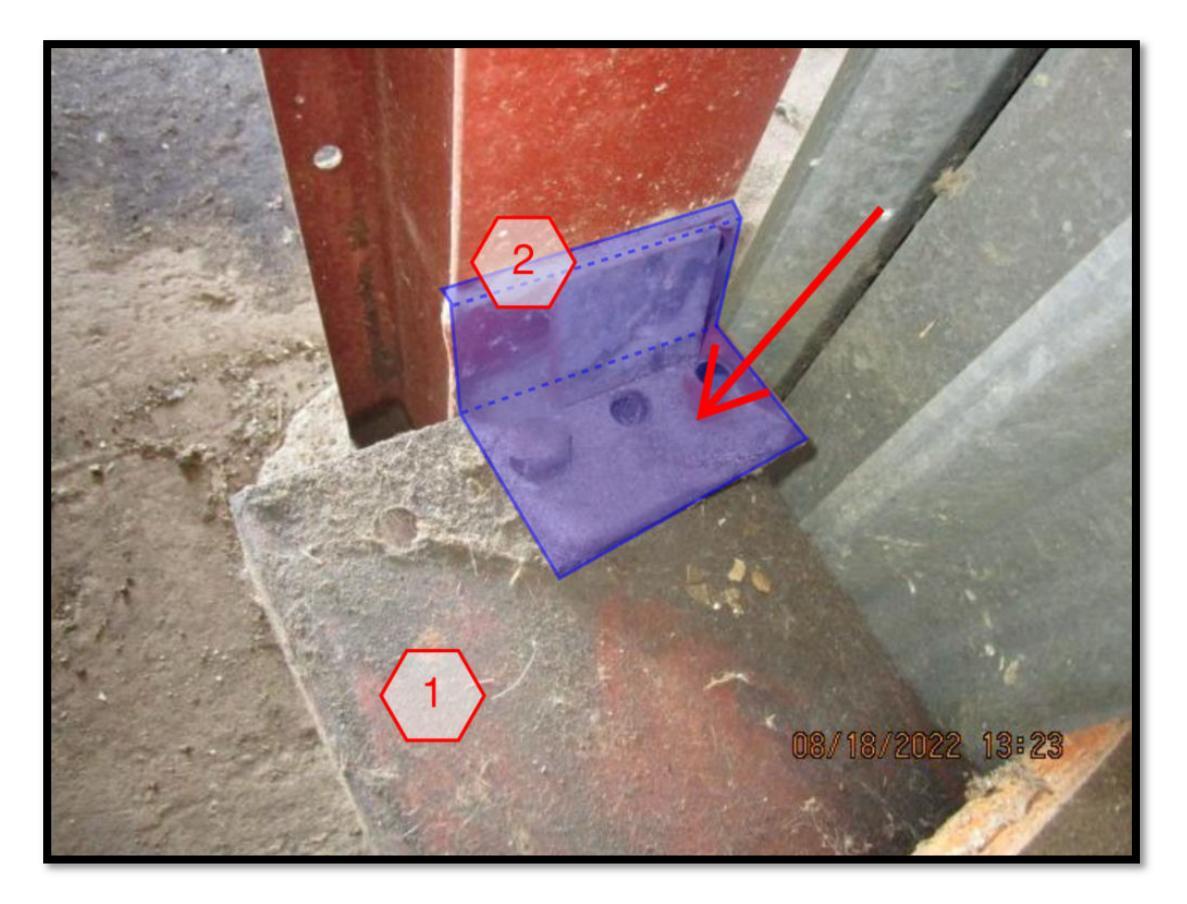
Figure 3

Additionally, it was observed that the hangar was constructed incorrectly. In Hangar 4910-B (Unit 8) it was observed that the shop-fabricated members were not fully fastened. However, it is unclear if full attachment is necessary based on the original design. Additionally, at the connection between the column and wall girt, there is a welded bracket on the column, as shown in Figure 3. The girt (location 1) has been connected to the underside of the bracket (location 2) and secured with one bolt. Instead, it is assumed that the girt should have been installed on top of the bracket so that the loads would be transferred through the weld and column, rather than relying solely on the bolt. It is also likely that is connection was intended to be fastened with more than one bolt, however without the original plans, this cannot be confirmed. This condition was observed in several instances throughout both units and is assumed to be consistent for the building in its entirety.

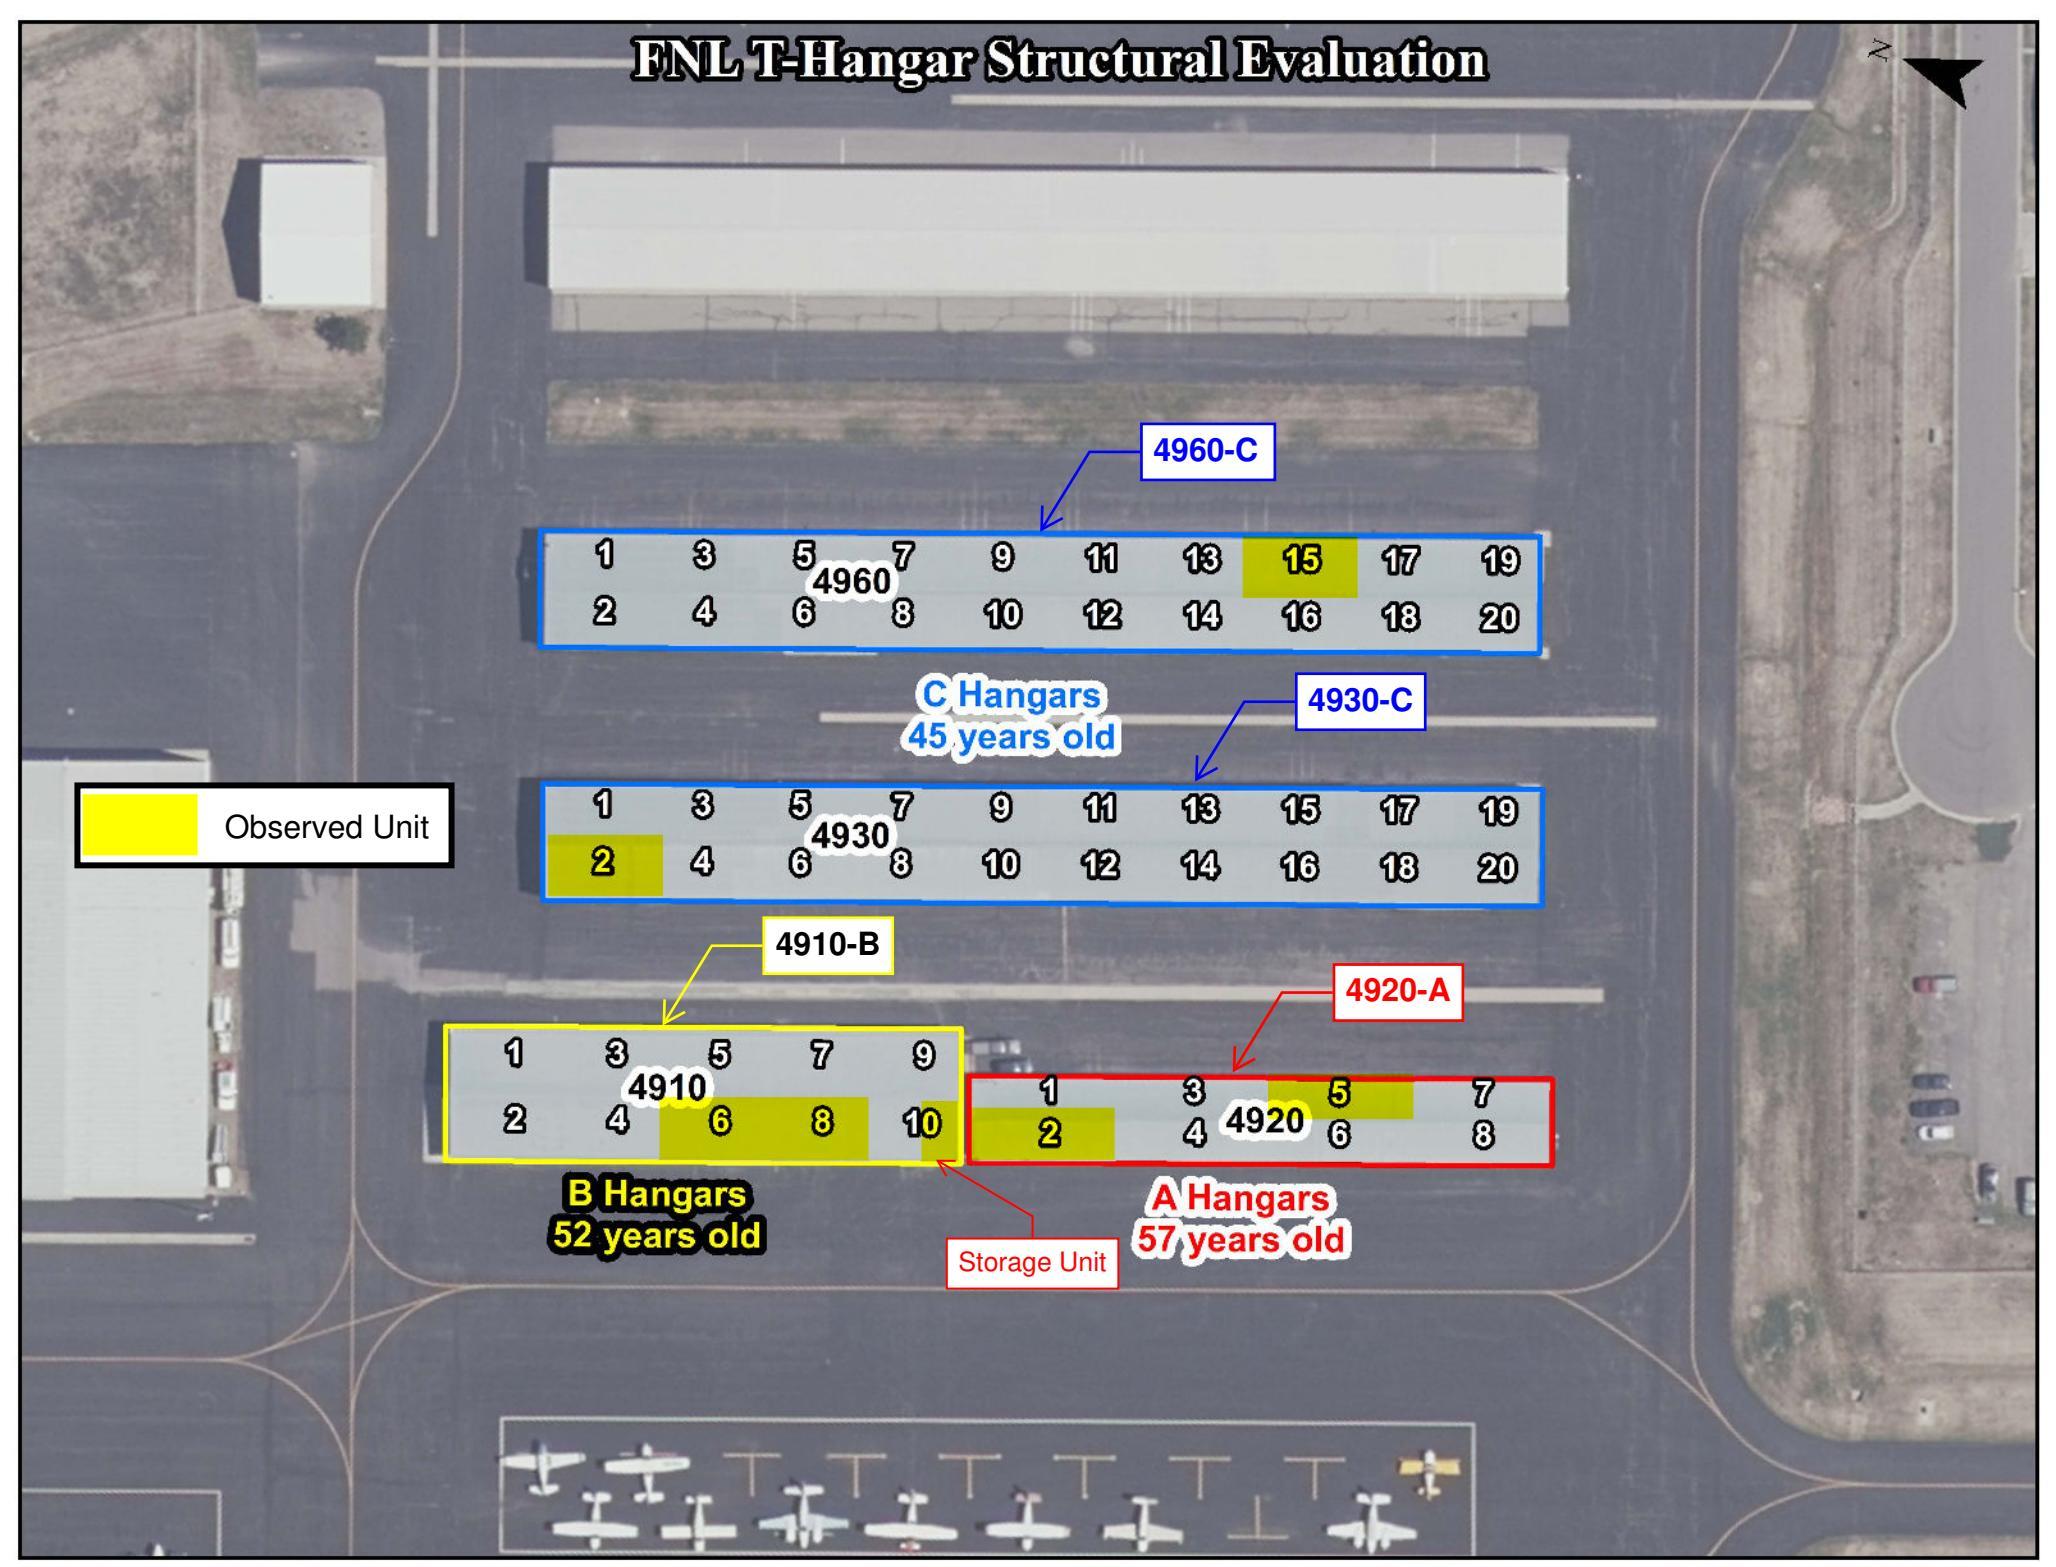
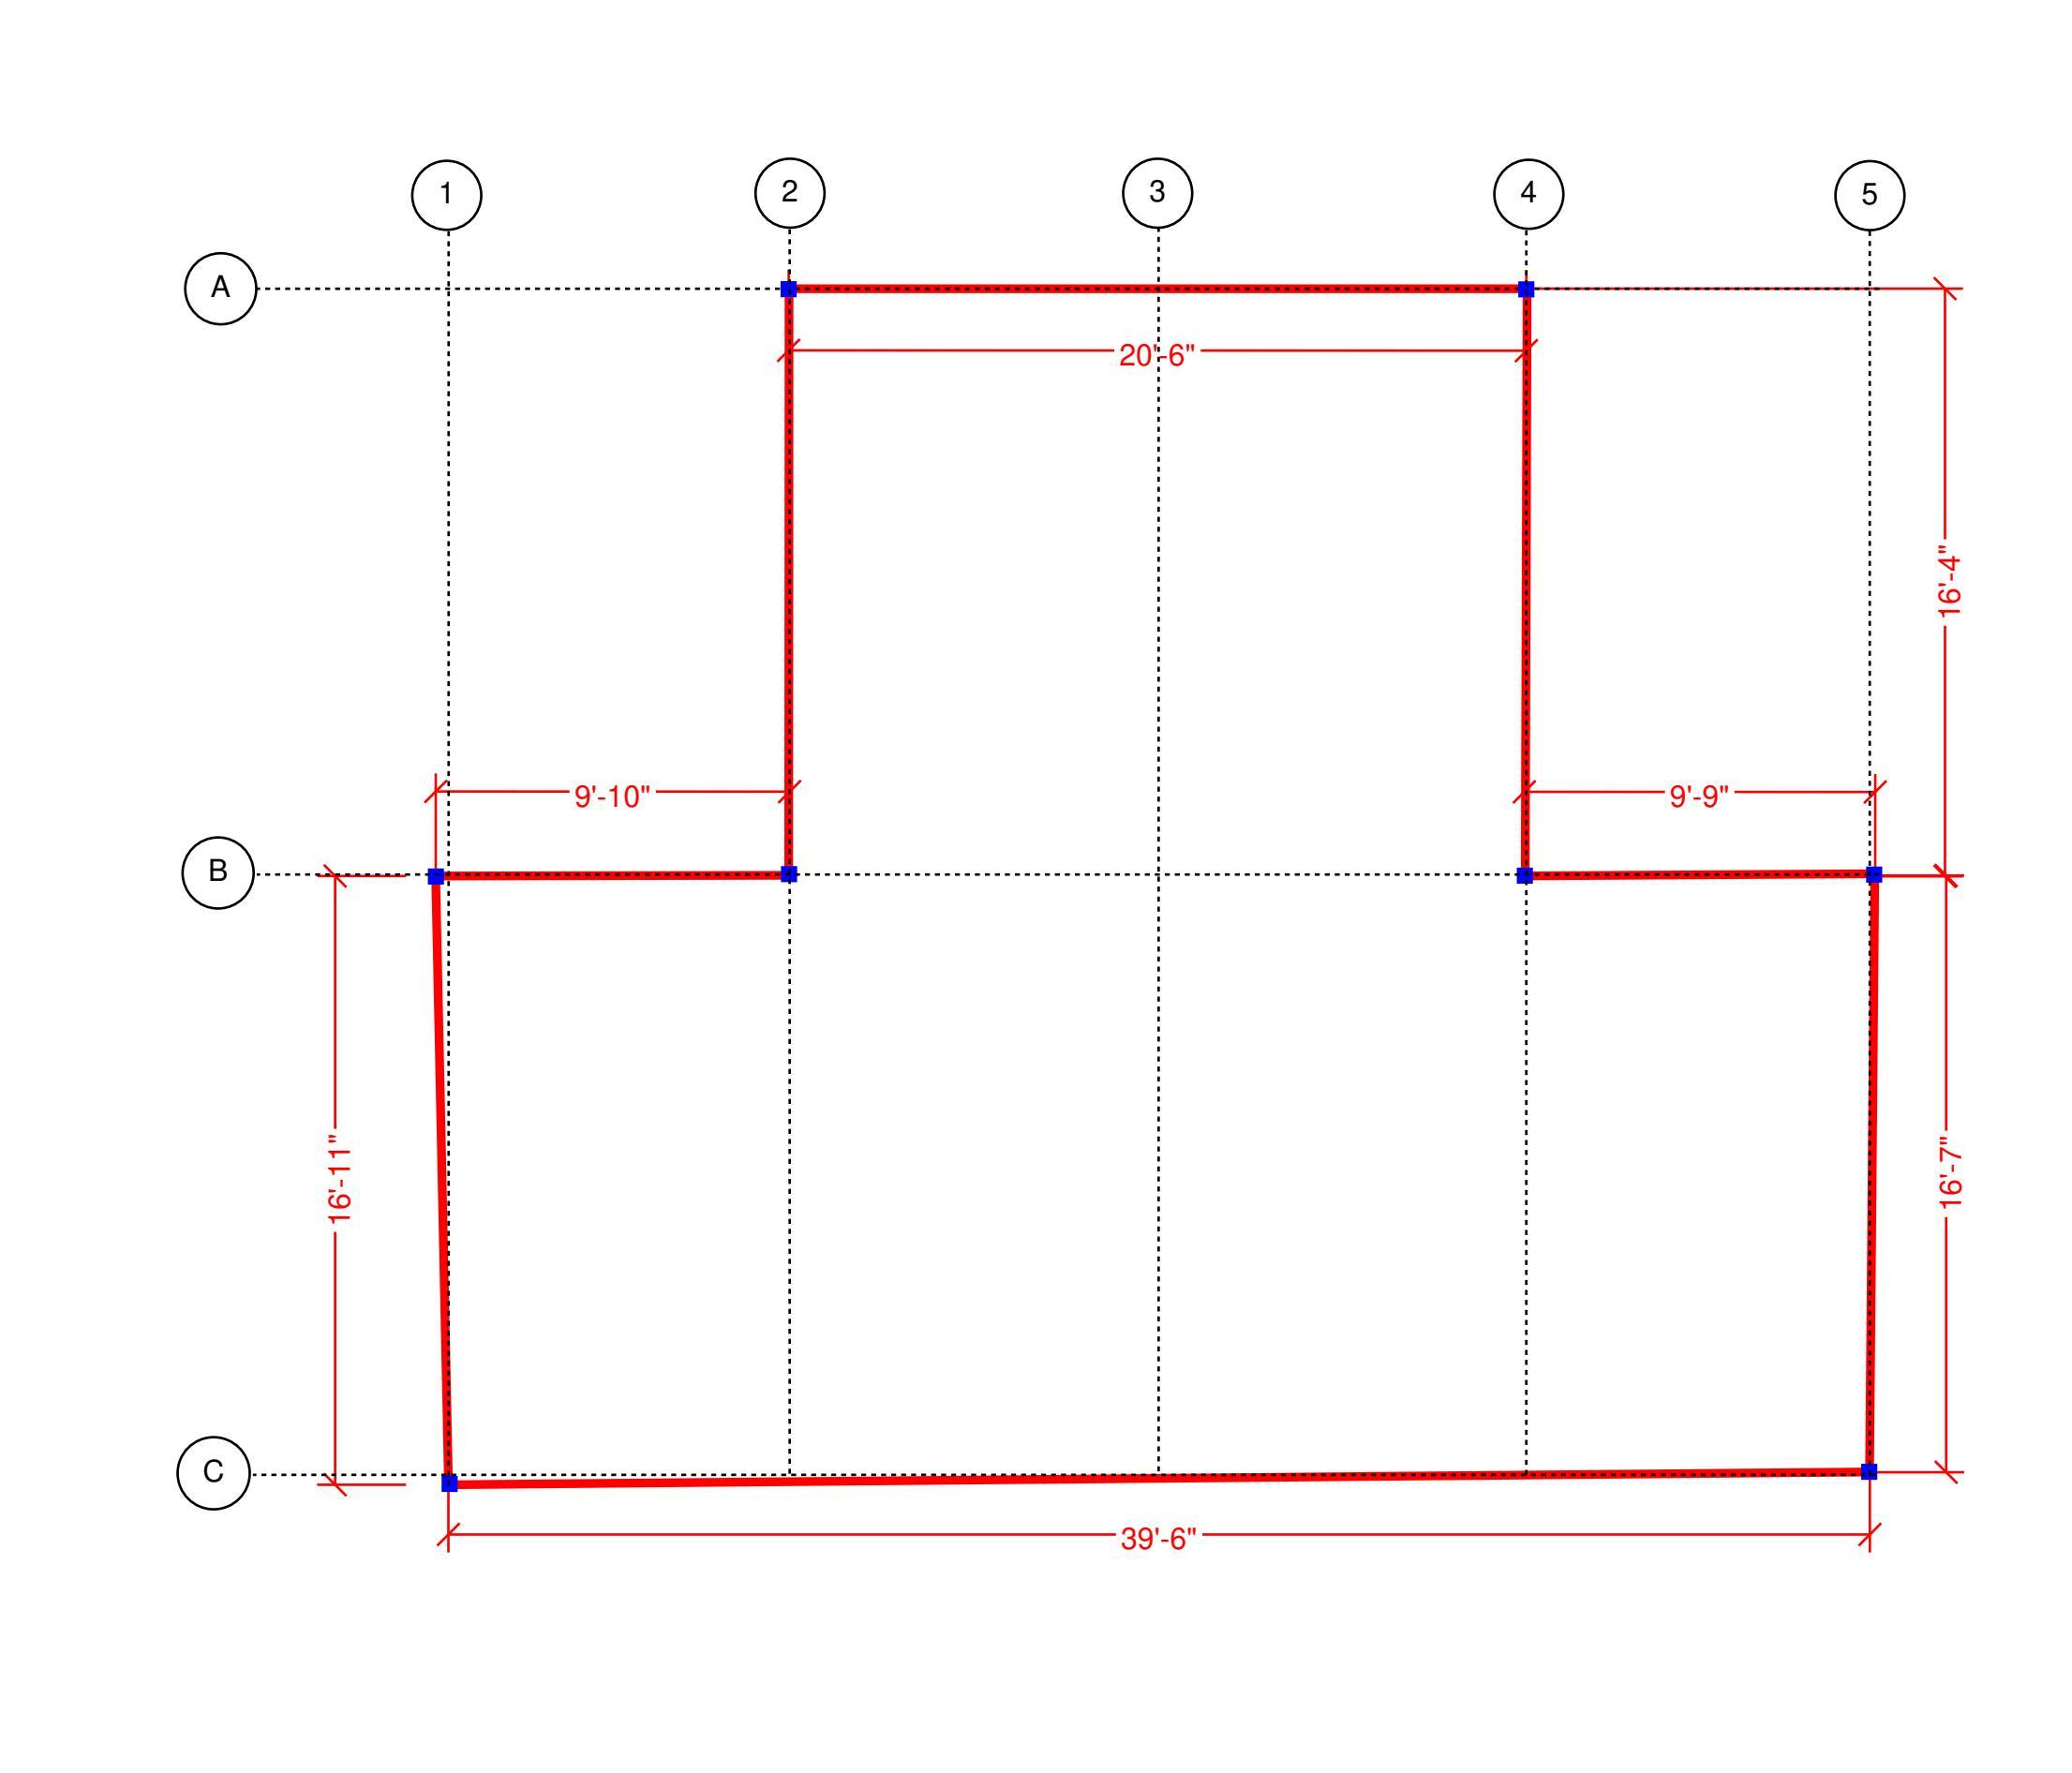
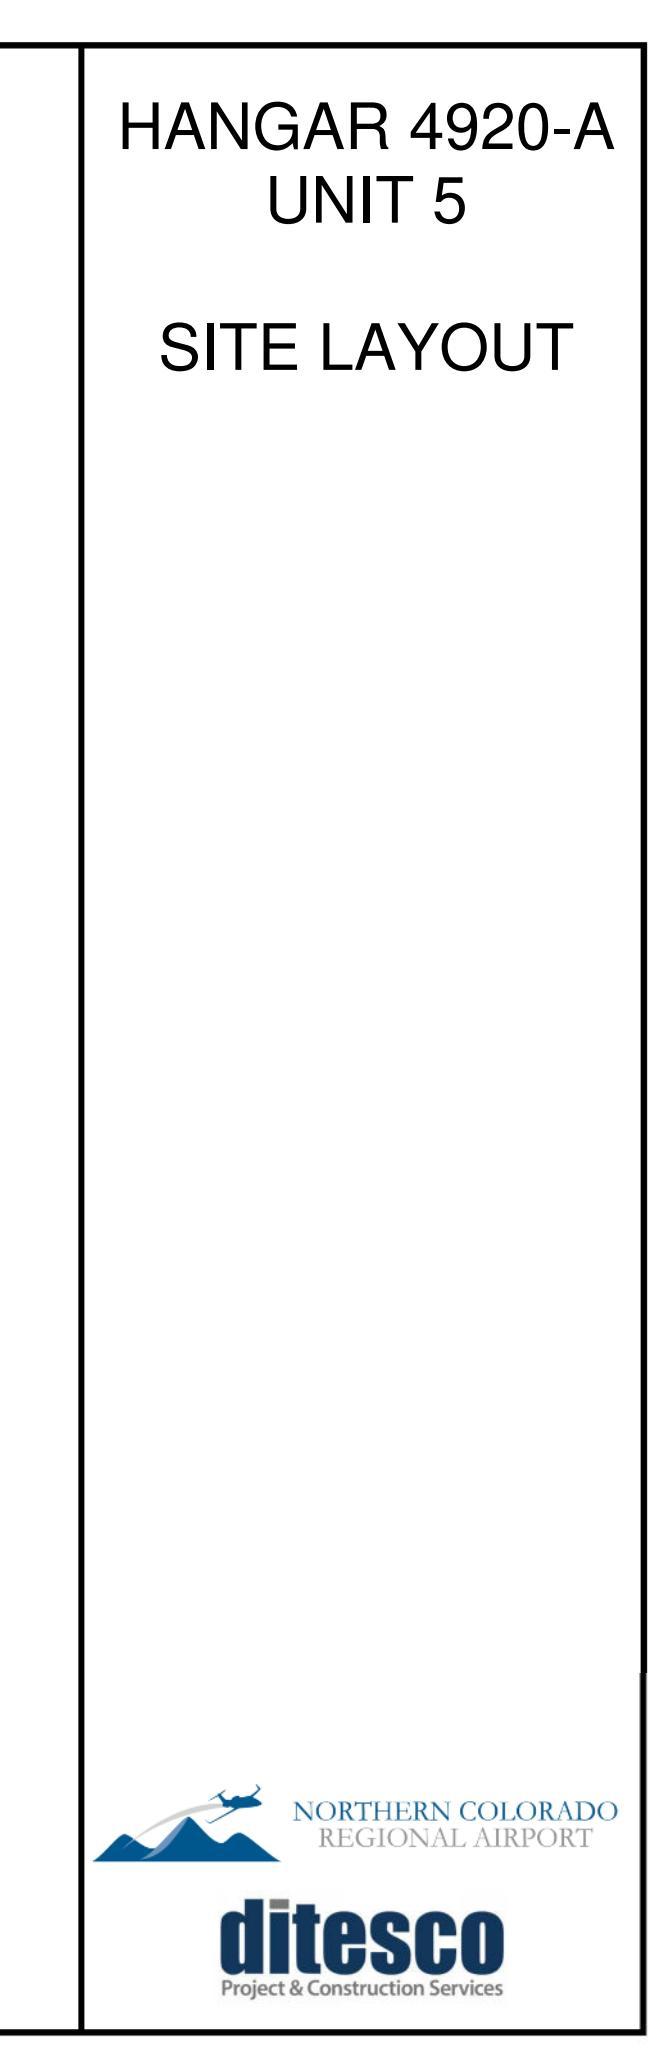
Page 2 of 16

Gridline C	Contraction of the the	Entire Structure	
Unsuitable, expansive soils are causing the pavement to heave.	08/18/2022 12:09	Roof is not properly sealed allowing water infiltration.	08/
РНОТО 2		ΡΗΟΤΟ 5	
Gridling A		Gridling R2	
	Etan Star		
After market		20-inch diameter	
completed. Rebar has		anchors connected to	
along its length.		foundation is unknown.	
	08/18/2022 12:17		Da
PHOTO 3		PHOTO 6	
Gridline C		Gridline A	
The door roller		Damage to exterior	
condition with		metal panels.	
misaligned track.			
	08/18/2022 12:36		08/

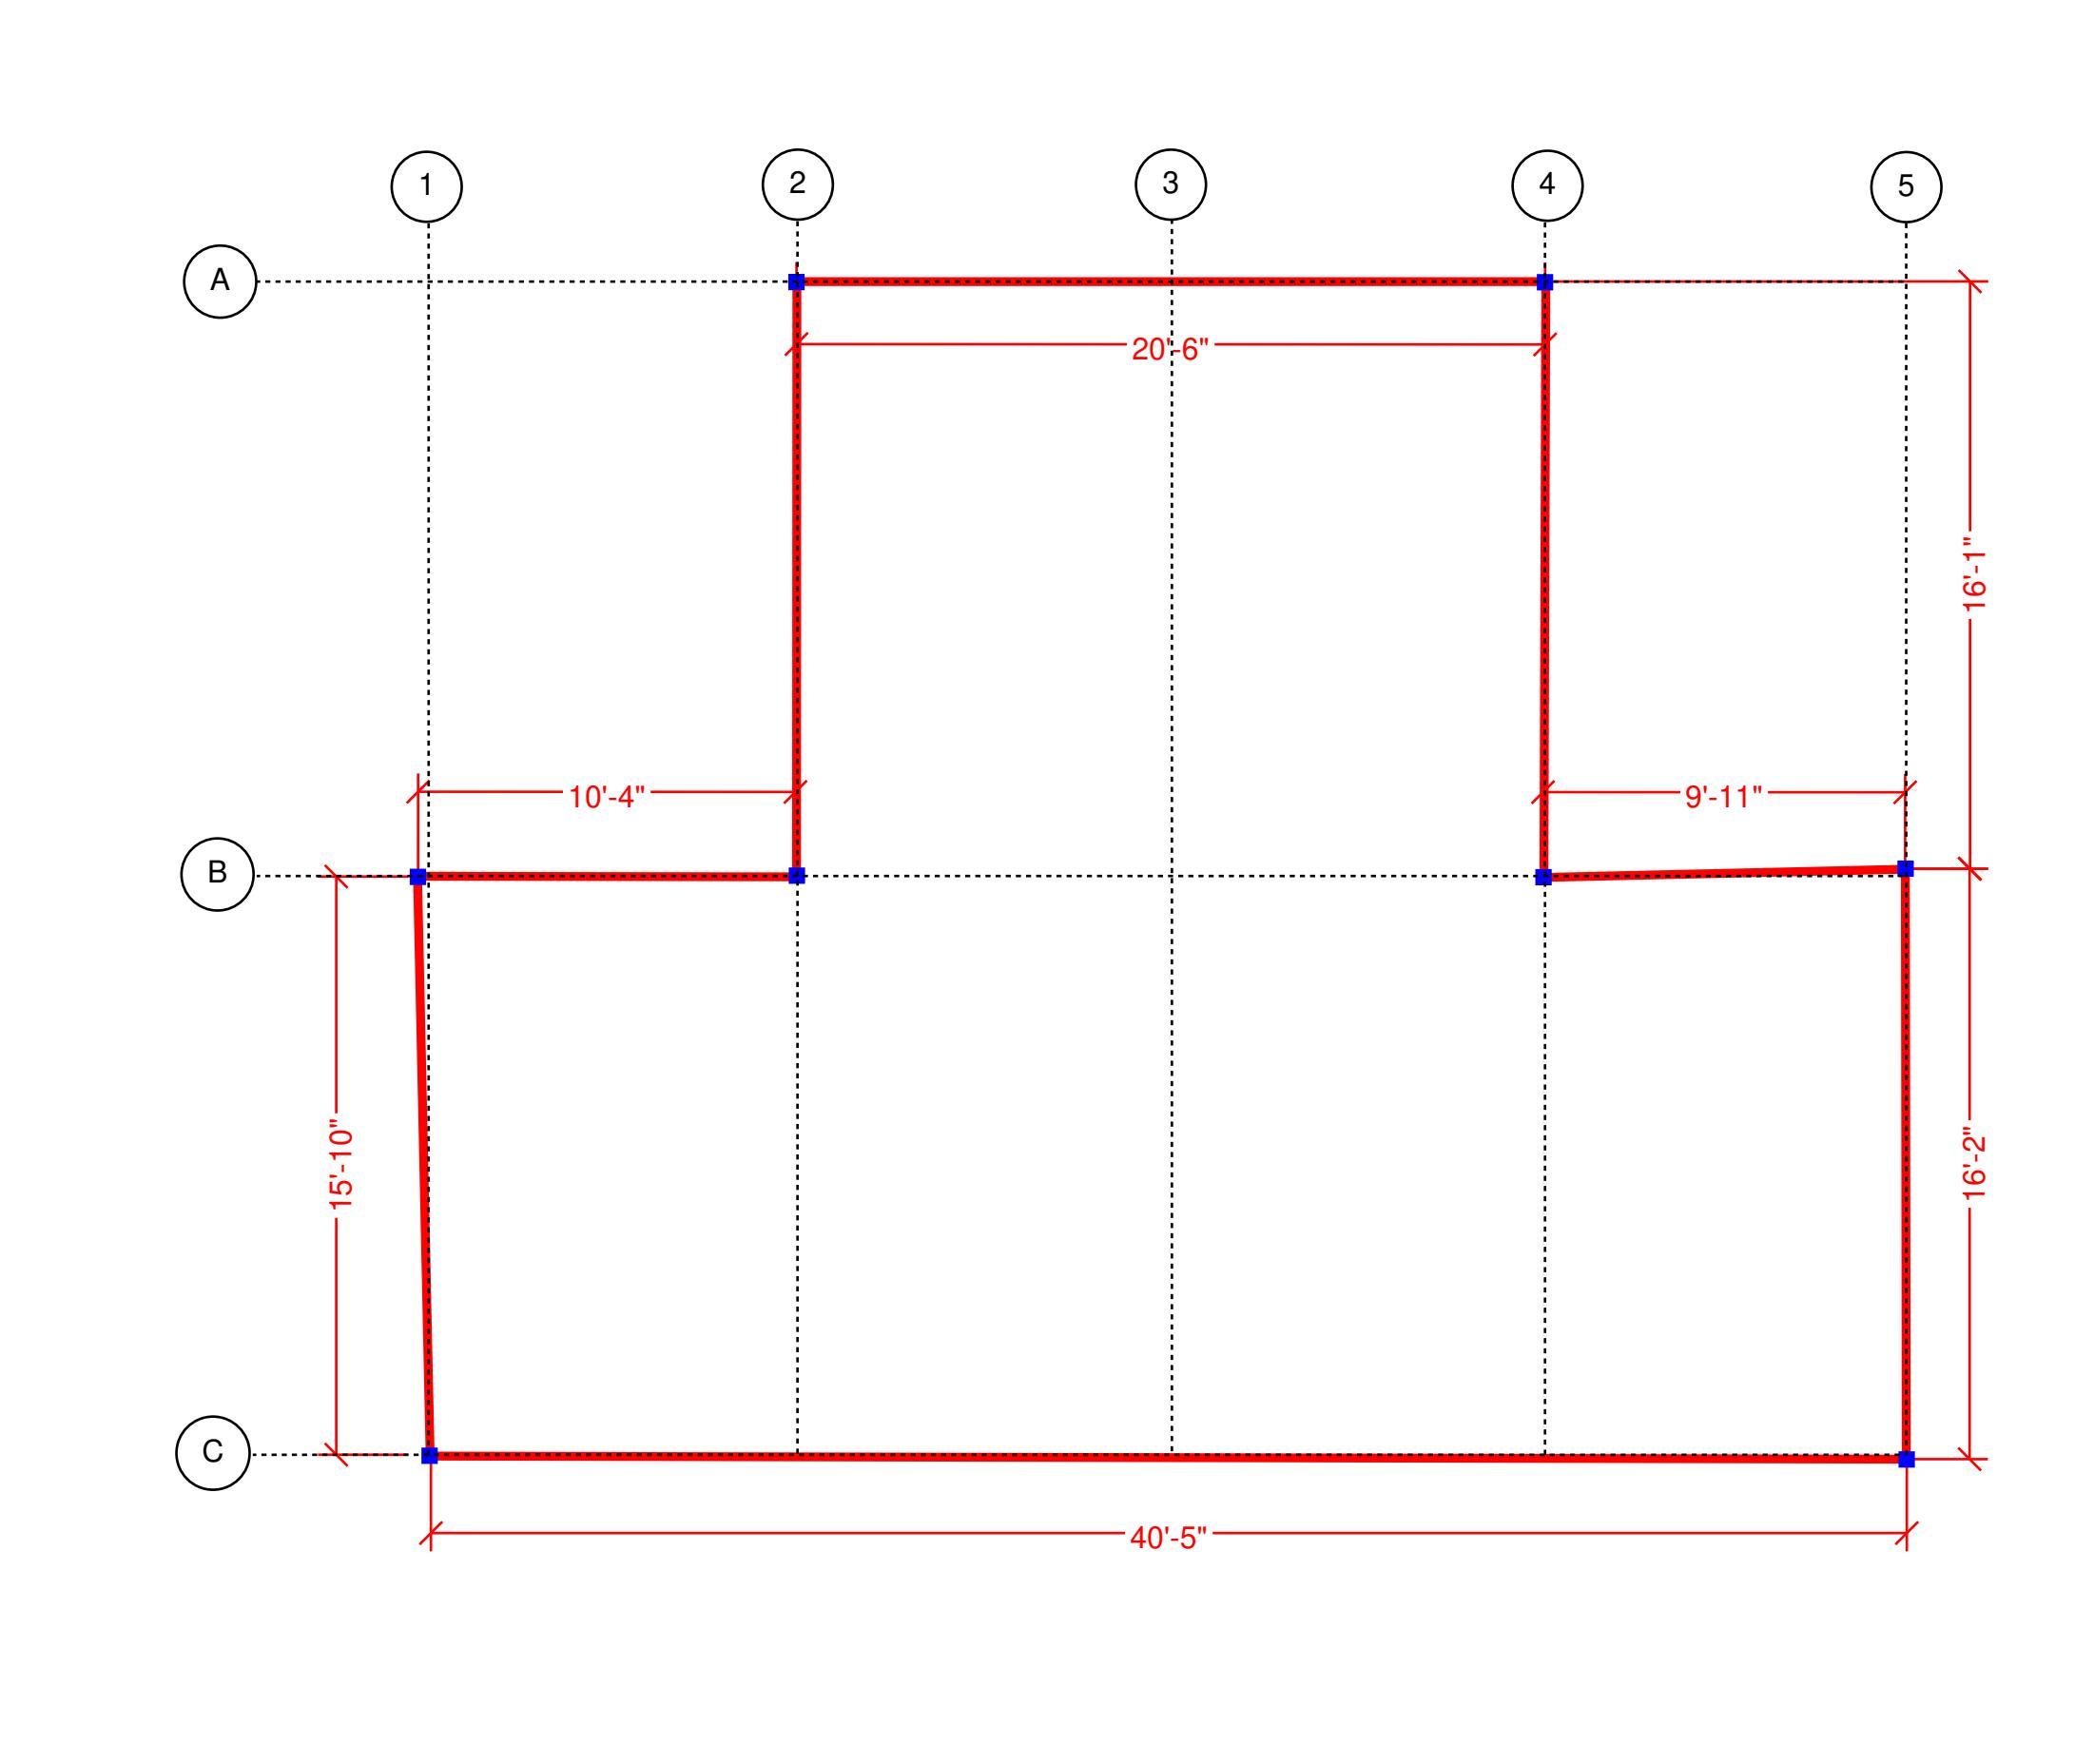
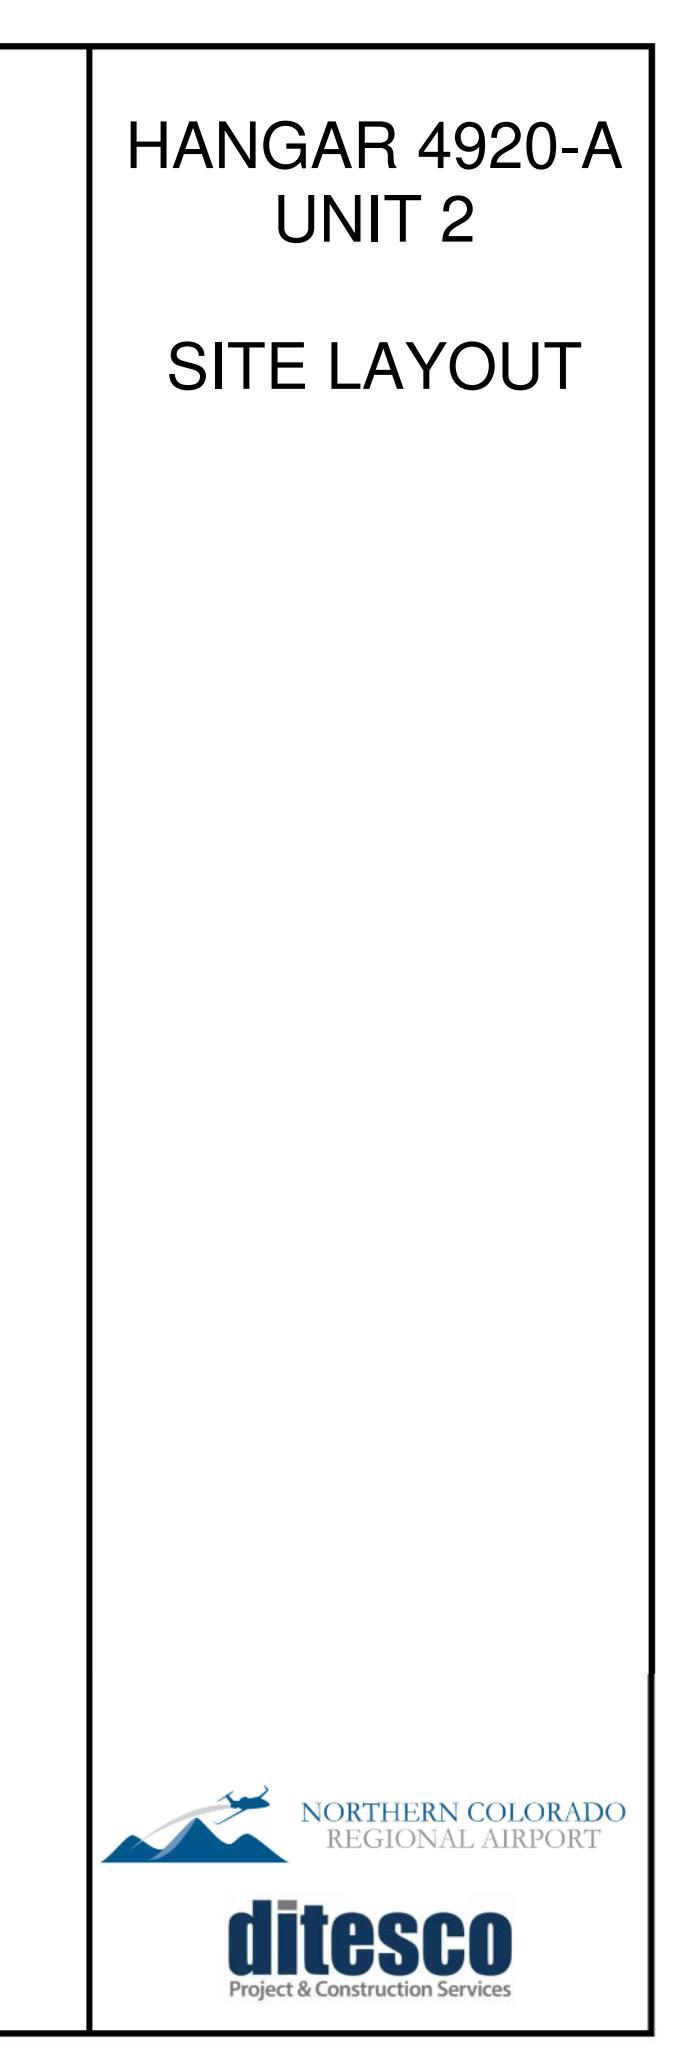
Page 4 of 16

PHOTO 7		PHOTO 10	
Gridline A2		Gridline B4 to B5 and B5 to C5	
Damage to structural member. Column observed to be torqued in the upper third.	08/18/2022 13:07	After market remediation repairs completed. Additional 2 x 4's installed as stiffeners for the columns.	
PHOTO 8 Gridline A			
20-inch diameter caissons with two anchors connected to the column. Depth of foundation is unknown.	DB/18/2022 13:12		
PHOTO 9 Gridline B4 to C4			
After market remediation repairs completed. Additional truss members have been added to the double howe truss.	<u></u>

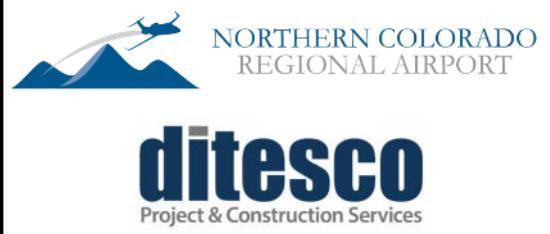
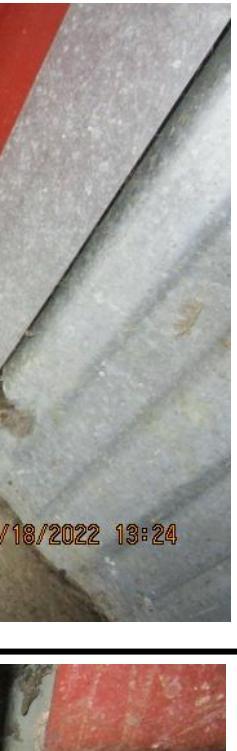
Page 6 of 16

PHOTO 11	ME AND A REAL PROPERTY AND	PHOTO 14	
Gridline C4	MEAS.	Gridline A2	
Deterioration of foundation and missing anchors.	- - - - - - - - - - - - - -	16-inch caisson at column connection. Anchors are missing the nut and washer. Hole in column is oversized for anchor allowing additional movement. Column is incorrectly bearing on the shim.	
PHOTO 12		PHOTO 15	
Gridline B2		Gridline A4	
16-inch caisson at column connection. Missing anchors and incorrectly bearing on shim.		Concrete failure of foundation at anchor location. Anchor is missing nut and washer. Hole in column is oversized for anchor allowing additional movement.	
PHOTO 13			
Gridline B2			
Incorrect installation of structural members. Wall girt should be bearing on welded bracket.	B/18/2022 13:23
