NORTHERN COLORADO REGIONAL AIRPORT COMMISSION

Hangar Leases Discussion and Possible Executive Session Consistent with C.R.S. Sections 24-6-402(4)(e)(I), 4(a), and 4(b)

RE: Northern Colorado Regional Airport
T-Hangar Structural Analysis

T-Hangar Observation Report Log

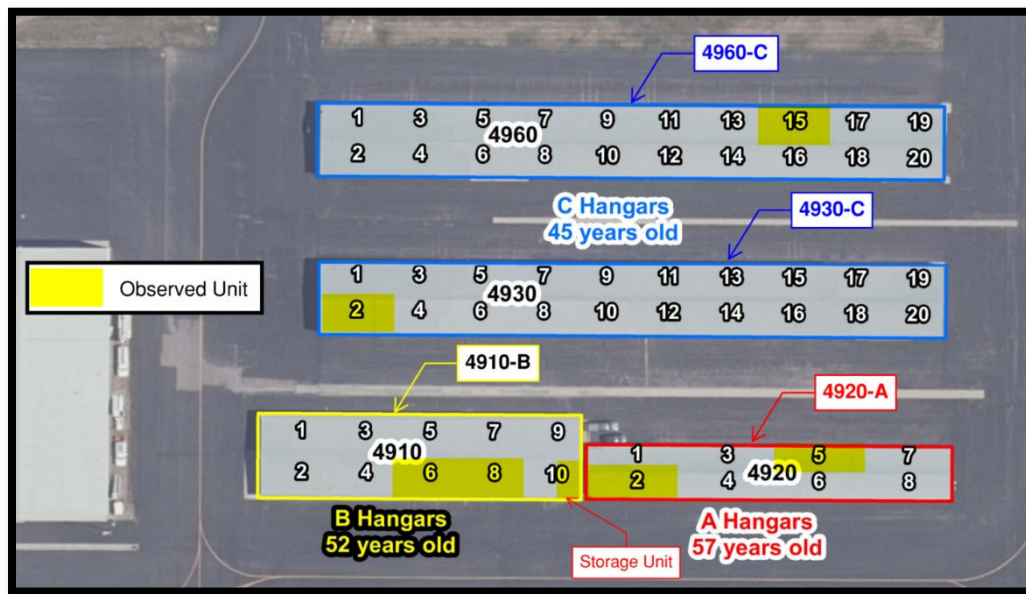
Figure 1

Ditesco performed a structural evaluation of the four hangars on August 18, 2022. Due the high-level approach of this report, only select units were inspected in detail, as shown in Figure 1. The conditions observed in the select units were assumed to be representative of the hangars in their entirety.

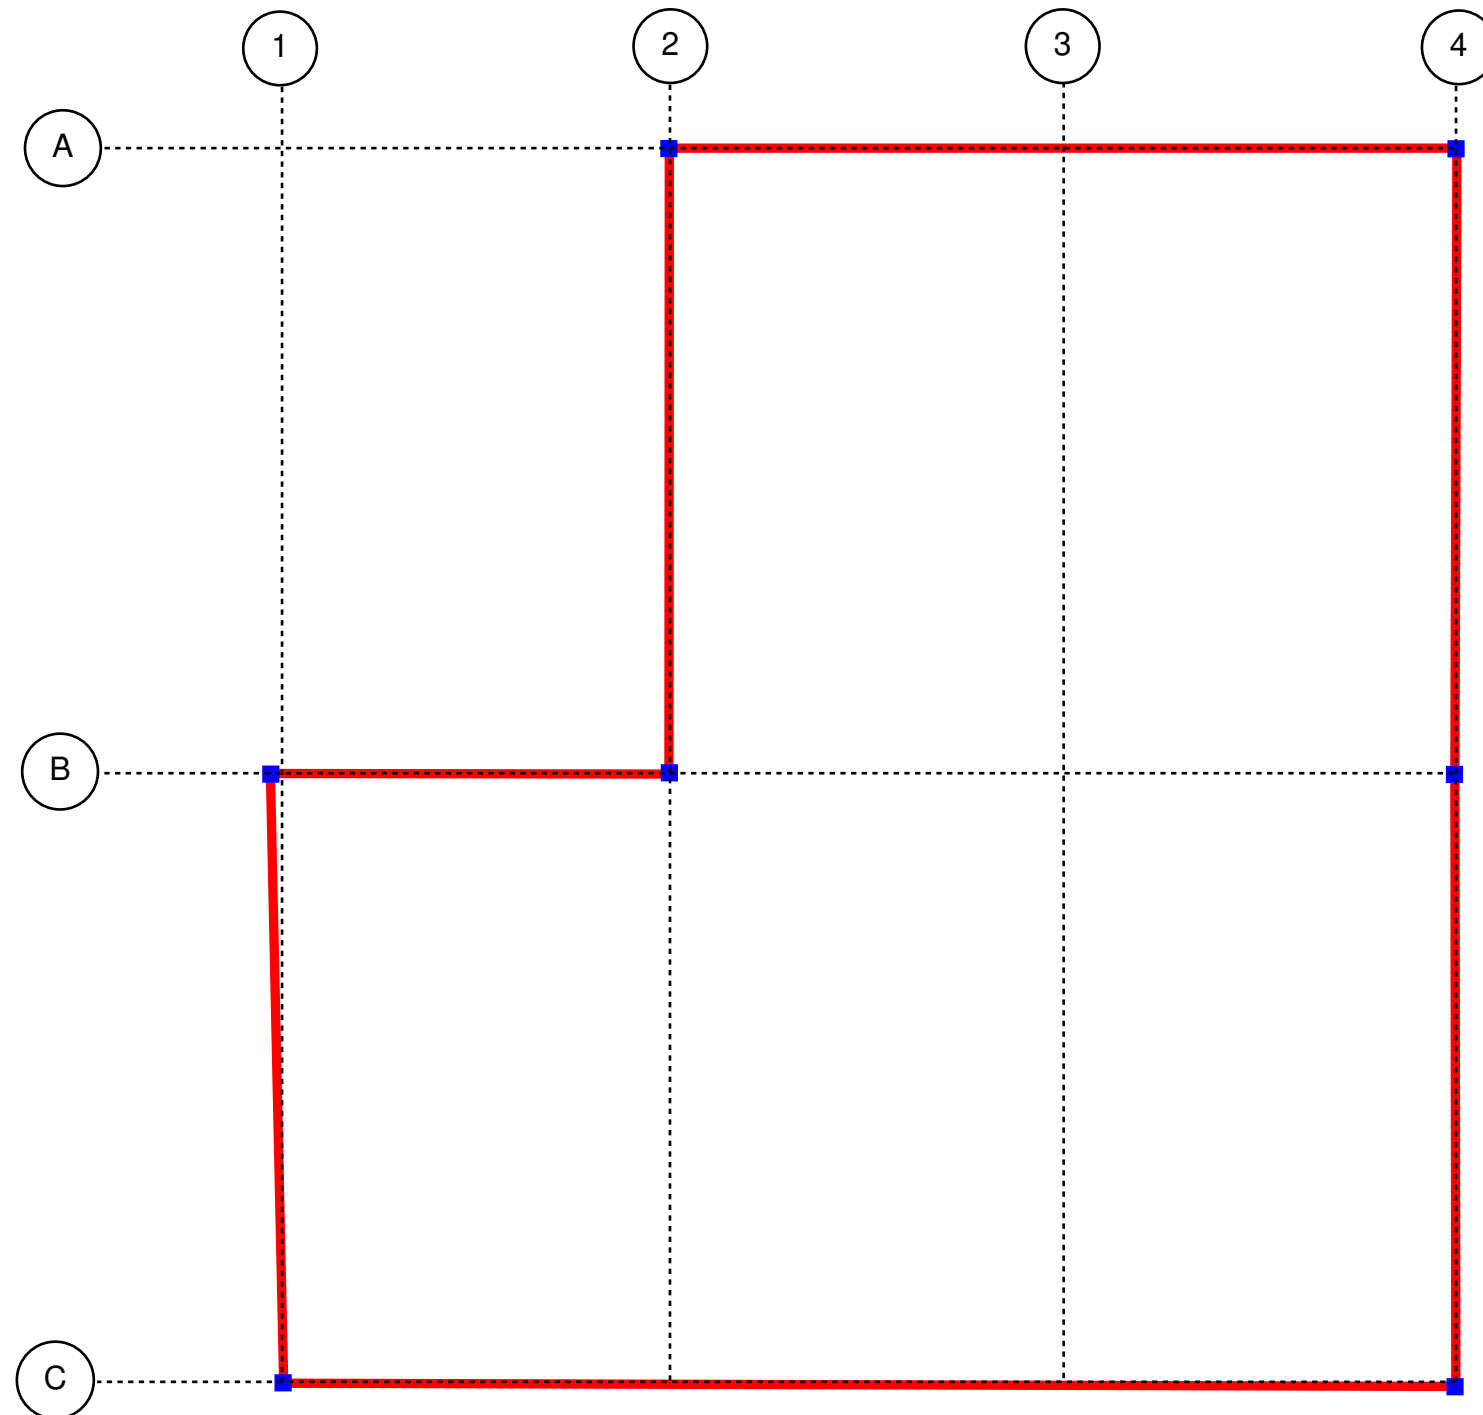
HANGAR 4910-B STORAGE UNIT

<div>PHOTO 11</div> <div>Gridline C4</div> <div>Deterioration of foundation and missing anchors.</div>

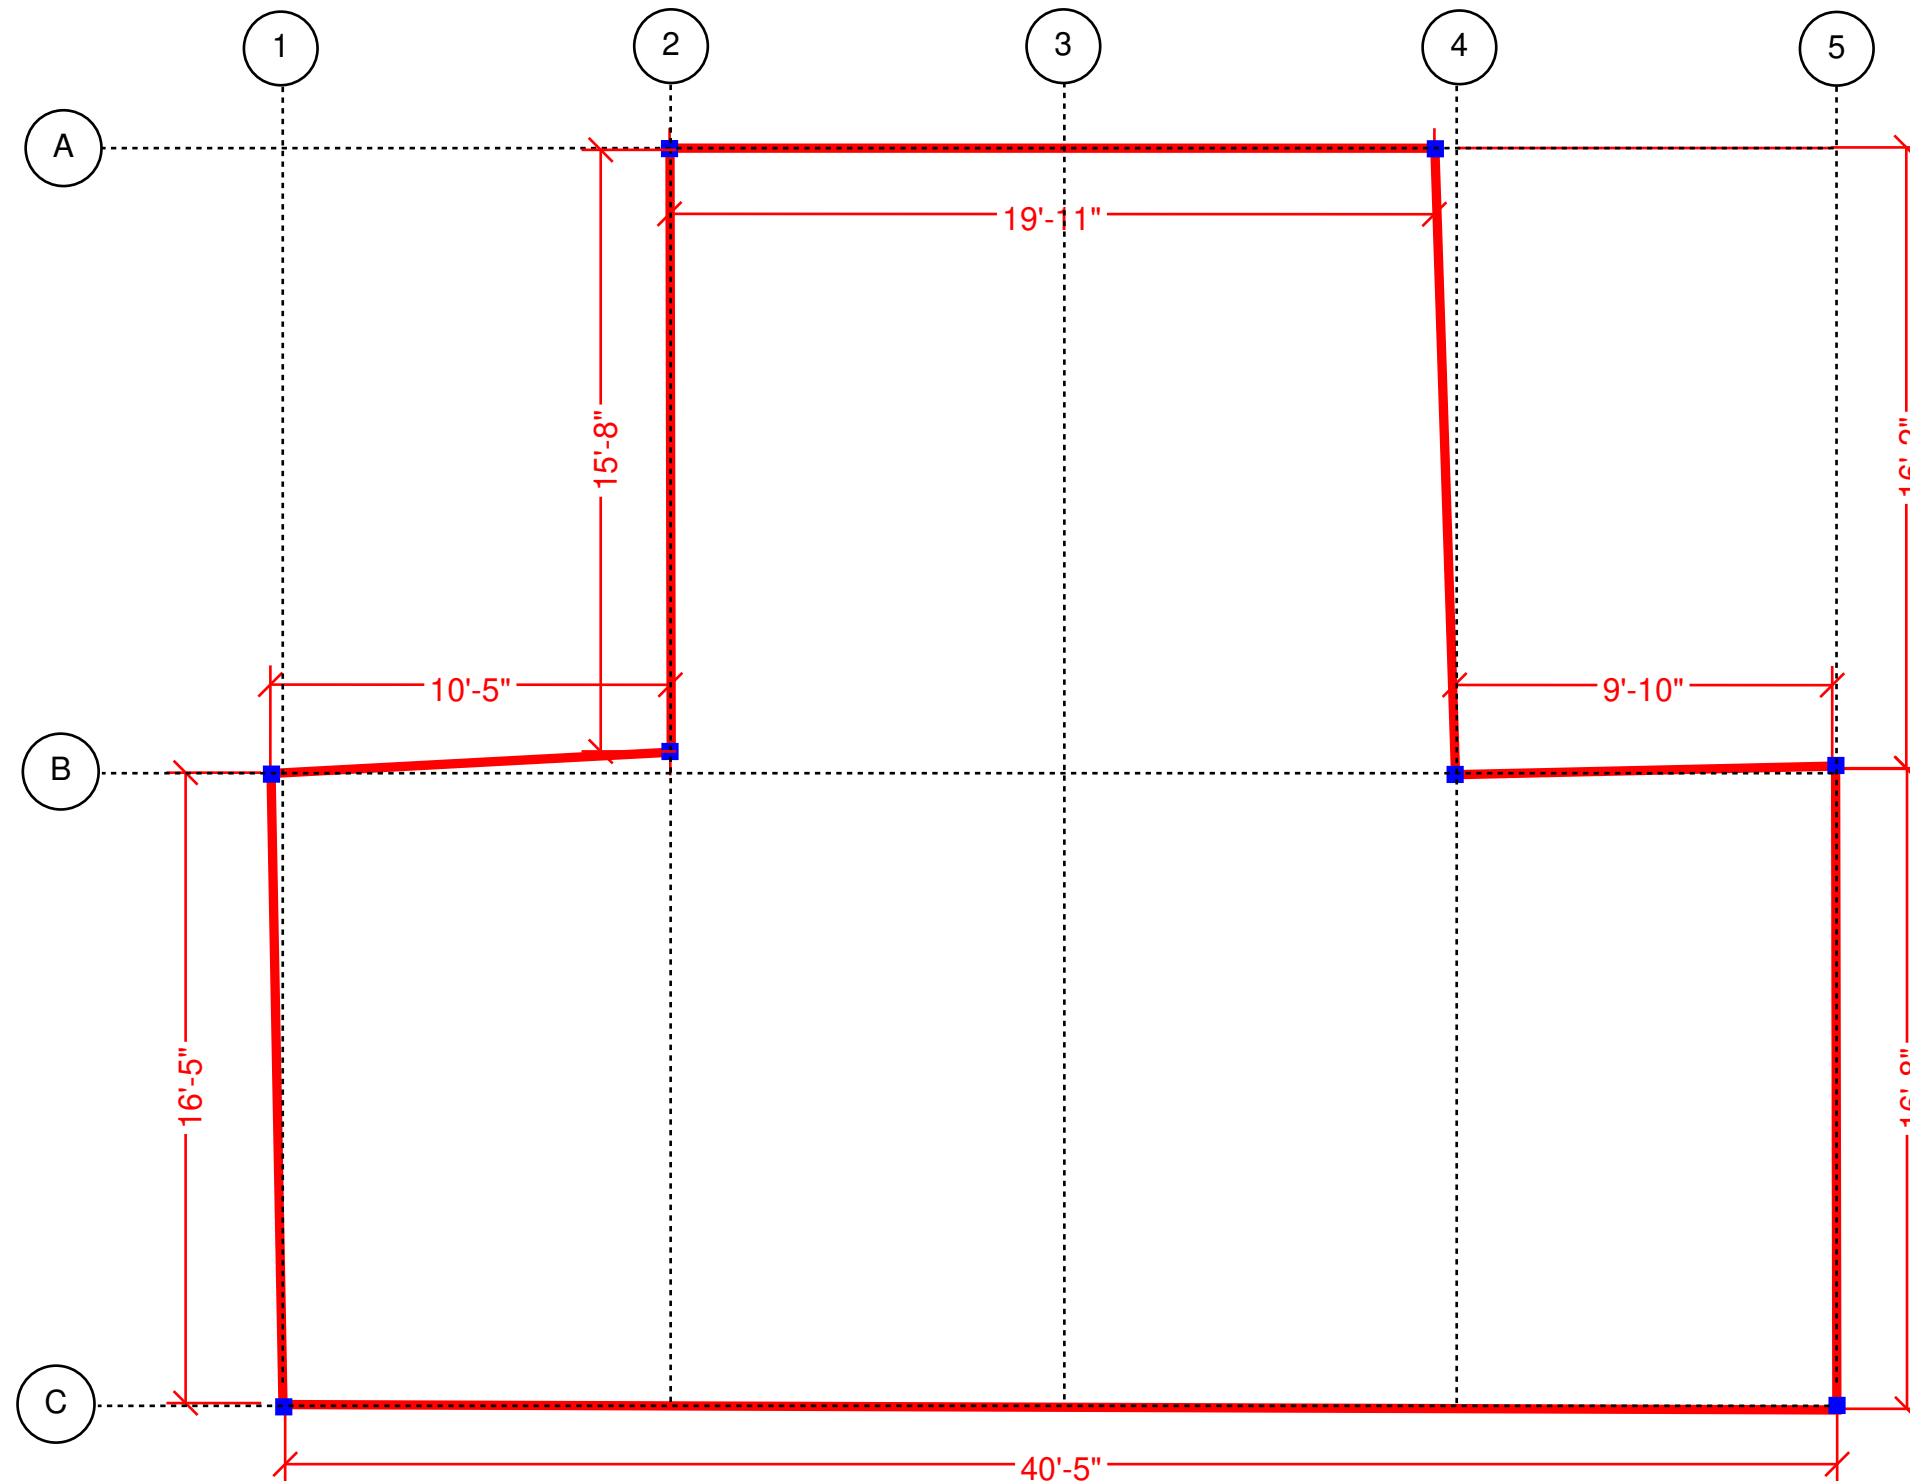
HANGAR 4910-B UNIT 6

<div>PHOTO 16</div> <div>Gridline C</div> <div>Poorly maintained wheel roller mechanism.</div>

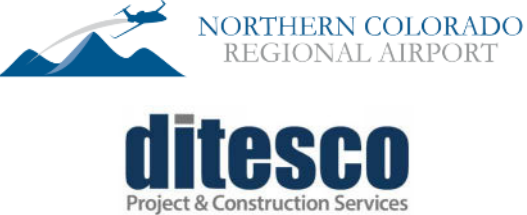
</div>
<div>PHOTO 17</div> <div>Gridline C4</div> <div>After market remediation repairs. Cable installed from floor to beam to prevent doors from falling into hangar.</div>

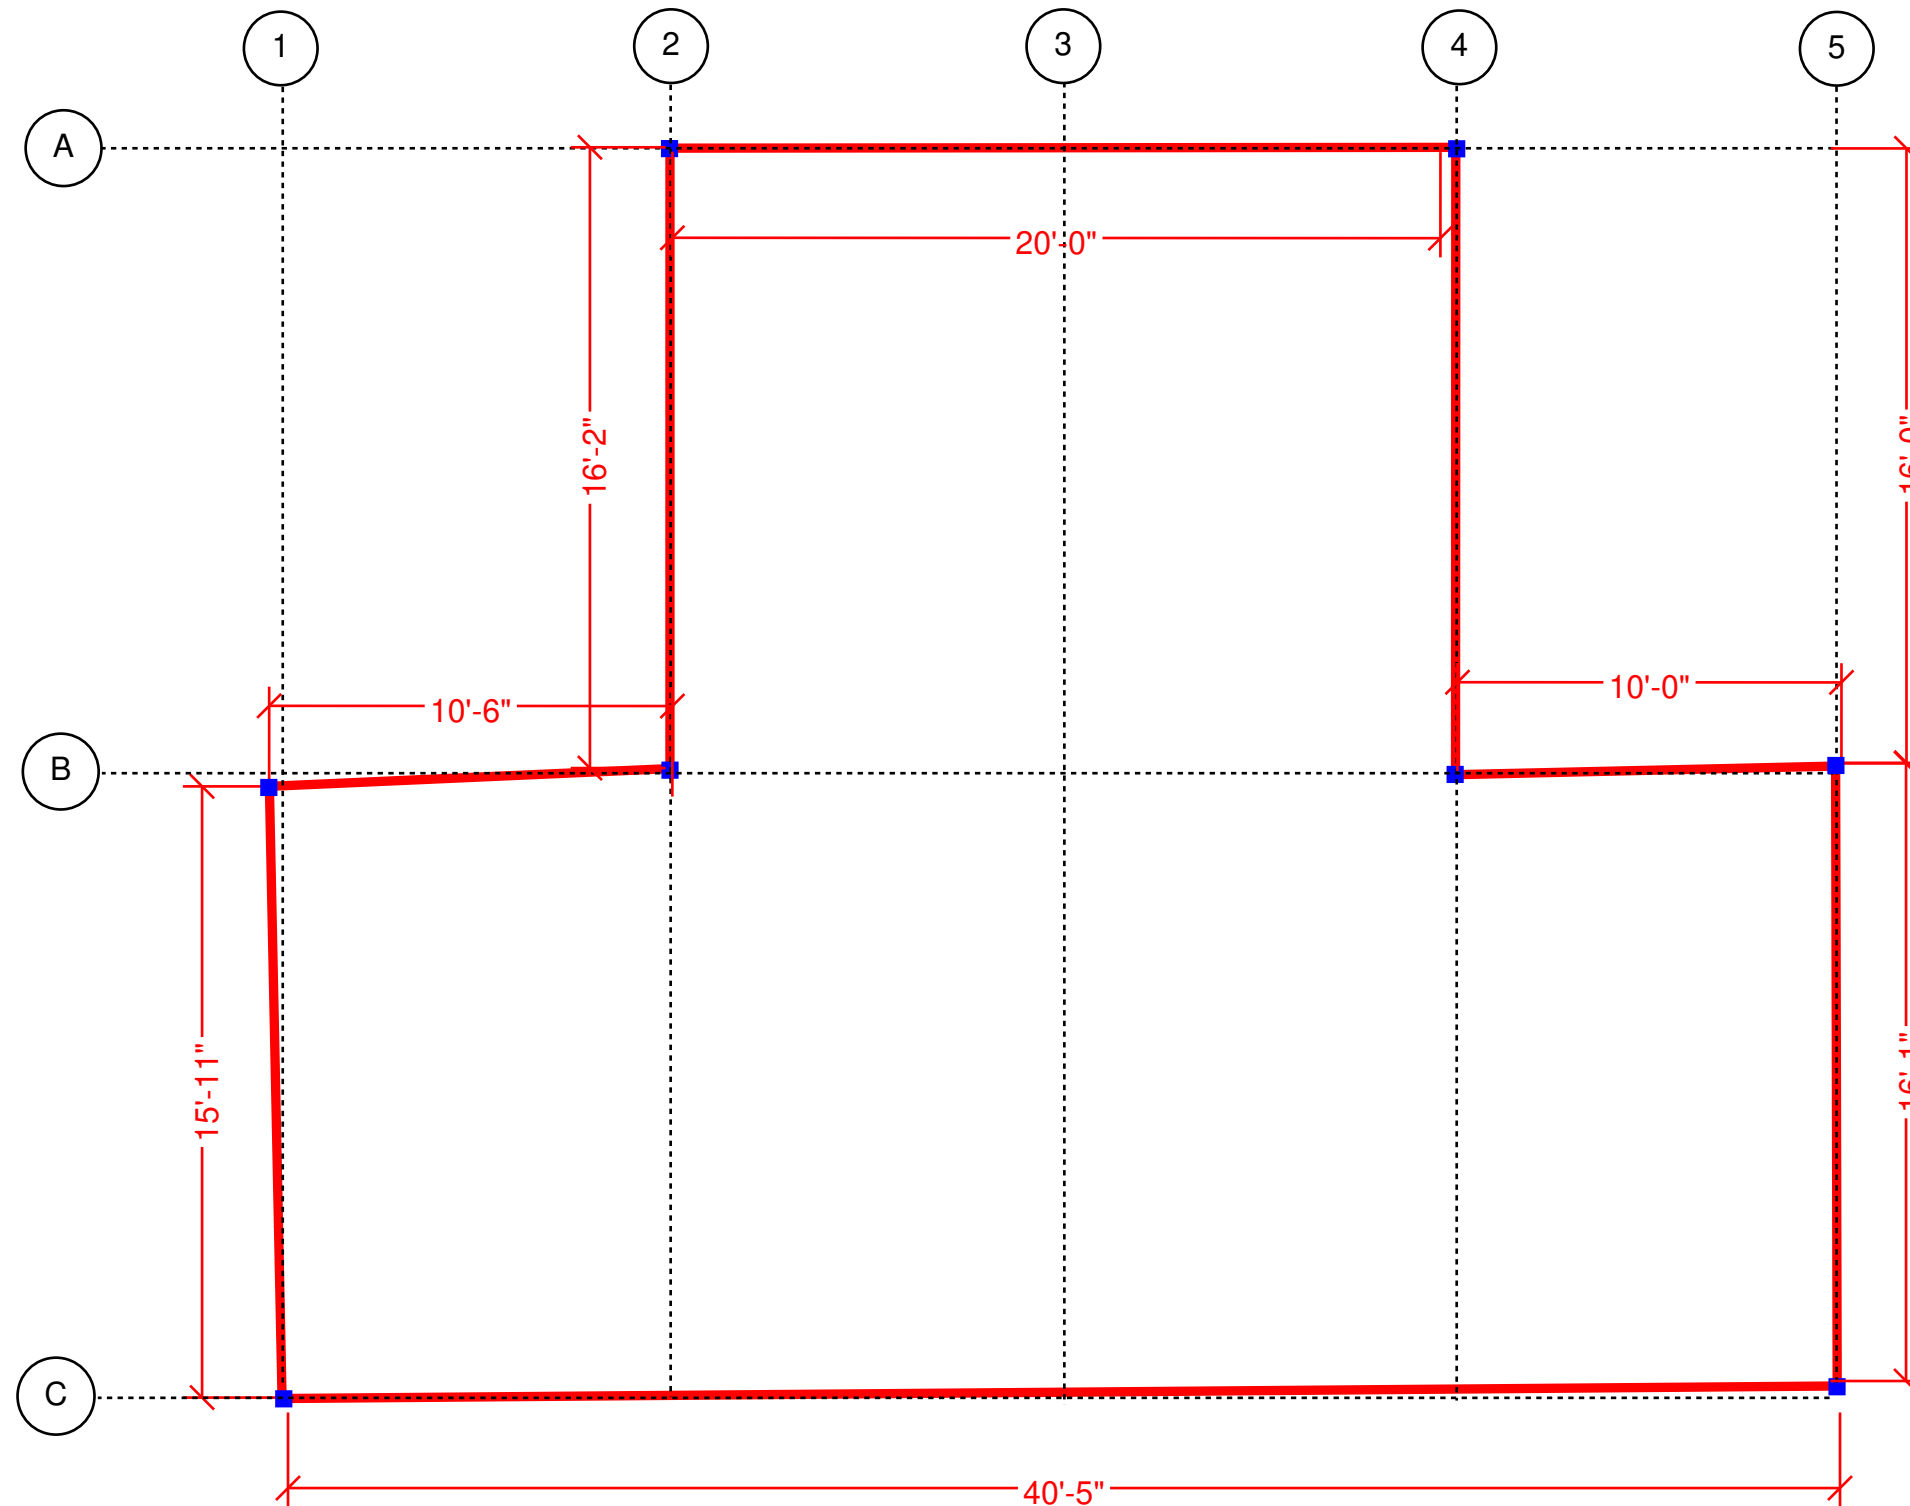
HANGAR 4930-C UNIT 2

<div>PHOTO 30</div> <div>Gridline C</div> <div> <p>Mill and overlay maintenance has resulted in taxilane grade higher than hangar finish floor, resulting in poor drainage.</p> </div>
