DATE:	September 20, 2022
TO:	Aaron Ehle - Northern Colorado Regional Airport
FROM:	Jill Burrell, PE – Ditesco Kelsey Madsen, PE - Ditesco
RE:	Northern Colorado Regional Airport T-Hangar Structural Analysis

Appendix A T-Hangar Observation Report Log

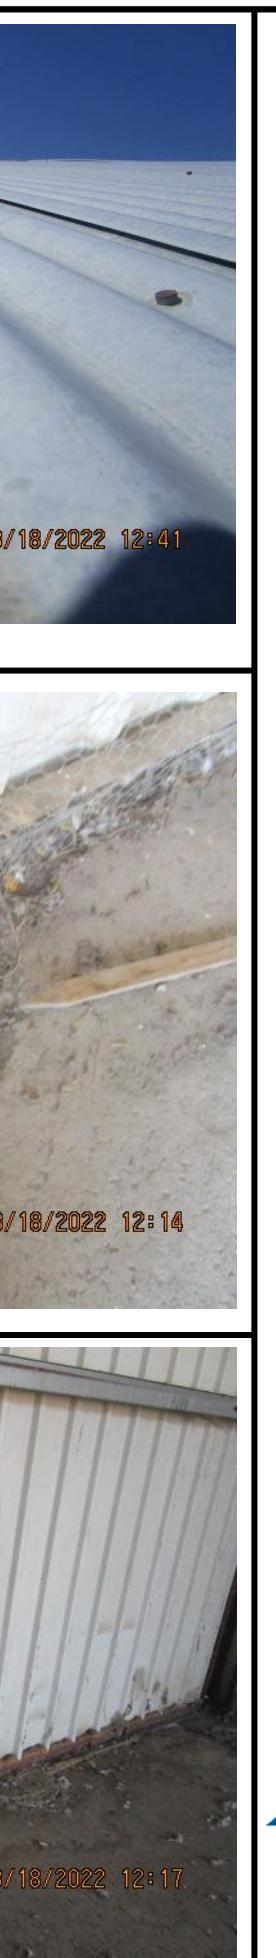
HANGAR 4920-A UNIT 5

Gridline C	Contraction of the the	Entire Structure	
Unsuitable, expansive soils are causing the pavement to heave.	08/18/2022 12:09	Roof is not properly sealed allowing water infiltration.	08/
РНОТО 2		ΡΗΟΤΟ 5	
Gridling A		Gridling R2	
	Etan Star		
After market		20-inch diameter	
completed. Rebar has		anchors connected to	
along its length.		foundation is unknown.	
	08/18/2022 12:17		Da
PHOTO 3		PHOTO 6	
Gridline C		Gridline A	
The door roller		Damage to exterior	
condition with		metal panels.	
misaligned track.			
	08/18/2022 12:36		08/

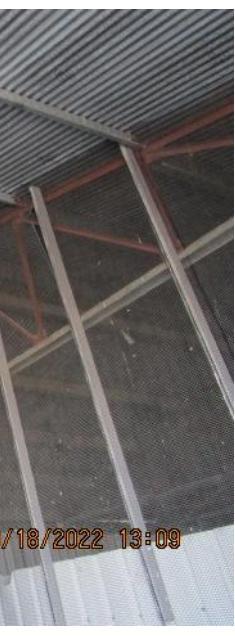
HANGAR 4920-A UNIT 2

PHOTO 7		PHOTO 10	
Gridline A2		Gridline B4 to B5 and B5 to C5	
Damage to structural member. Column observed to be torqued in the upper third.	08/18/2022 13:07	After market remediation repairs completed. Additional 2 x 4's installed as stiffeners for the columns.	
PHOTO 8 Gridline A			
20-inch diameter caissons with two anchors connected to the column. Depth of foundation is unknown.	DB/18/2022 13:12		
PHOTO 9 Gridline B4 to C4			
After market remediation repairs completed. Additional truss members have been added to the double howe truss.	<u></u>

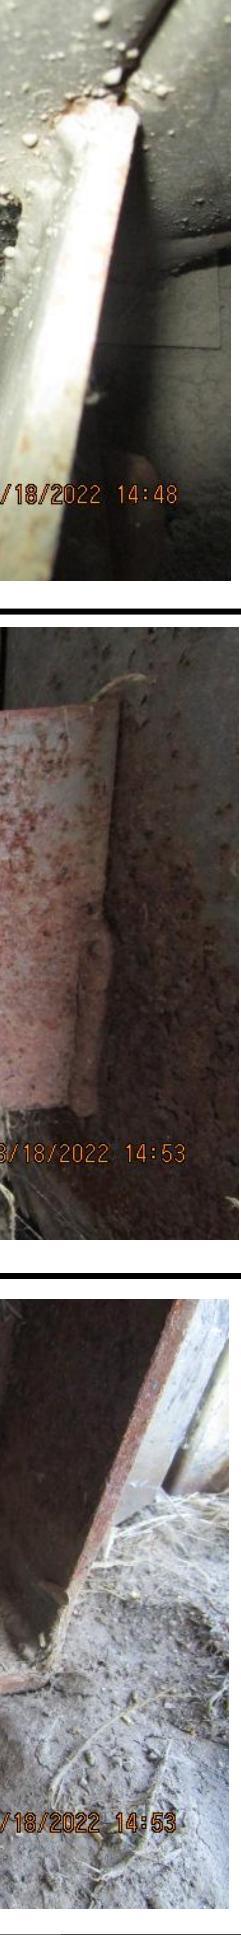
HANGAR 4960-C UNIT 15

Corrosion was present on the steel columns, anchor bolts, and the hangar door track. In some instances, the corrosion at the column led to pitting of the steel creating an oversized hole at the anchor bolt connection, as shown in Photo 35 of Appendix A. The oversized hole allows excess movement of the structure, or in the most severe cases, provide no connectivity to the foundation. In Hangar 4930-C (Unit 2), the column at Gridline B4 had an anchor bolt completely removed from the foundation. The anchor bolt was severely corroded and assumed to be undersized compared to current industry standards. Additionally, in Hangar 4960-C (Unit 15), the corrosion of the steel resulted in a failed weld at the tension rod connection to the column at Gridline B4.

PHOTO 35		PHOTO 38	
Gridline C1		Gridline B4	
Corrosion of steel column resulting in oversized hole at anchor bolt location. Column is not anchored to concrete at this location.	08/18/2022 14:44	Top view of failed weld at tension rod connection to column.	
PHOTO 36		PHOTO 39	
Gridline B4		Gridline C5	
Corrosion of tension rod and column.	08/18/2022 14:48	Corrosion of tension rod.	
PHOTO 37		PHOTO 40	
Gridline B4		Gridline C5	
Side view of failed weld at tension rod connection to column.	08/18/2022 14:48	Corrosion of column and anchor bolt. Column load bears poorly on foundation.
